**ENHANCE PLACE MINE**

**2020**

**ANNUAL ENVIRONMENTAL  
MANAGEMENT REPORT**

**(Small Mine Version)**

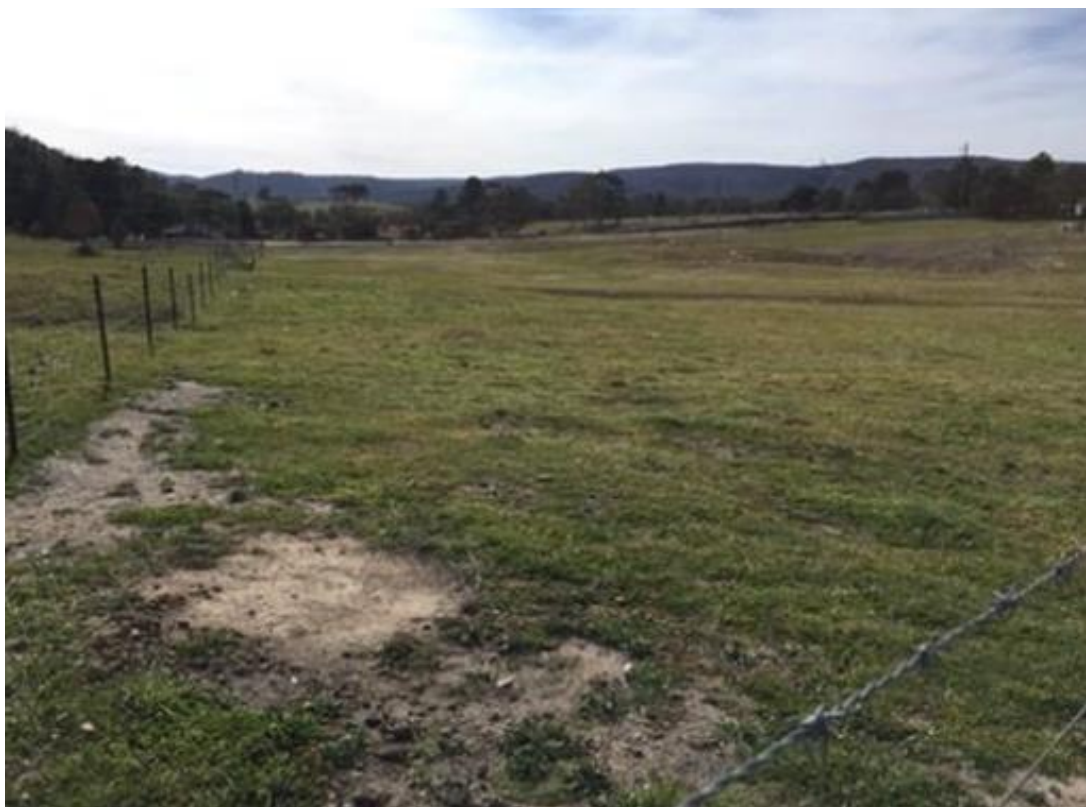
**Photograph 1** *Quadrat 1 from southwest looking northeast*

- An overall increase in pasture total living cover was observed compared to the 2019 reporting period at all four quadrats. The percentage of annual living cover has decreased in favour of perennial species at quadrats 1, 2 and 4. Quadrat 3 has increased due to an increase in the annual species.

As groundcover conditions were considered satisfactory, and due to the challenges and restrictions imposed by the Coronavirus Pandemic application of fertiliser was not undertaken during the 2020 reporting period.

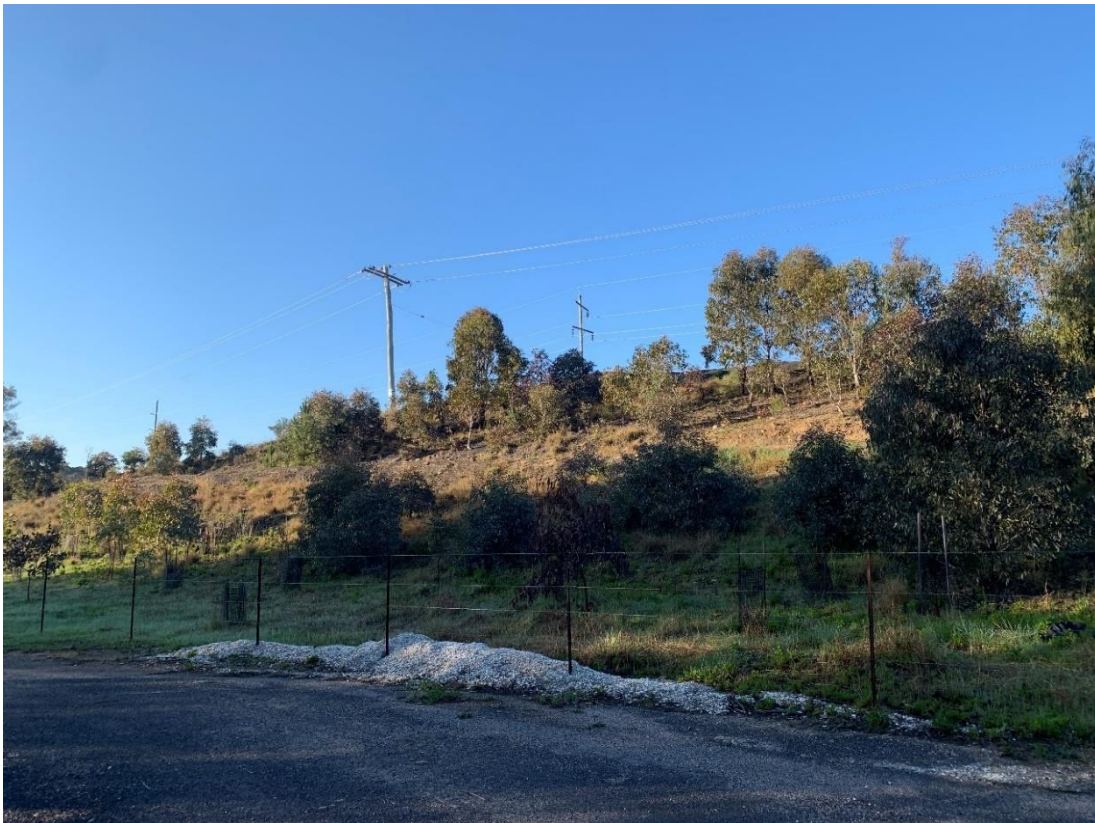
**Photograph 5** *Transect 8 looking south*

Total living groundcover in the treed rehabilitation areas was noted to increase from 80% during 2019 to 90% at transect 8. The total living groundcover at transect 7 has remained stable since 2019 at 80%. Establishment of vegetation in the treed rehabilitation areas is considered good with more than 80% of native forest indicator species represented. A photo of the treed area during October 2020 is shown in Photograph 5

- Total living area within the treed area has remained unchanged at transect 7 and has increased at transect 8. Both transects showed an increase in perennial cover.
