Neubecks Creek Ecological Monitoring Program Report Spring 2012-Spring 2018

Neubecks Creek EMP Spring 2012 to Spring 2018

Prepared for EnergyAustralia NSW

24 September 2019

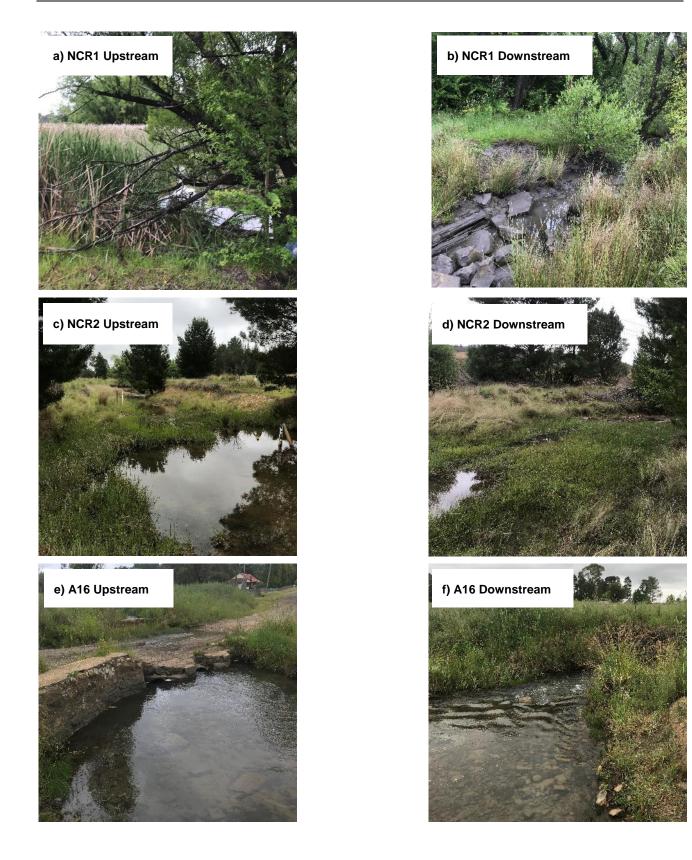
While the section of Neubecks Creek at the impact site NCR2 (**Plate 1c** and **d**) also did not appear to have been subject to recent modification, the banks just downstream of the site had been re-sectioned and reinforced. Riparian vegetation consisted primarily of grasses and a few isolated trees. The absence of substantial bank stabilising vegetation likely explains the bank slumping and erosion present throughout the site. The channel consisted of loose material covered with fine sediment / diatom layer. A concrete gauging station / ford situated through the centre of the site acted as a small weir. Bank slumping was evident, though bank material was somewhat stabilised by grasses. The channel consisted primarily of loose cobbles and pebbles and moderate water flow was present at the time of sampling.

The relatively steep banks, uniform bank profile and absence of any trees and other substantial riparian vegetation at A16 (**Plate 1e** and **f**) suggest that this section of the Coxs River has been re-aligned and / or re-sectioned. Bank slumping was present, though bank material was somewhat stabilised by grasses. The channel consisted primarily of loose cobbles and pebbles and moderate water flow was present at the time of sampling.

Plate 1: Photographs of NCR1 looking a) upstream and b) downstream, NCR2 looking c) upstream and d) downstream and A16 looking e) upstream and f) downstream in spring 2018
