# PINE DALE MINE ANNUAL REVIEW 2020

**Prepared by Enhance Place Pty Ltd  
Revision 1.2 – 12 February 2021**

This Annual Review has been prepared pursuant to Schedule 5, Condition 3 of the Project Approval 10\_0041, and in accordance with the Annual Review Guideline developed by the NSW Department of Planning and Environment (Ref [1]).

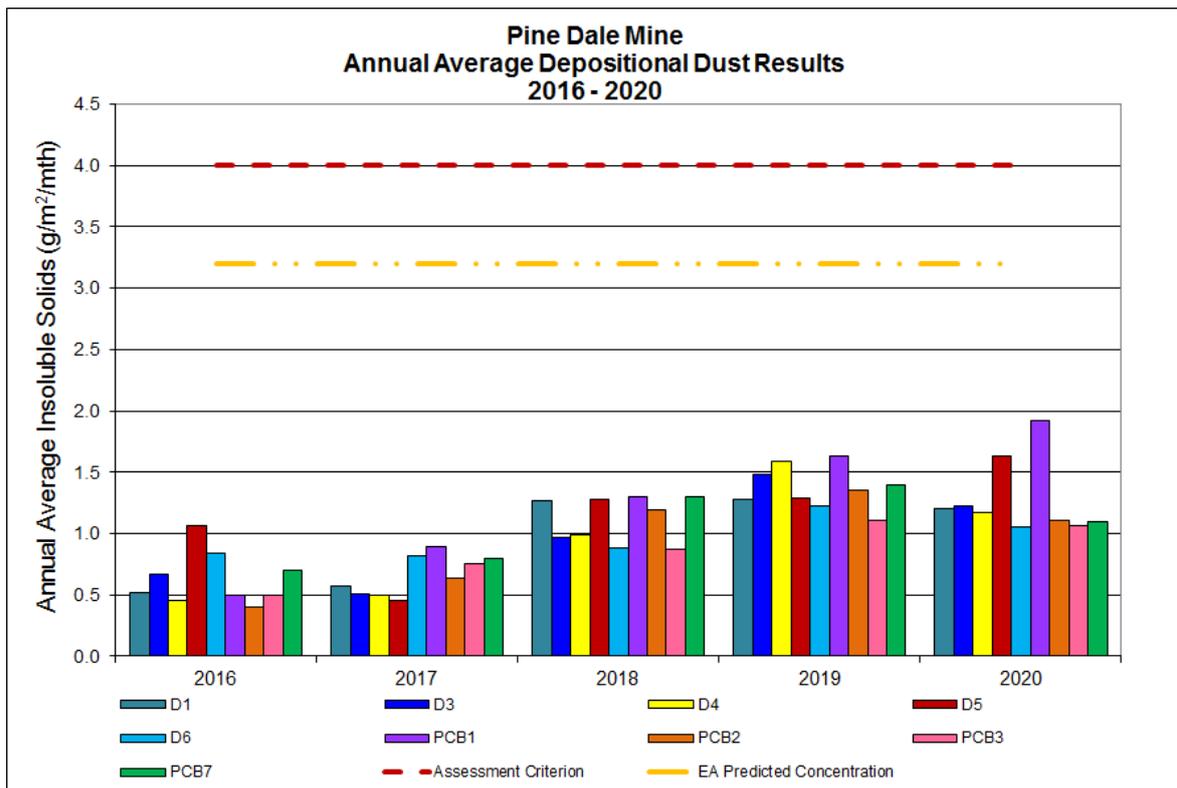
**Figure 6-1** *Depositional dust data: 2016 – 2020*

<b>Annual average assessment criterion: 4.0g/m<sup>2</sup>/month</b>

An examination of the historical data (refer **Table 6-3**) indicates most dust monitoring locations show a slight decrease in the 2020 annual averages deposited dust concentrations when compared to the 2019 annual averages. Dust monitoring locations D5 and PCB1 were an exception showing a slight increase ( $0.3\text{g/m}^2/\text{month}$ ) and PCB3 which showed no change. Annual average deposited dust concentrations are generally shown to be higher in 2020 than in 2016 and 2017 (refer **Figure 6-1**). This is not considered to be due to a change in site activities at PDM as the mine has been in care and maintenance since 2014, rather it is considered to be influenced by prolonged dry conditions due to below average rainfall (refer **Section 6.3**) resulting in low soil moisture, making the region more prone to dust storms. Dust storms were observed during 2018, 2019 and early 2020. Furthermore, bushfire activity during late 2019 and early 2020 would have also partially influenced the annual average deposited dust concentrations. Increased rainfall during 2020, has resulted in a slight decrease in deposited dust concentrations from the 2019 reporting period. The 2020 annual average deposited dust concentrations are shown to be lower than the concentrations predicted in the site Environmental Assessment annual average criterion of  $3.2\text{g/m}^2/\text{month}$  annual average (refer **Table 6-1**).

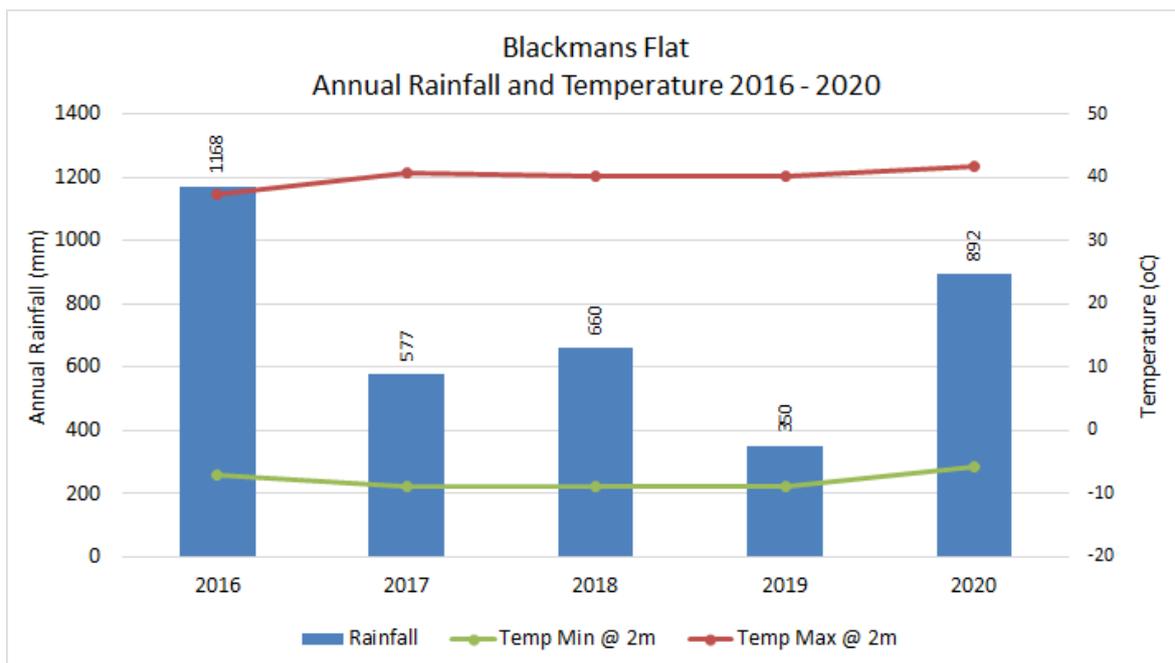
**Figure 6-3** Annual Temperature and Rainfall Summary: 2016 – 2020

The total annual rainfall and the minimum and maximum temperature at 2m is shown graphically in **Figure 6-3**.

PDM received 892mm of rainfall across 165 rainfall days during the 2020 reporting period. Rainfall during this reporting period was observed to be greater than the annual rainfall recorded during 2019 (350mm), 2018 (660mm) and 2017 (577mm). The rainfall recorded during 2016 was 1.3 times the amount recorded during 2020.

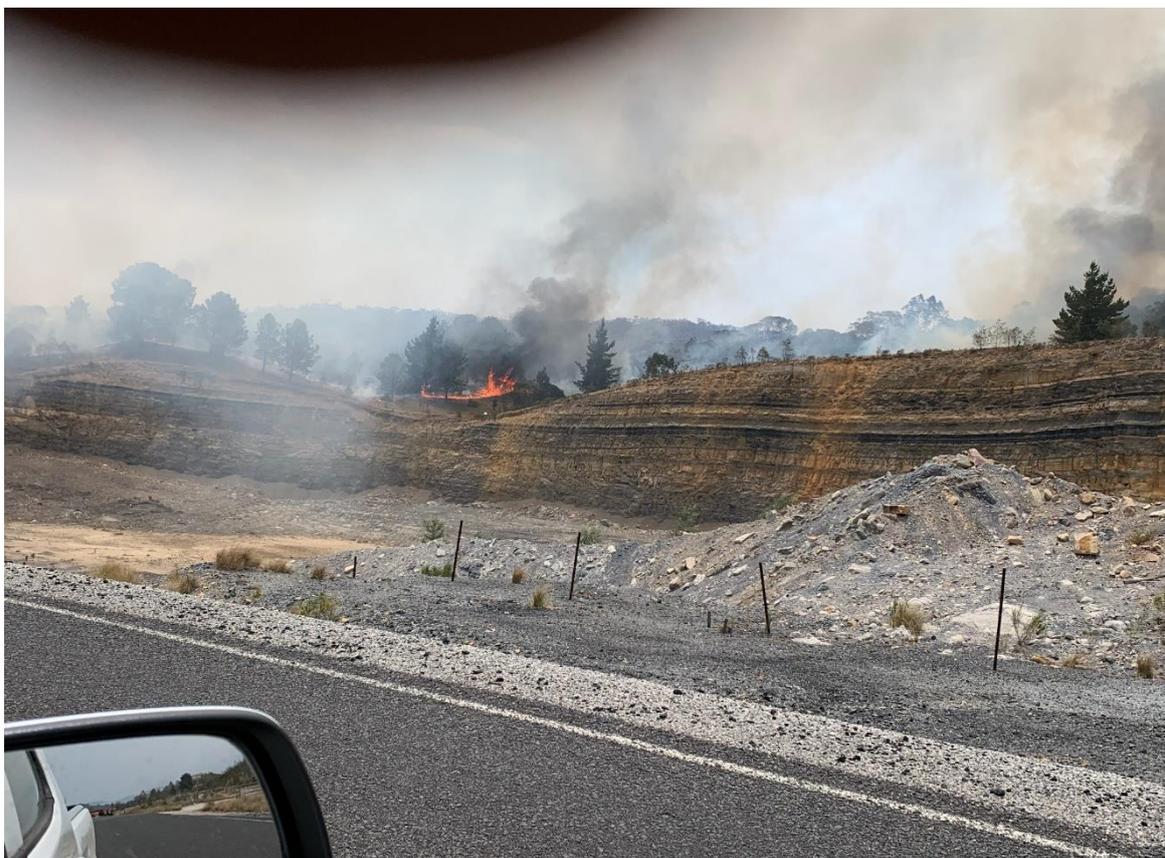
**Photograph 6-1** *Gospers Mountain Bushfire impacting PDM*

**Photograph 6.1** shows fire activity at PDM and **Photograph 6.2** shows the fire activity in the surrounding area. Bushfire activity continued to persist in the region throughout February 2020 and detrimentally influenced air quality (refer **Section 6.2**). Due to bushfire damage in Ben Bullen State Forest, access was prohibited by Forestry Corporation of NSW during period January 2020 – September 2020. The forest was opened in October 2020.

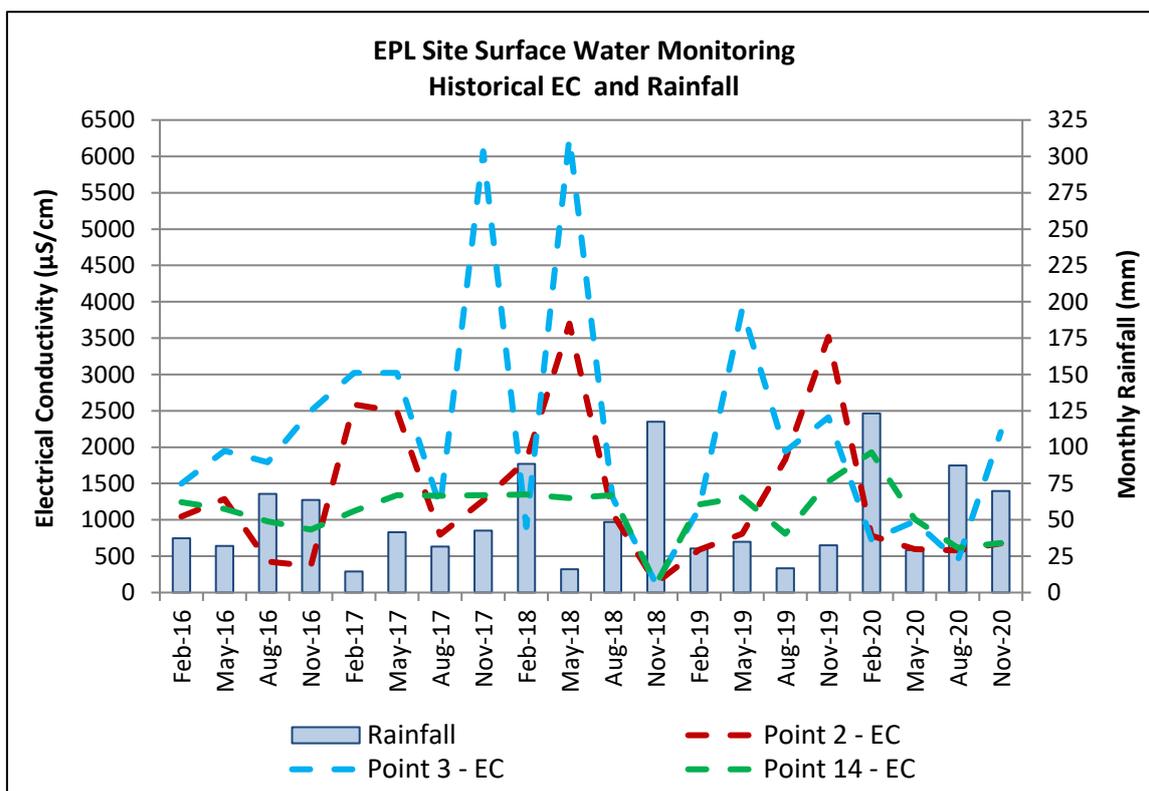
**Figure 7-2** Surface water at EPL monitoring points: Rainfall and (EC)

Monthly rainfall totals greater than 50mm appear to influence lower electrical conductivity results at EPA Points 2 and 3 presumably through dilution from runoff. (refer **Figure 7-2**). The elevated electrical conductivity at EPA Point 14 which was in excess of the approved trigger value during the February 2020 monitoring event is considered to have been influenced by the elevated electrical conductivity (refer **Figure 7-2**), from the licenced discharge point upstream of PDM. This exceedance is not considered to be attributable to PDM activities.

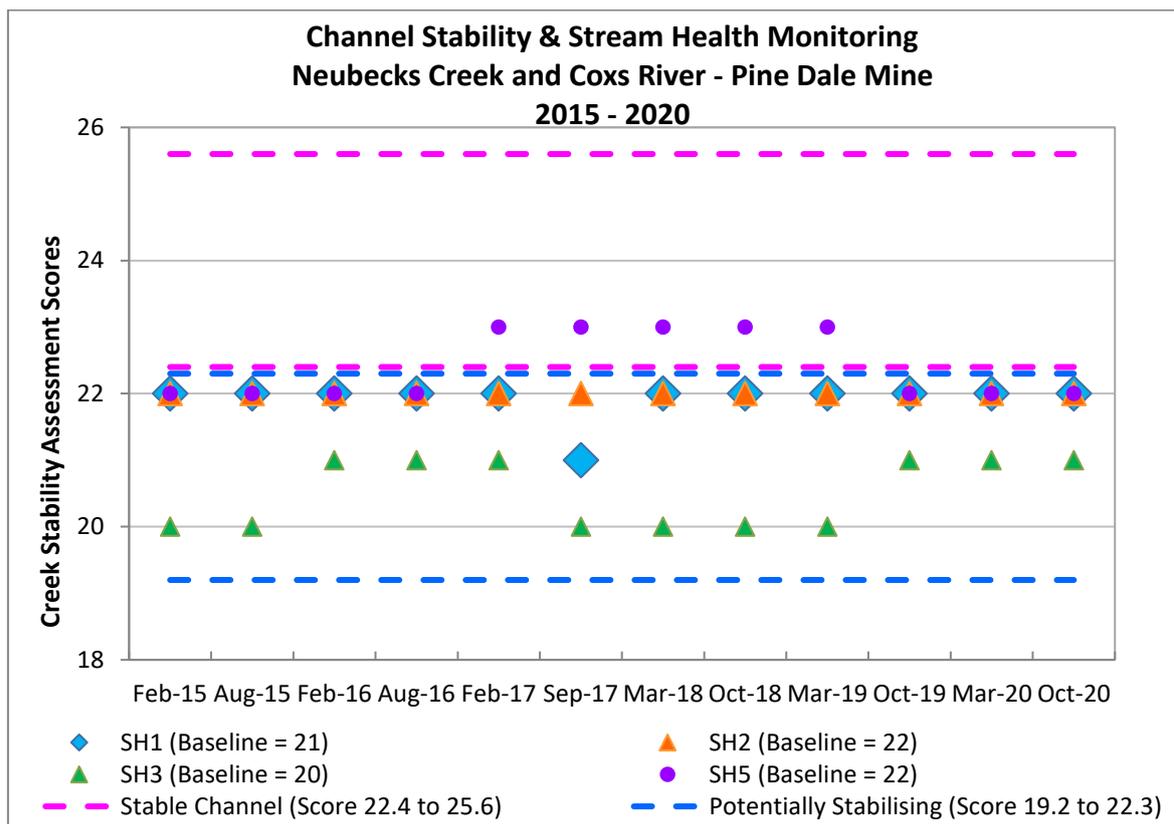
**Figure 7-9** Channel Stability and Stream Health Scores

Follow-up (six-monthly) assessments were conducted at the same monitoring locations, results of which indicated there had been no major change to the Neubecks Creek and Coxs River drainage lines, with each monitoring location classified as 'potentially stabilising'. During the 2017 assessment, the classification of Neubecks Creek did not change, however the particle size of the material on the Coxs River drainage line floor (site SH5) improved and the site was classified as 'stable'; these classifications continued throughout 2018 and March 2019 (refer **Figure 7-9**). During October 2019, there was a loss in vegetation in the drainage line walls which is considered to be due to below average rainfall (drought conditions), as such the classification was decreased to 'potentially stabilising.' During the March and October 2020 assessment, vegetation growth was observed; however, not to the density observed during March 2019.

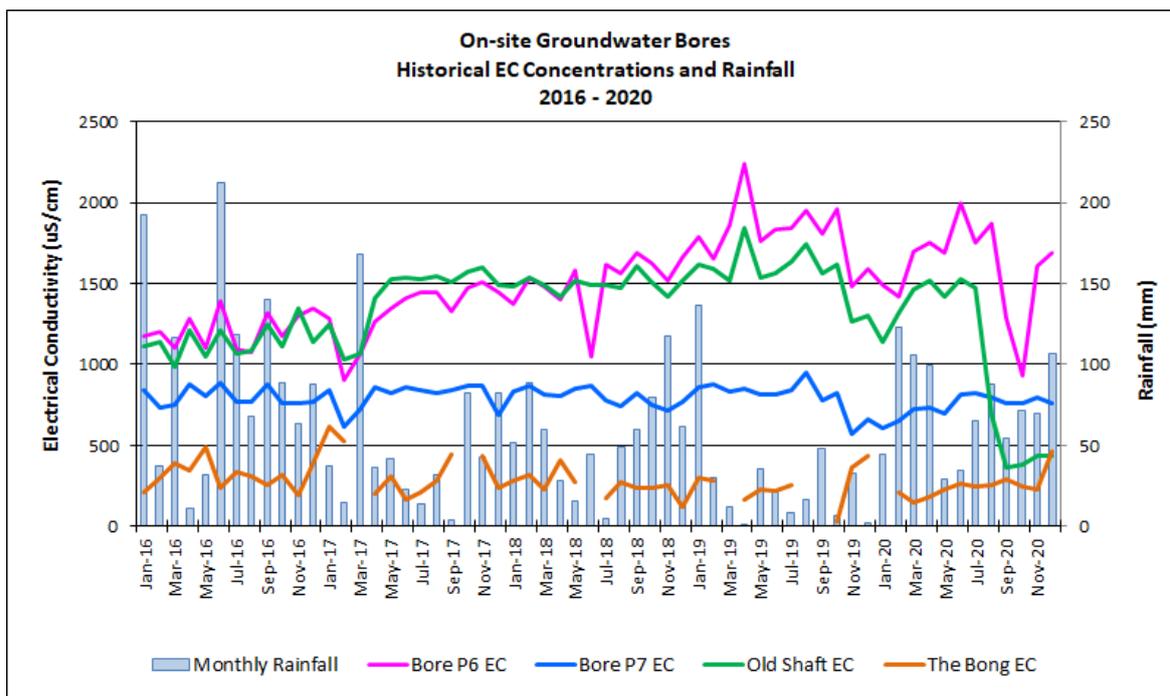
**Figure 7-12** Onsite Groundwater Bores Electrical Conductivity: 2016 – 2020

The electrical conductivity of the onsite groundwater monitoring bores for the period 2016 – 2020 is shown in **Figure 7-12**. Periods of no data (gaps in **Figure 7-11**) are due to the Bong being dry and therefore no sample being collected. The Bong and bore P7 did not exhibit any concentrations in excess of the approved trigger value.

During the 2016 – 2020 period the electrical conductivity within Bore P6 and Old Shaft follow a similar trend: increasing during the period January 2016 – April 2019, decreasing during May 2019 – January 2020 and increasing during February – July 2020. The increases in electrical conductivity within bore P6 and Old Shaft generally correspond to periods of decreased rainfall, while the decreases correspond to increased rainfall (refer **Figure 7-12**).

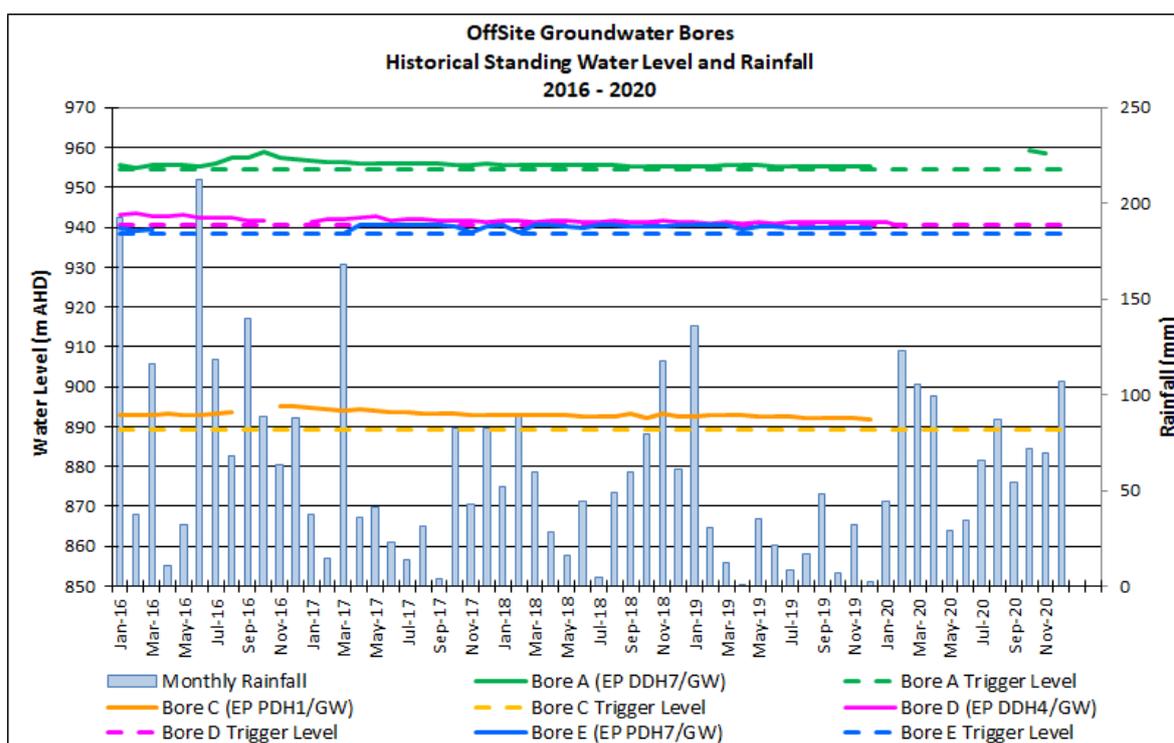
**Figure 7-13** Yarraboldy Groundwater Bores Standing Water Level: 2016 – 2020

During the 2016 – 2019 monitoring period, the standing water levels within the Yarraboldy groundwater bores show varying levels of response to rainfall fluctuations, with a slight decreasing trend observed from November 2016 – December 2019. The standing water level recorded at bore A during October and November 2020, has increased when compared to the 2019 levels.

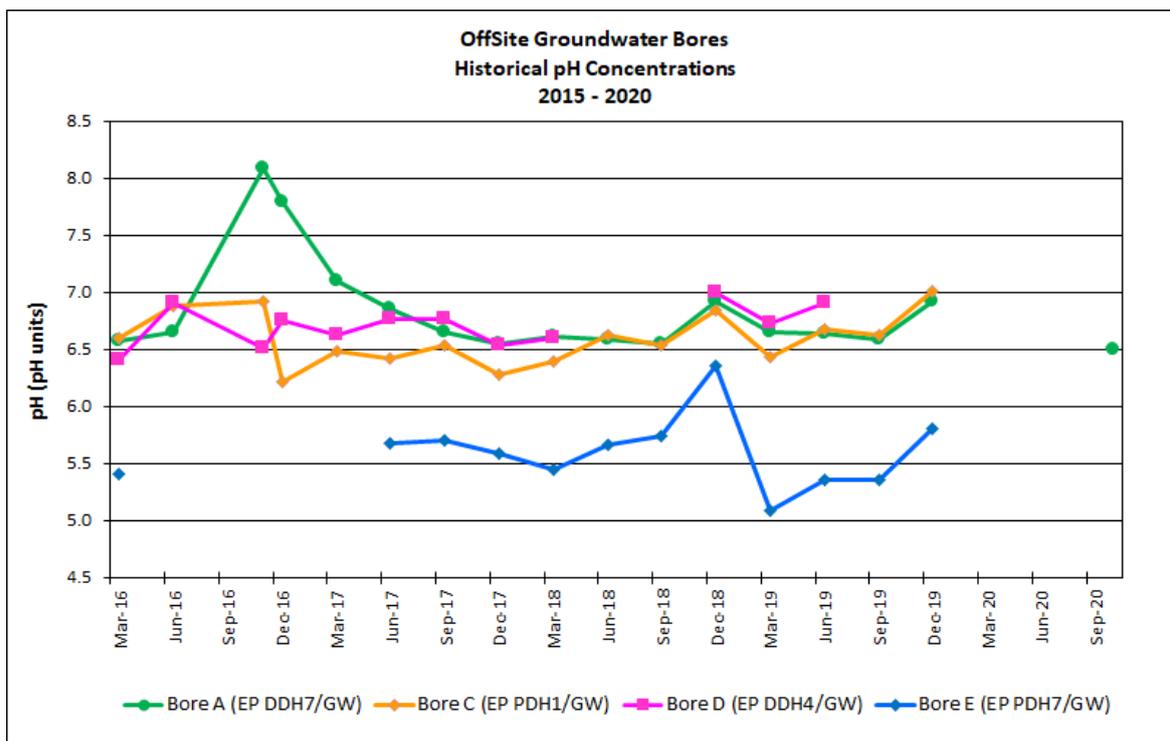
**Figure 7-14** Yarraboldy Groundwater Bores pH: 2016 – 2020

During the 2016 – 2019 monitoring periods, the pH is generally stable in bore A, following a sharp change in pH between June 2016 and September 2017. The pH has generally stabilised at bore A for the period January 2018 – December 2019; however, the pH reading taken during the October 2020 monitoring event is lower than the pH reported during the 2019 monitoring events. Bore C shows a decreasing trend in pH during January 2015 – December 2017, followed by a slight increasing trend for the period January 2019 – December 2019. The pH trend at bore D shows a slight increasing trend during the 2016 – 2019 monitoring period, noting that at times bore D was dry and unable to be sampled. Bore E shows a period of increasing pH during June 2017 – October 2018, followed by a sharp decrease in March 2019. The pH continues to increase throughout the remainder of 2019. It is noted that concentrations of sulphate and iron are generally low within Bores A, C and D and as such it is considered unlikely that pyrite oxidation and acid mine drainage are influencing pH. There are some elevated levels of iron and low pH values within bore E during the 2019 monitoring period; however, this is unaccompanied by sulphate concentrations. As such, it remains unclear if the impacts of acid mine drainage from the Wallerawang underground workings have spread to Bore E (Middle River seam).

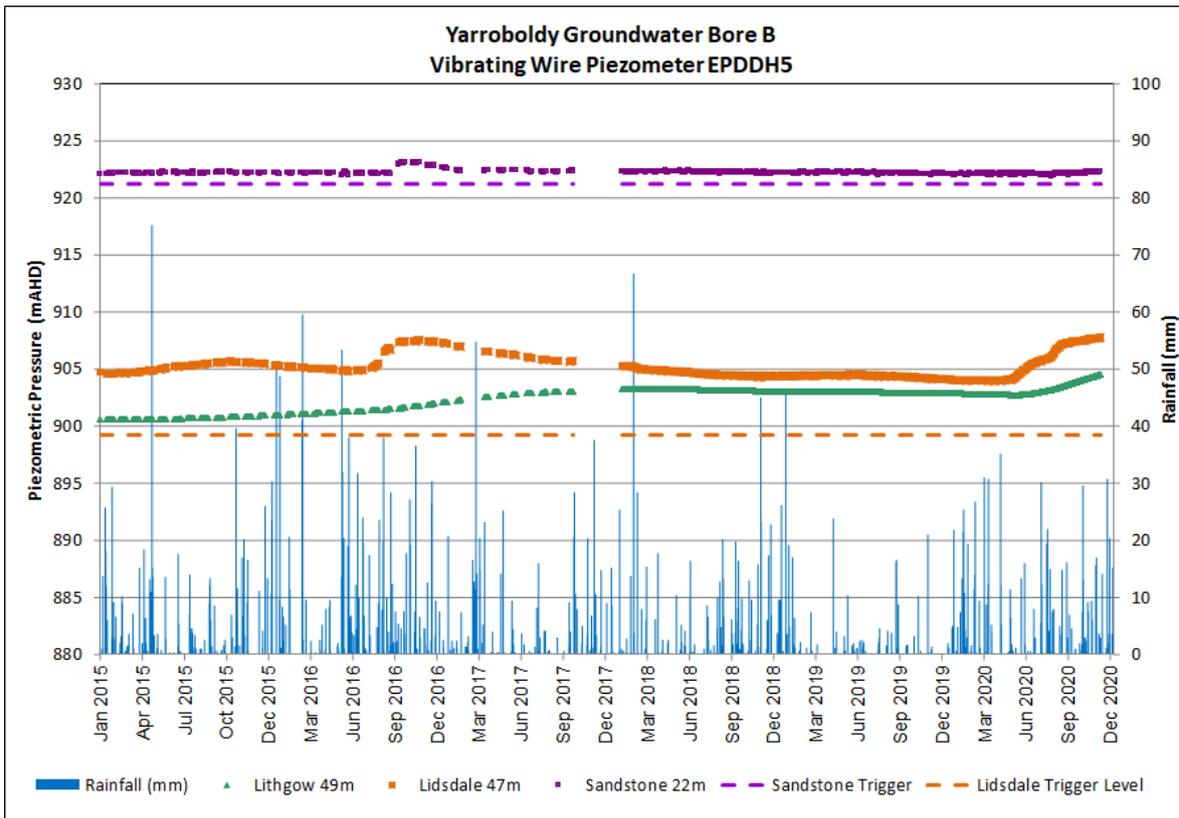
Figure 7-16 Yarraboldy Bore B Hydrograph and Rainfall

Groundwater level hydrographs and rainfall for the 2015 – 2020 period are shown in **Figure 7-16** and **Figure 7-17** noting the last successful download was November 2020 for Bore C. Bore E was inaccessible for the full 2020 reporting period and as such the groundwater level hydrographs and rainfall in **Figure 7-18** is for the 2015 – 2019 period only. There was no data available at Bore B for the period 19/10/2017 – 1/2/2018 and Bore C for the period 11/5/2017 – 1/2/2018 due to connectivity issues with the vibrating wire piezometer loggers. The loggers were removed from site and new loggers installed on 2/2/2018.

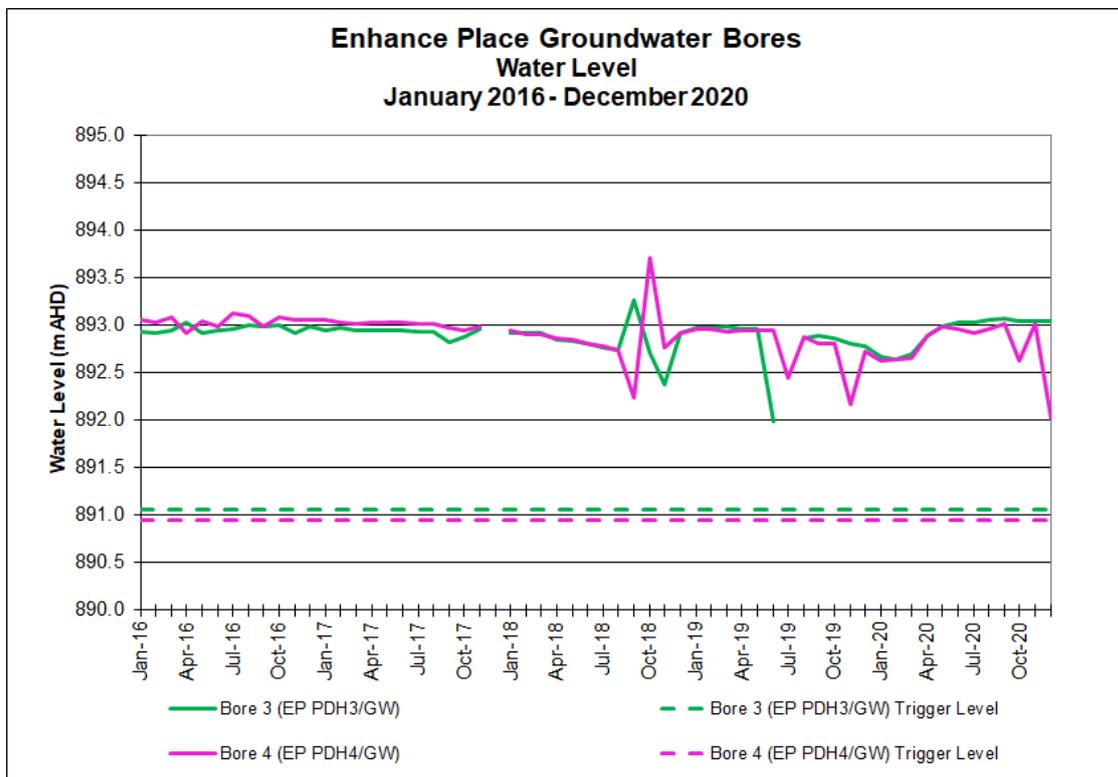
**Figure 7-19** Enhance Place Standing water levels 2016 – 2020

Two (2) monitoring bores are located within the former Enhance Place Mine and are measured monthly for standing water level. The standing water level for the period January 2015 – December 2020 is shown in **Figure 7-19**.

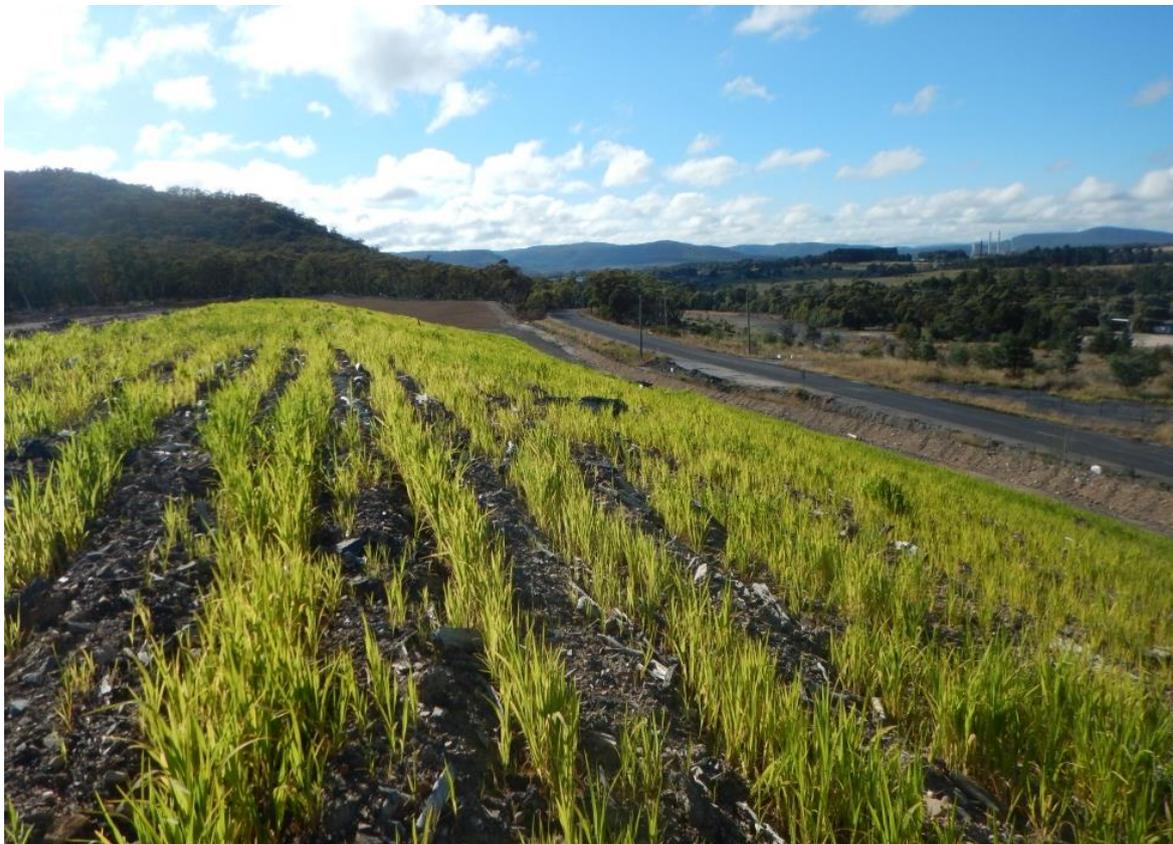
**Photograph 8-1**      *Amenity Bund looking east following application of mulch and native mix 2015*

The amenity bund located along the southern boundary of the Yarraboldy Extension was re-profiled in 2014, with the southern batter having a gradient of 18° to minimise erosion and enhance establishment of seedlings. Following the application and tilling of topsoil, a native species grass and tree species seed mix was applied followed by mulch (refer **Photograph 8-1**).

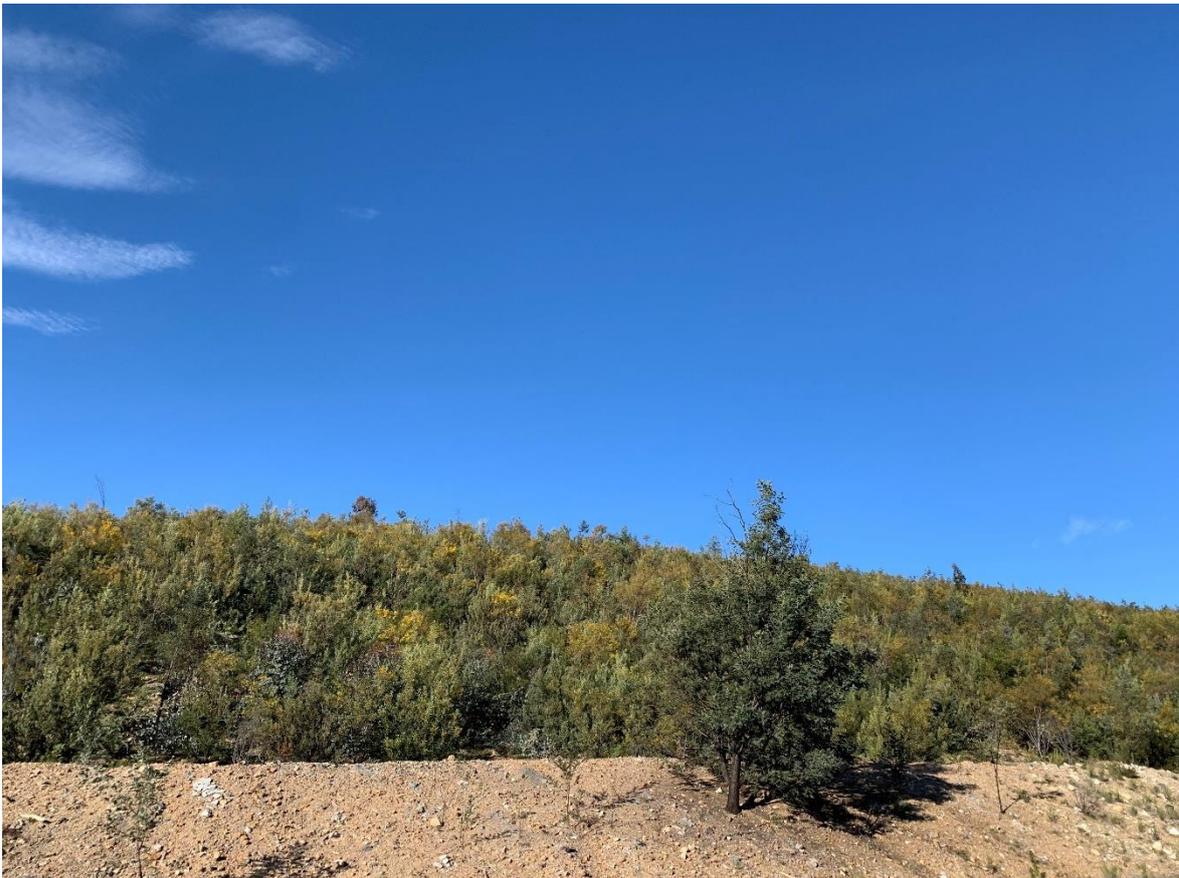
**Photograph 8-2**      *Amenity Bund looking north October 2020*

During the reporting period, maintenance works was not required to be undertaken in the Yarraboldy Extension. No rehabilitation maintenance activities were undertaken. Current vegetative cover on the bund (photo taken October 2020) is shown in **Photograph 8-2**.

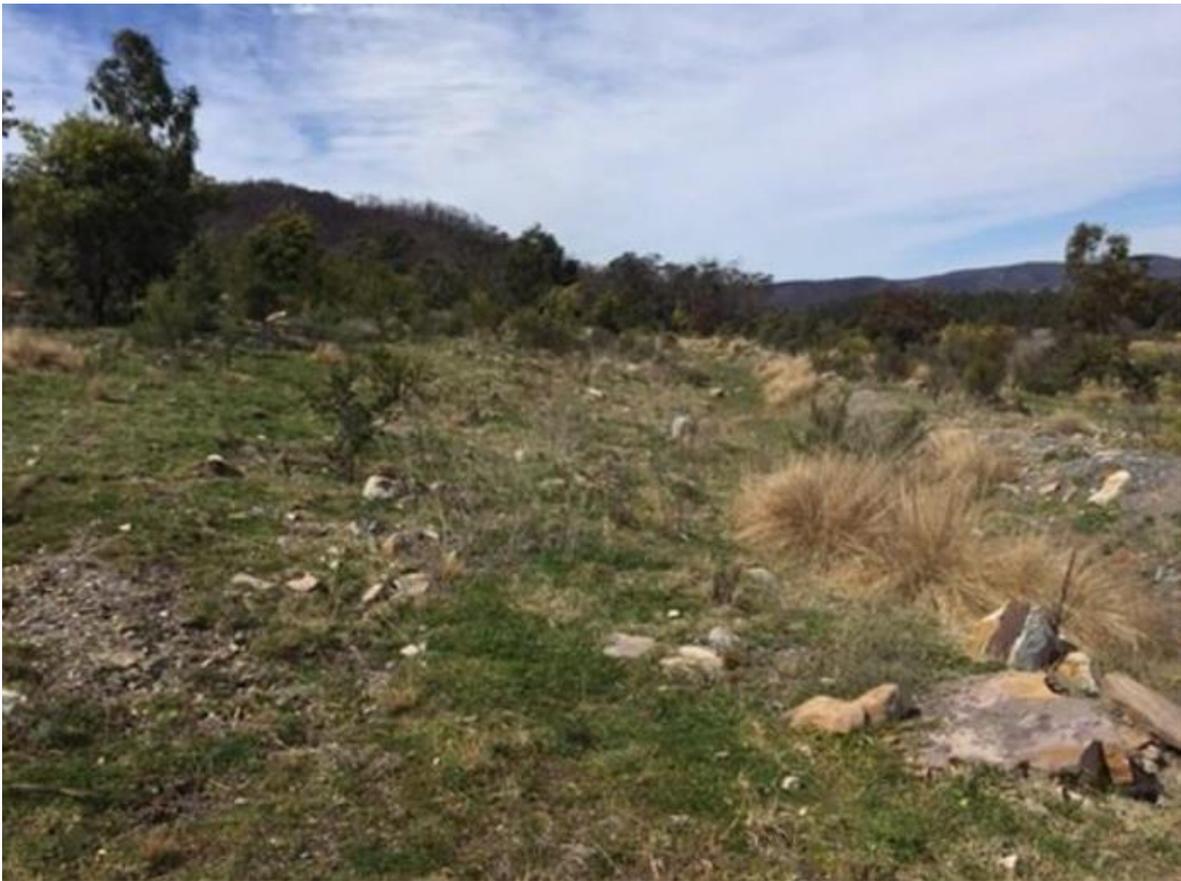
**Photograph 8-3**      *Area A: Vegetation Cover: October 2020*

The PDM 2020 Rehabilitation Monitoring report (Ref [4], attached in **Appendix C**) indicated that the total living groundcover within the monitoring transects in Area A (transect 5 and transect 6) has increased compared to the 2019 survey. Total living cover within the transect 5 area has increased from 70% in 2019 to 80% in 2020 due to an increase in perennial groundcover. The total living cover at transect 6 has increased from 20% in 2019 to 80% in 2020 due to decreases in both litter cover and bare surface. The total vegetation cover at Area A during October 2020 is shown in **Photograph 8-3**.

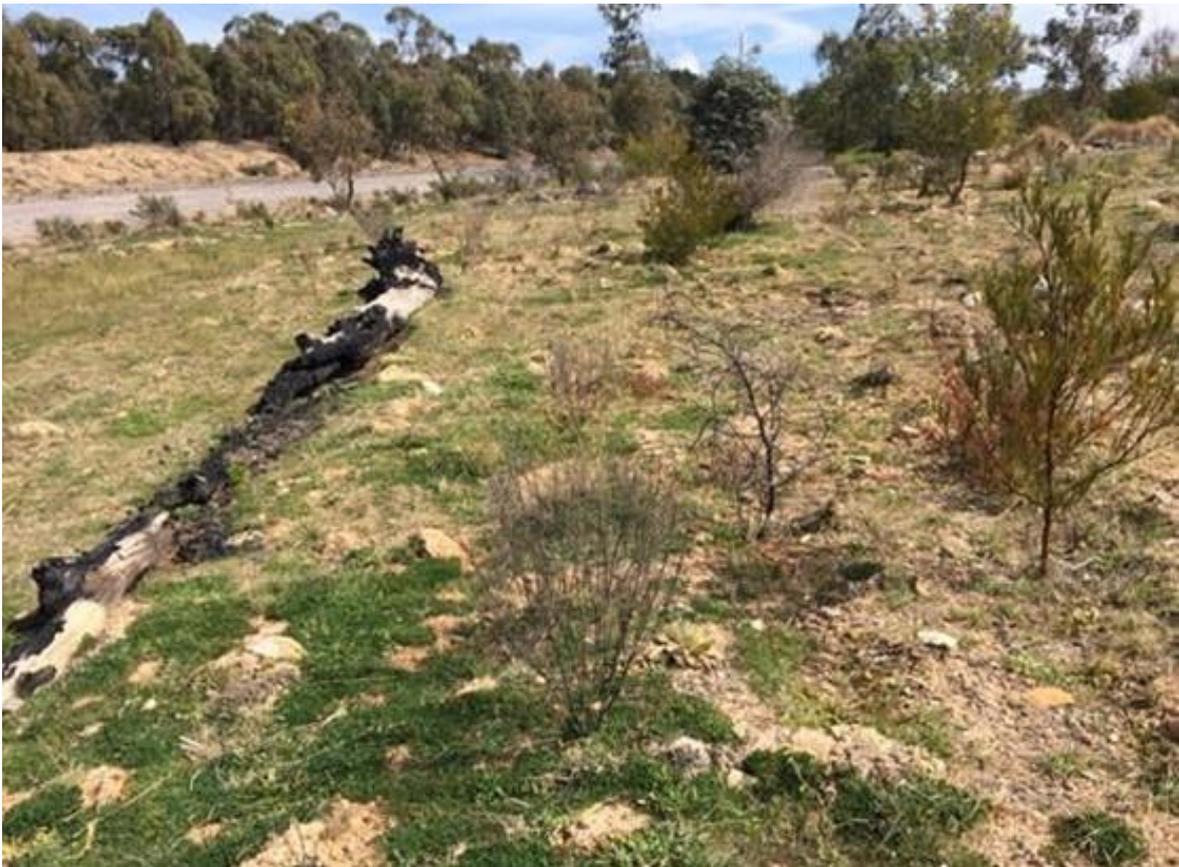
**Photograph 8-4**      *Evidence of burnt trees: Transect 5: looking west October 2020*

There was some evidence of bushfire affecting the treed rehabilitation areas, as previously fallen trees were observed to be burnt and some residual mulch has been lost (Ref [4]), refer **Photograph 8-4**; however, these areas are showing evidence of regeneration.

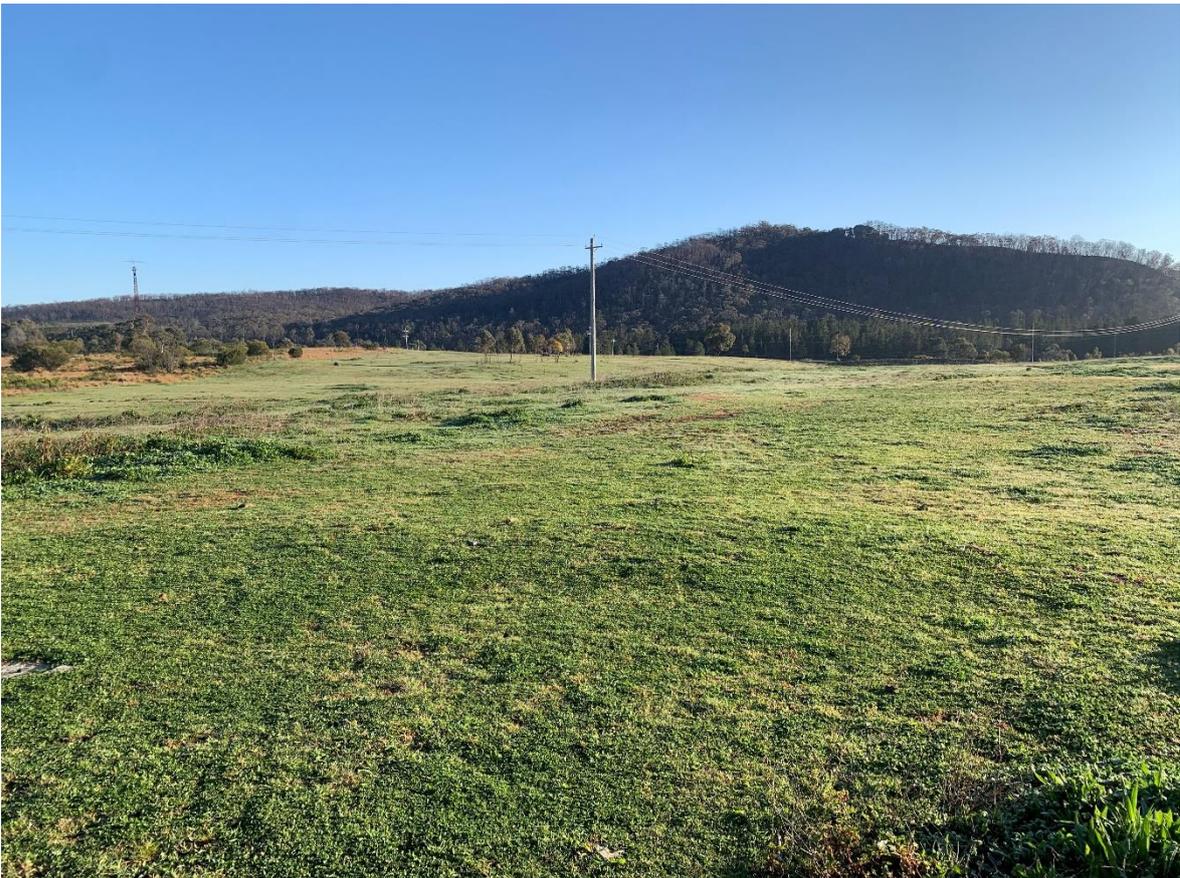
**Photograph 8-5**      *Area B Groundcover October 2020 looking east.*

The groundcover at Area C is shown in **Photograph 8-5**, this groundcover is also considered representative of Area B.

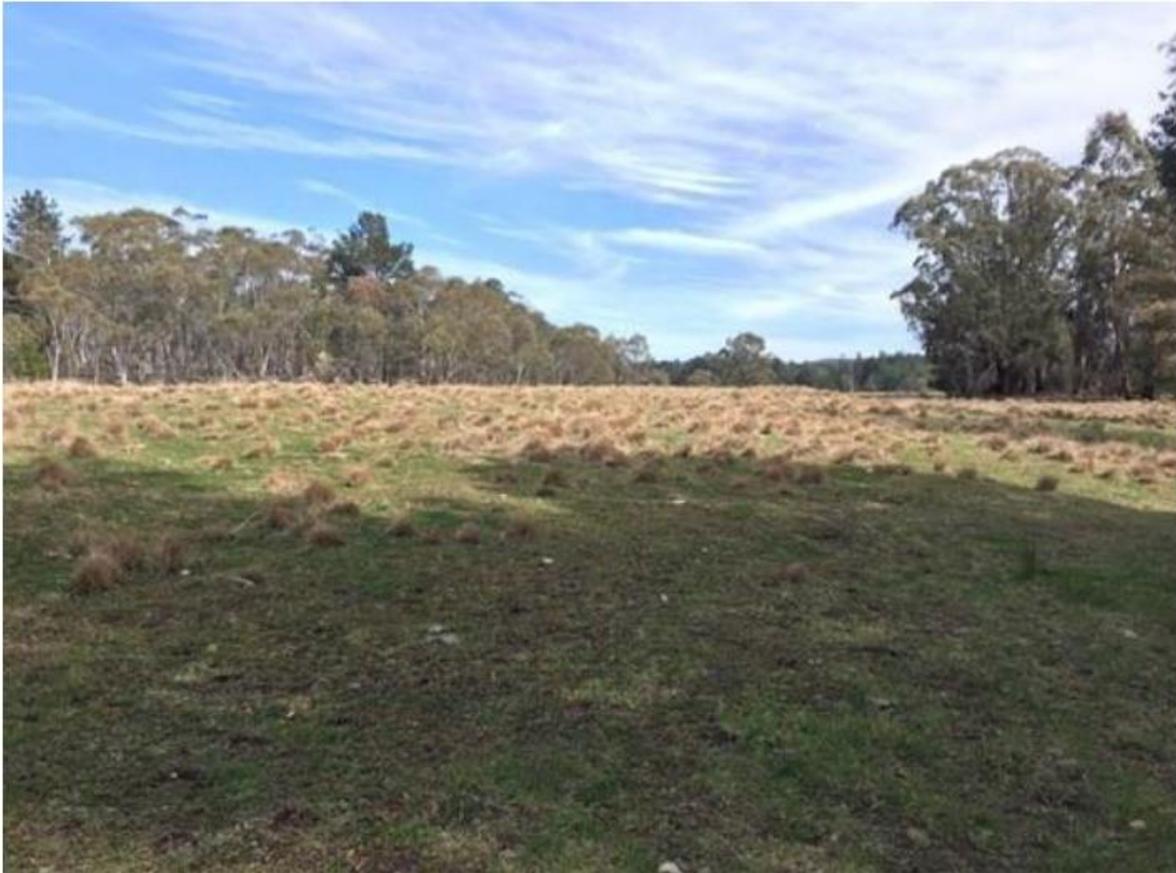
**Photograph 8-6**      *Area 8 groundcover: October 2020*

The groundcover at Area 8 during 2020 is shown in **Photograph 8-6**.

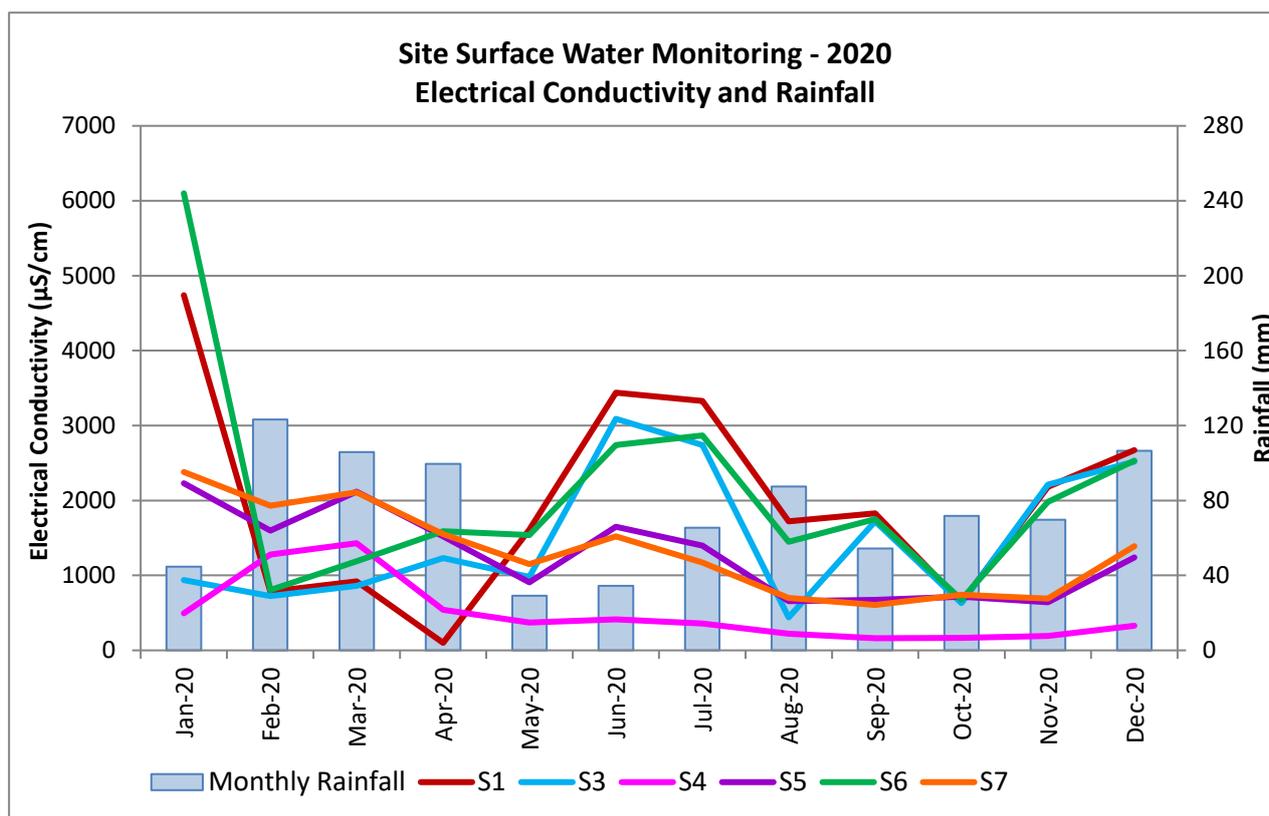
**Figure 11** Site Surface Water Electrical Conductivity and Monthly Rainfall

Historically, conductivity generally increases in response to decreased rainfall. This trend was generally observable during 2020 as shown in **Figure 11**. Historically, water monitoring locations in Neubecks Creek (surface water sites S1, S3 and S6) indicate larger increases in electrical conductivity due to decreased rainfall than the surface water sites located at Blue Lake (S5) and Coxs River (S4, upstream of Blue Lake and S7, downstream of Blue Lake). A review of the surface water data (Ref [11]) indicated that increases in electrical conductivity at surface water sites S1, S3 and S6 is attributable to the increase in electrical conductivity upstream of PDM. A licence discharge point (not associated with PDM or EPL 4911) is located at the confluence of EPL Point 2 and it is considered that the volume and conductivity concentration of the discharge located upstream of PDM has the greatest influence upon electrical conductivity within Neubecks Creek.

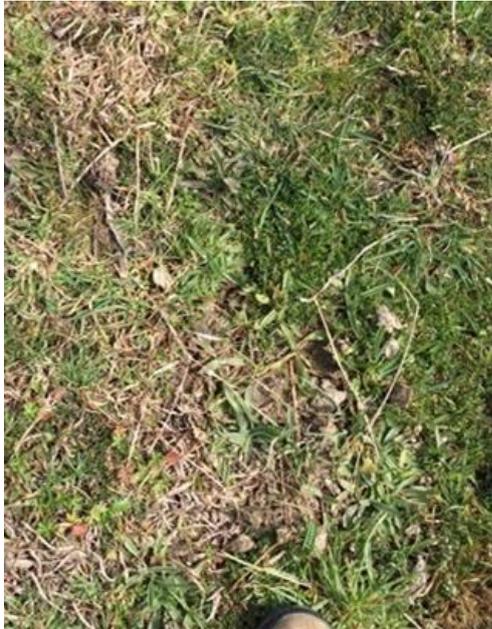
Figure 2 Pasture composition at the Pasture Analogue site

**Species composition at pasture rehabilitation areas** – Pasture rehabilitation areas are established with a mix of ~70% perennial grasses and ~20% annual legumes and are consistent with species composition at the analogue pasture site. Examples of analogue pasture and Transect 1 pasture are shown in Figure 2 and Figure 3.

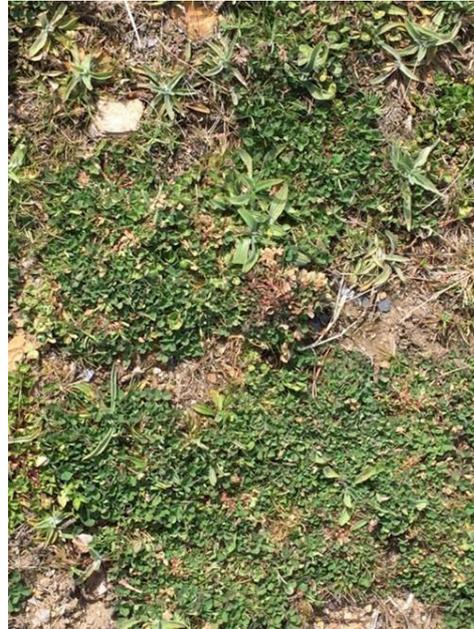
Figure 3 Typical pasture composition at Transect 1

**Groundcover at pasture rehabilitation areas** – Rehabilitated pasture surfaces in each of the transect areas support living groundcover of approximately 90%.

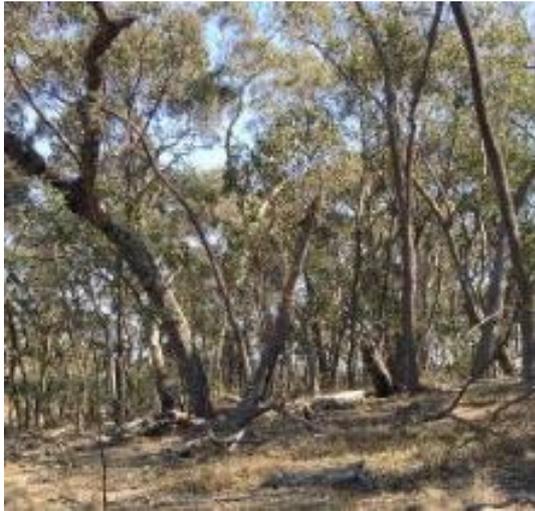
Figure 4 Vegetation structure of treed analogue site (Transect 7) in 2019

In 2019 the treed analogue site was characterised by a canopy to 14 m height with 20% canopy cover over a sparse shrubby mid-storey to 3 m height and isolated shrubs to 1.5 m height in the understorey. Groundcover consisted of grasses and herbs with a cover of >95% (Figure 4).

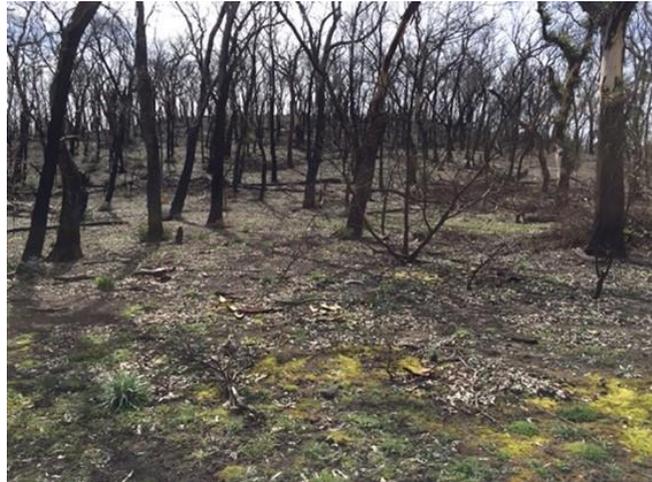
Figure 5 Vegetation structure at Transect 7 in 2020

Figure 5 shows the vegetation structure at the treed analogue site in 2020. Many of the standing trees are showing evidence of new growth however the presence of epicormic growth is not an indicator of long-term survival of the tree. Recently fallen timber is contributing to ground cover. The trees are providing no appreciable canopy cover. The shrub layer is very sparse. Ground cover is actively growing. Regeneration of woody plants is occurring across the site.

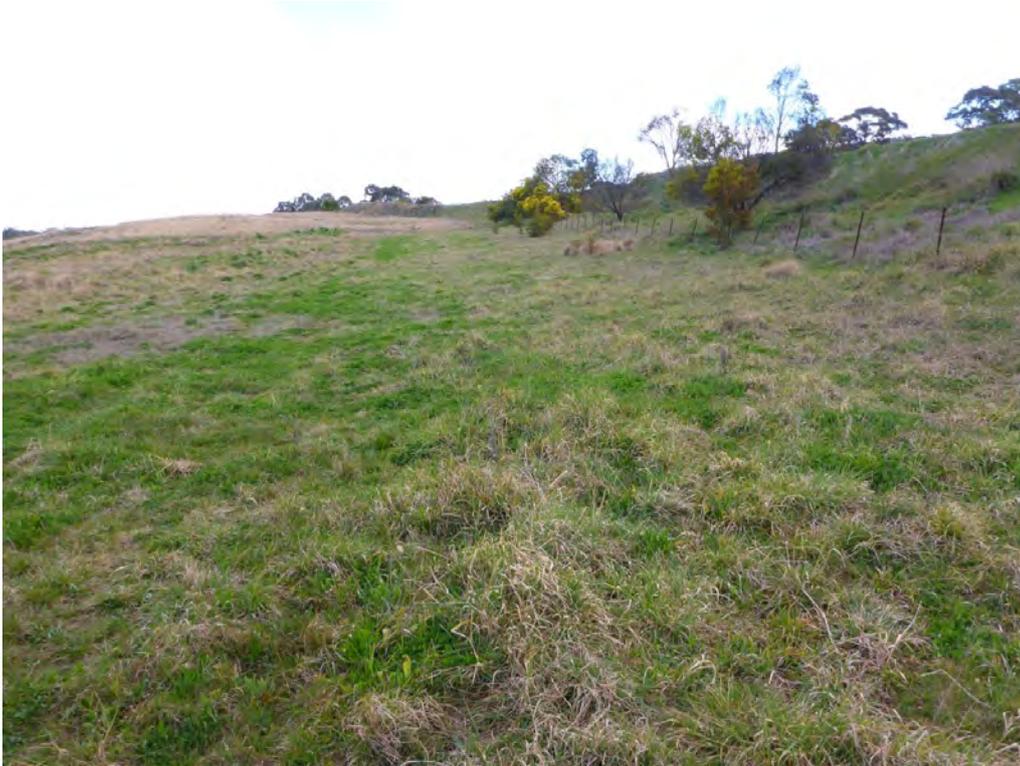
**Photo 1    Analogue Site PD3 – September 2014**

Topsoil consists of a sandy clay loam over a medium clay subsoil. This area supports a perennial grass and clover pasture, including cocksfoot, tall fescue, phalaris, sub clover, with some annual ryegrass. These pasture species have a winter and spring growth habit, with the difference in pasture mass clearly evident between the 2014 (September) and 2018 (March) inspections.

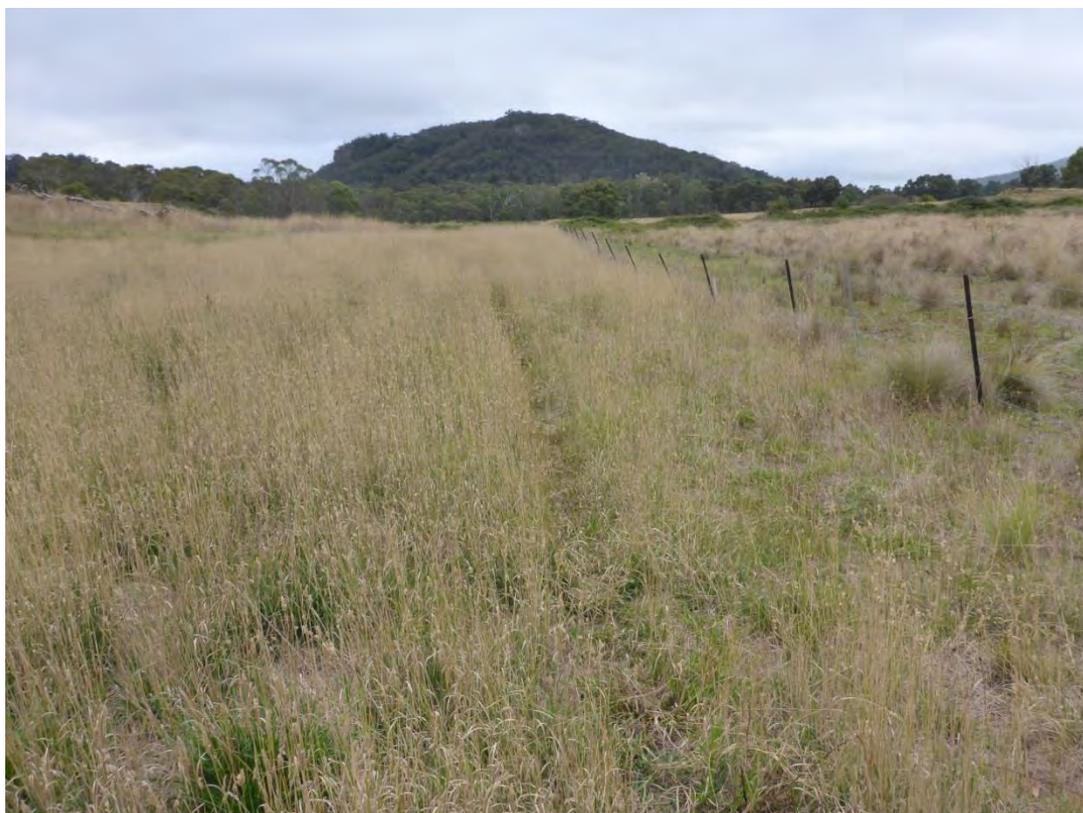
**Photo 3 Analogue Site PD6 March 2018**

**Photo 3** shows the general landscape setting for Site PD6 within Area C at Pine Dale Mine during the 2018 inspection. Pasture at Site PD6 is dominated by the perennial grasses phalaris and fescue.
