# PINE DALE MINE ANNUAL REVIEW 2020

**Prepared by Enhance Place Pty Ltd  
Revision 1.2 – 12 February 2021**

This Annual Review has been prepared pursuant to Schedule 5, Condition 3 of the Project Approval 10\_0041, and in accordance with the Annual Review Guideline developed by the NSW Department of Planning and Environment (Ref [1]).

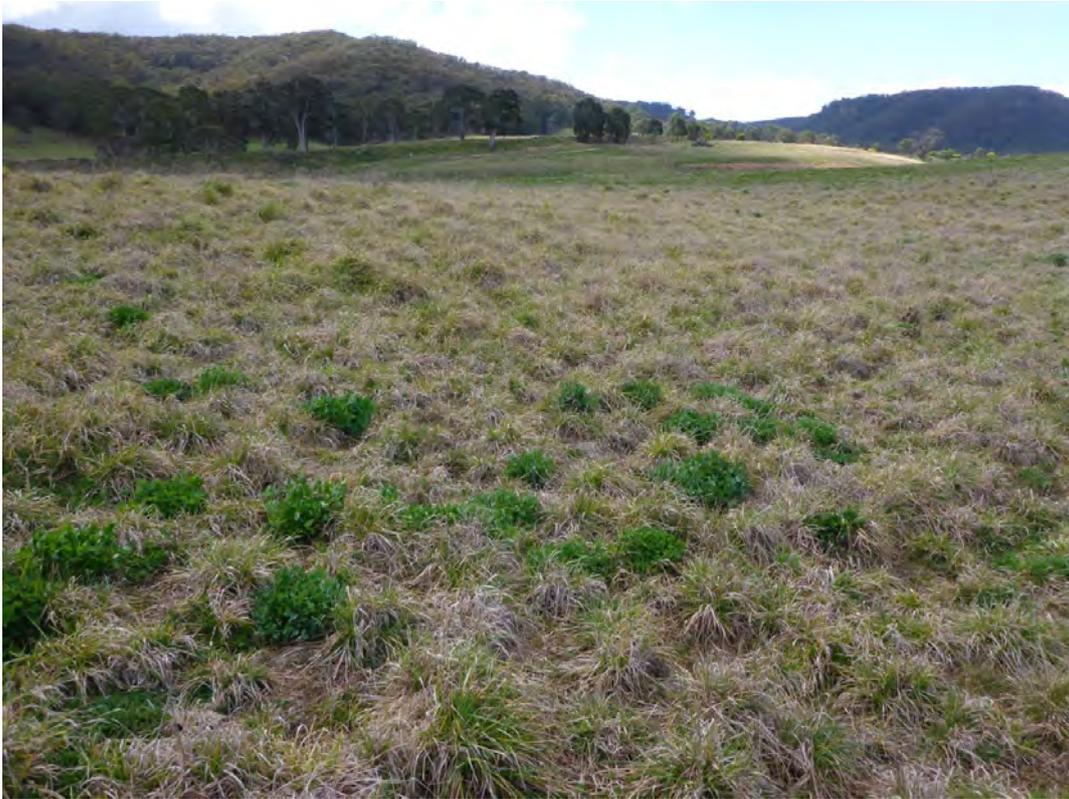
**Photo 4    Rehabilitated Site PD1 September 2014**

Pasture at Site PD1 is dominated by perennial cocksfoot and paspalum grass pasture with some sub clover and arrowleaf clover present in the sward, with greater than 90% groundcover. There is no African lovegrass present. The difference in pasture growth between autumn and spring can clearly be seen.

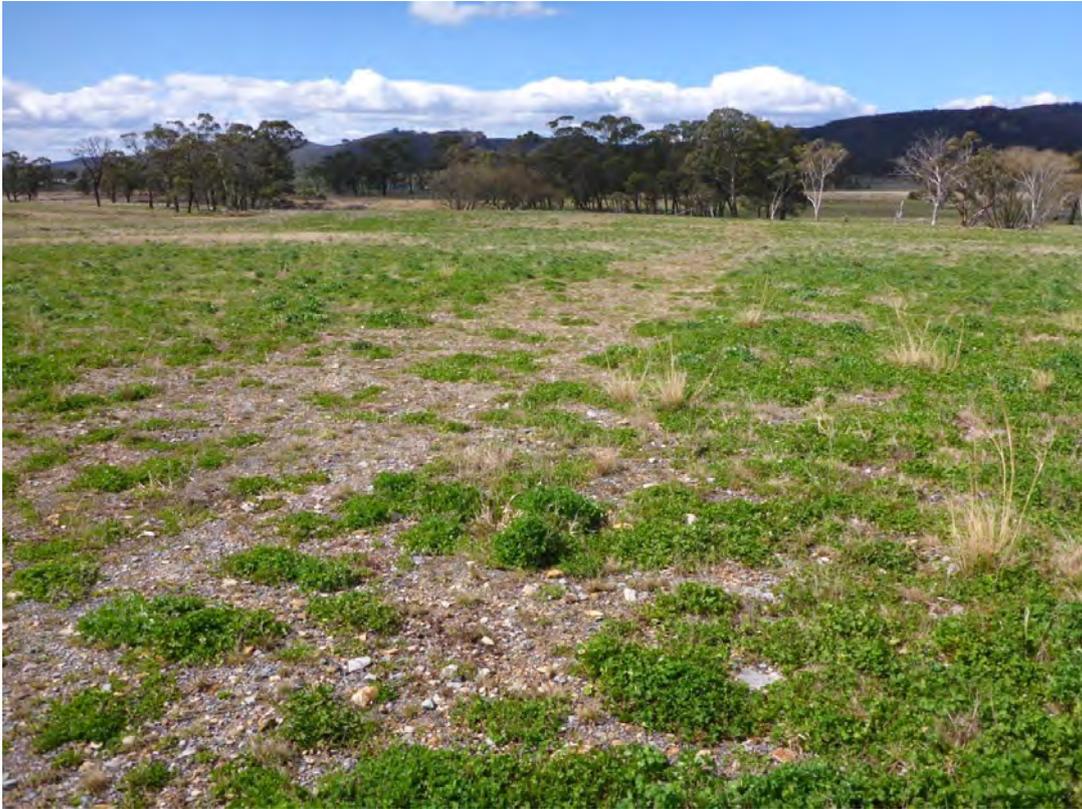
**Photo 6    Rehabilitated Site PD2 September 2014**

Pasture at Site PD2 is dominated by perennial cocksfoot and paspalum grass pasture with the herb plantain and some arrowleaf clover present in the sward, with greater than 80% groundcover. There are isolated African lovegrass tussocks present which comprise less than 5% of the pasture sward. Significant increase in perennial grass groundcover can be seen between the two inspection periods.

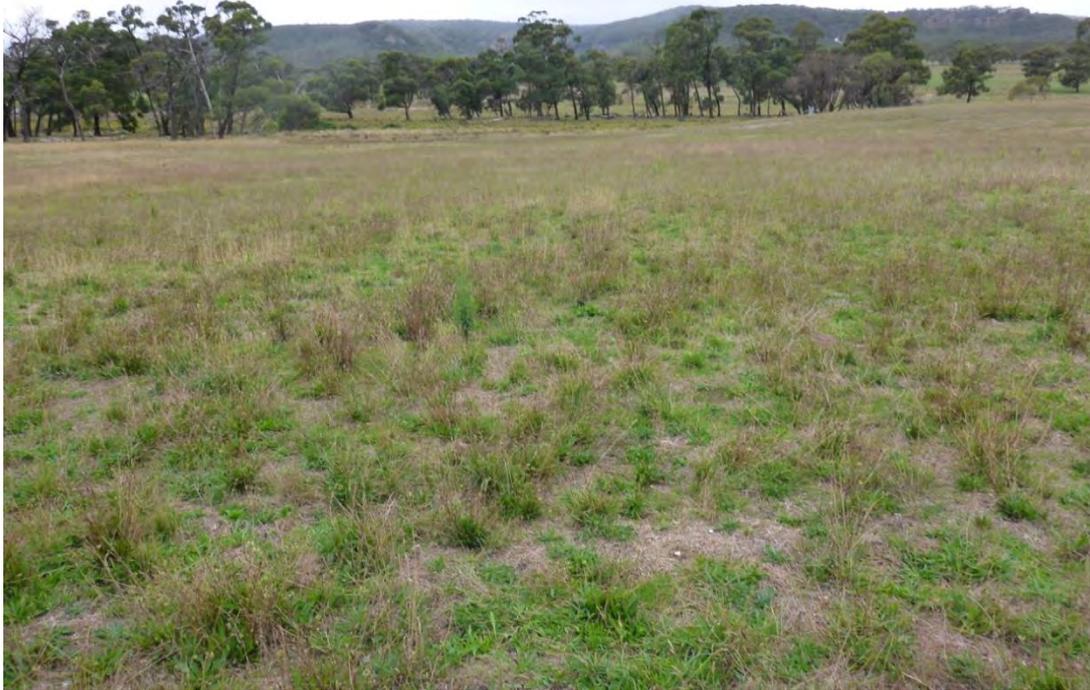
**Photo 8    Rehabilitated Site PD7 March 2018**

**Photo 8** shows the general landscape setting for Site PD7 within Area C at Pine Dale Mine during the 2018 inspection. Pasture at Site PD6 is dominated by perennial grasses phalaris, fescue and paspalum along with the herb plantain and arrowleaf clover. There is greater than 90% groundcover with only isolated tussocks of African lovegrass, which comprises less than 5% of the pasture sward.

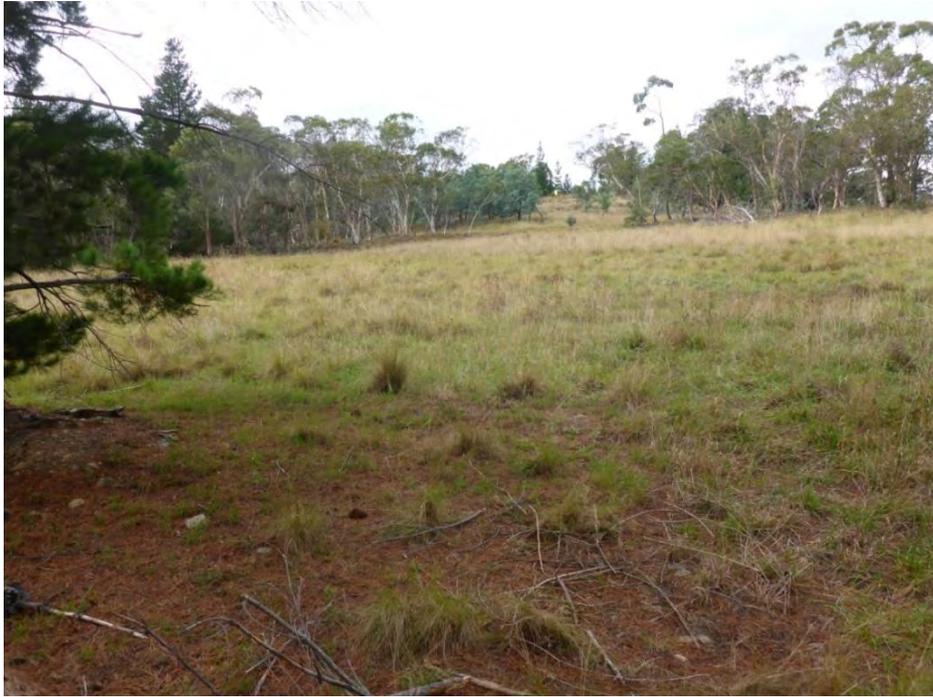
**Photo 9    Analogue Site PD8 March 2018**

**Photo 9** shows the general landscape setting for Site PD8 within Area 8 at Pine Dale Mine during the 2018 inspection. Pasture at Site PD8 is dominated by perennial phalaris and fescue with some arrowleaf clover present in the sward, with greater than 90% groundcover. There are isolated African lovegrass tussocks present which comprise less than 5% of the pasture sward.

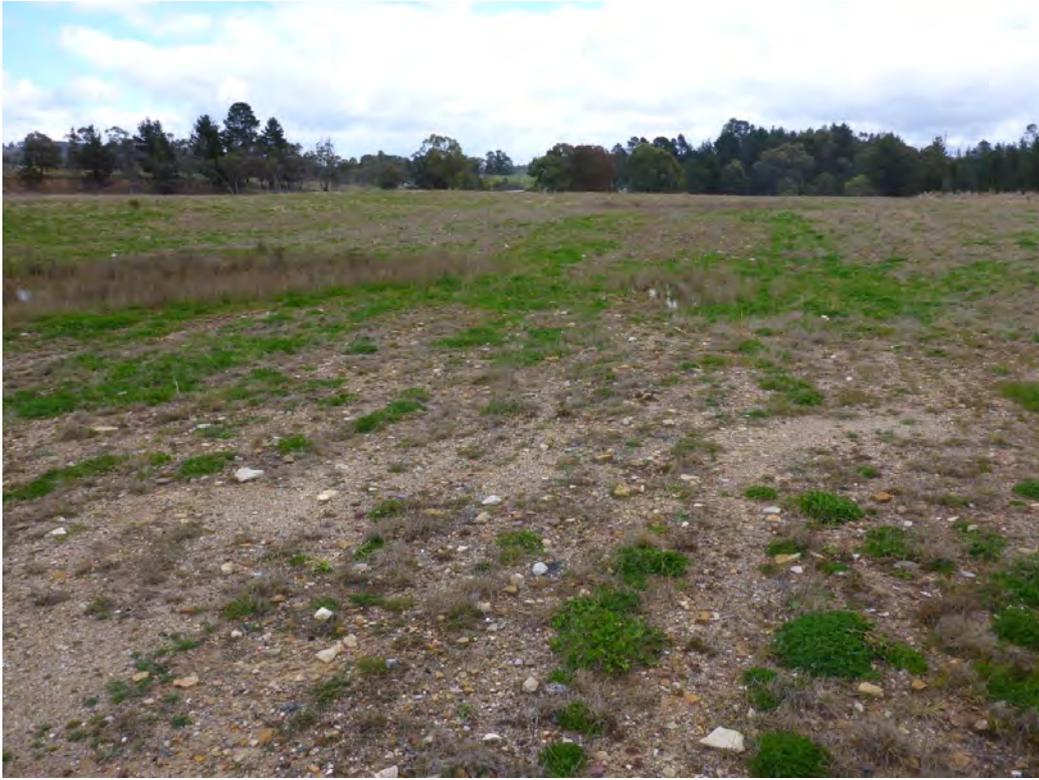
**Photo 10 Rehabilitated Site PD4 September 2014**

**Photo 10** and **Photo 11** show the general landscape setting for Site PD4 within Area 8 at Pine Dale Mine during the 2014 and 2018 inspections.

Pasture at Site PD4 is dominated by perennial grasses cocksfoot, fescue and paspalum with some arrowleaf clover present in the sward, and greater than 90% groundcover. There are isolated African lovegrass tussocks present which comprise less than 5% of the pasture sward. Significant increase in perennial grass groundcover can be seen between the two inspection periods.

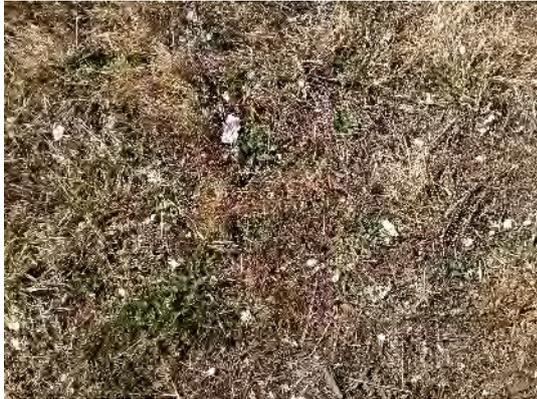
**Species composition at pasture rehabilitation areas** – Pasture rehabilitation areas are established with a mix of 70% perennial grasses and 20% annual legumes and are representative of species composition at the analogue pasture site. An example of transect 1, 2 and 3 pasture is shown in Figure 2 and Figure 3.

Figure 2 Typical pasture composition of transects 1, 2 and 3

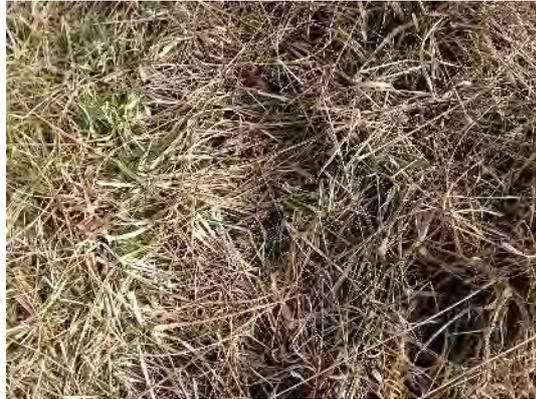
Figure 3 Pasture composition representative of transect 4

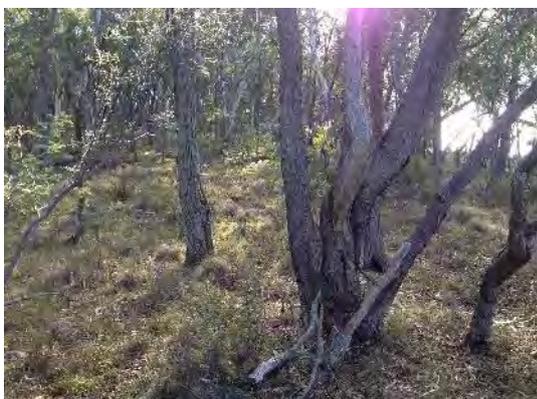
The treed analogue site is characterised by a canopy to 12m height with 40% canopy cover over a sparse shrubby mid-storey to 3m height and isolated shrubs to 1.5m height in the understorey. Groundcover consists of grasses and herbs with a cover of >95% (Figure 4).

Figure 4 Vegetation structure of treed analogue site (transect 7)

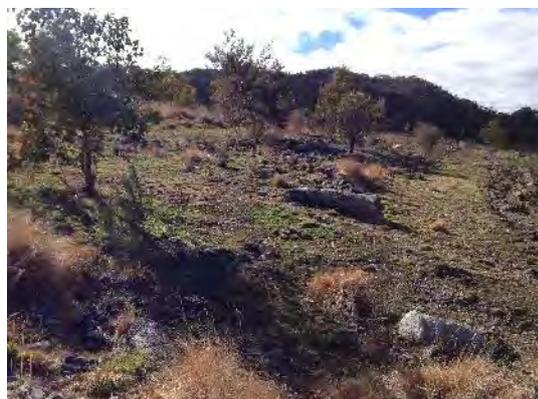
Figure 5 Transect 6 vegetation structure

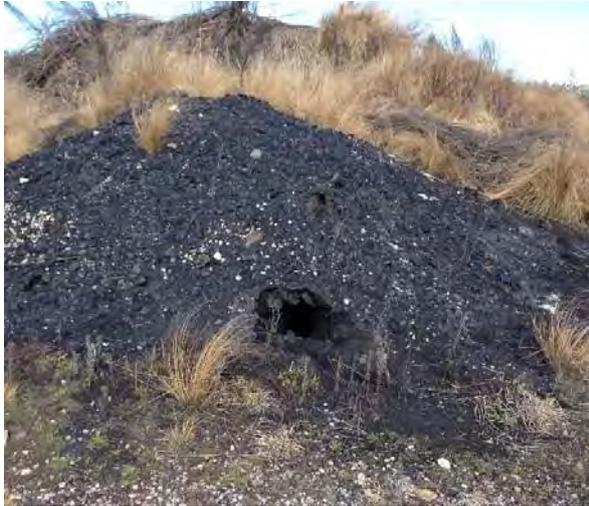
Figure 6 An active burrow in an equipment storage area

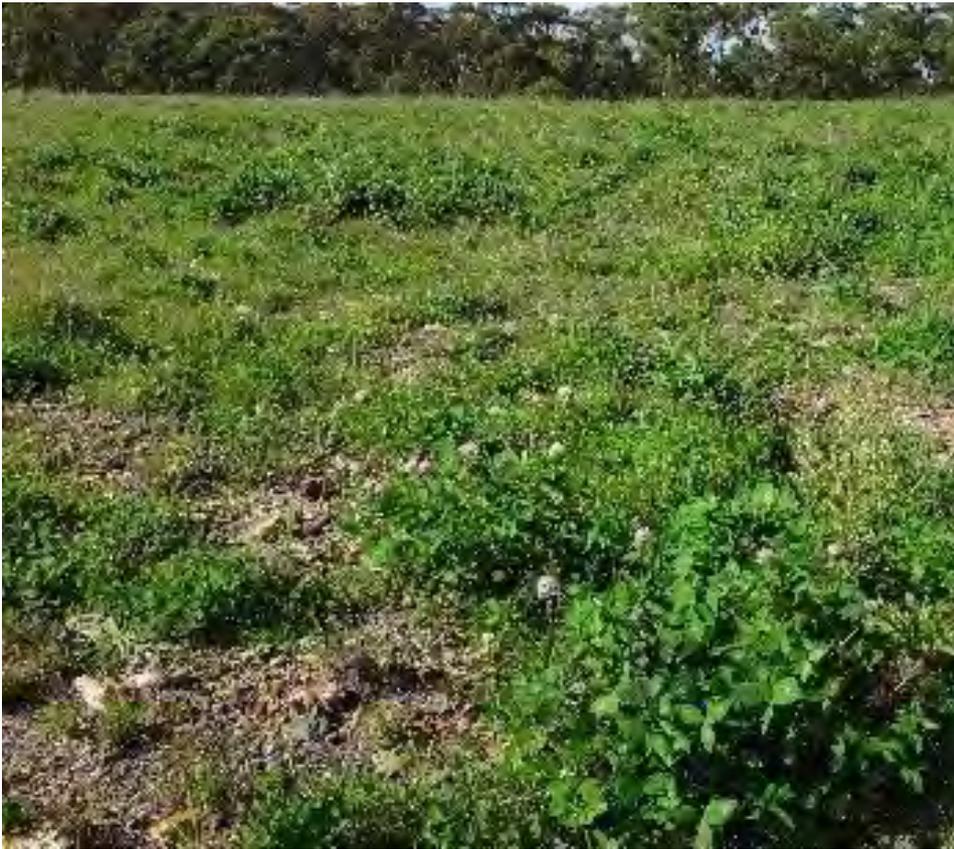
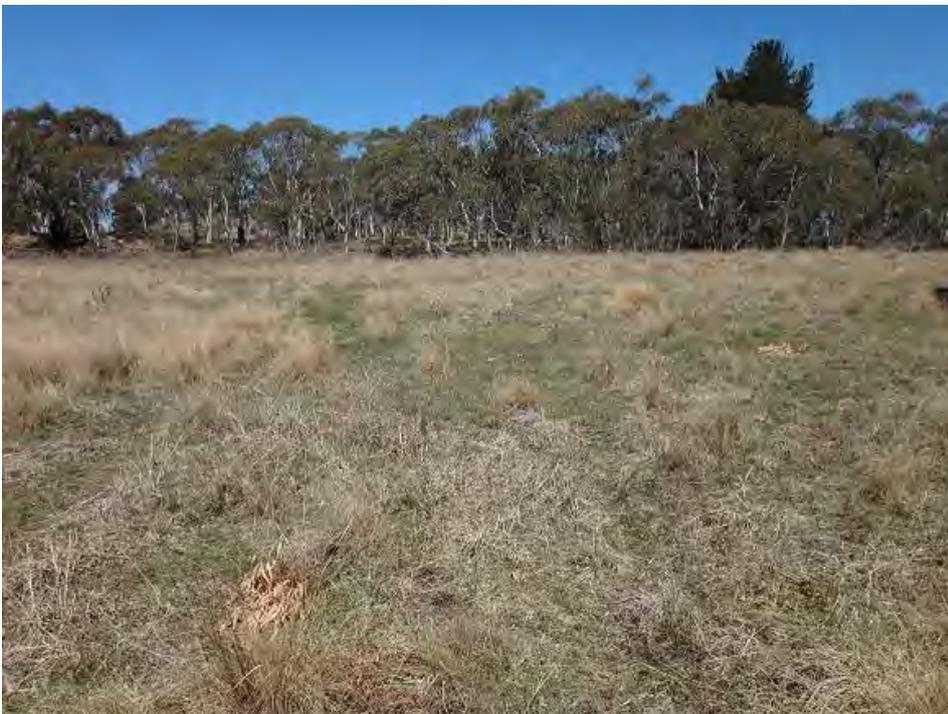
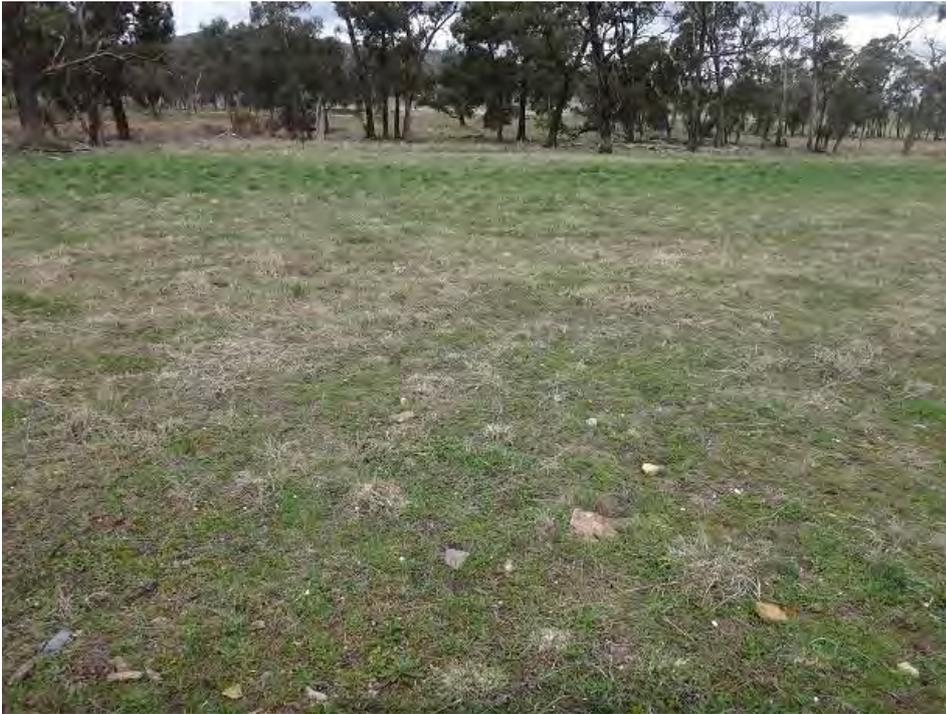
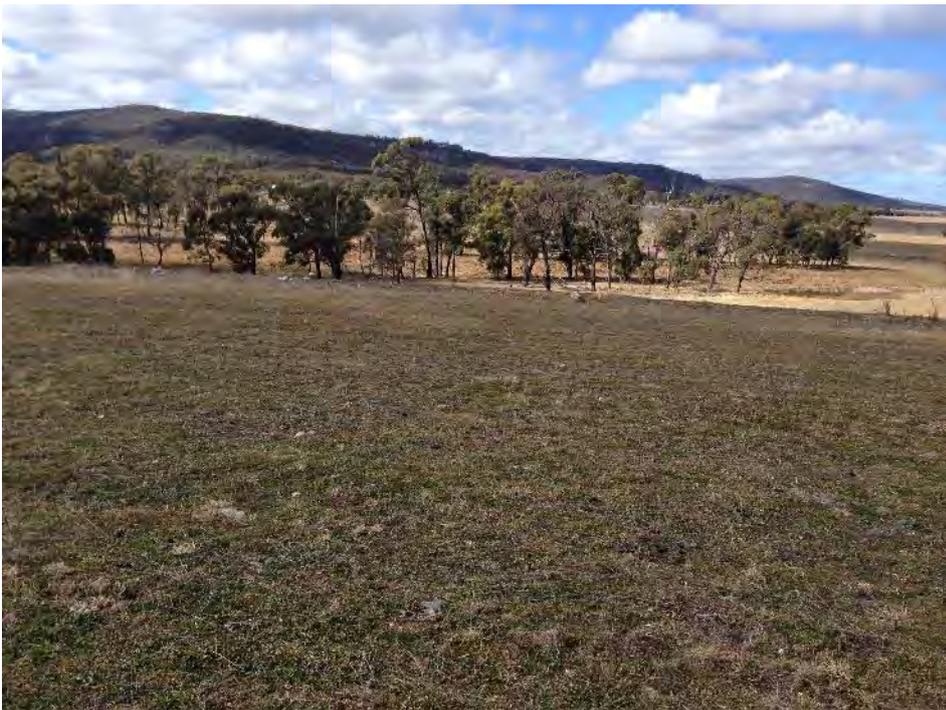
**Transect 1 looking south 2014**

**Transect 1 looking south 2015**

**Transect 1 looking south 2016**

**Transect 1 looking south 2017**

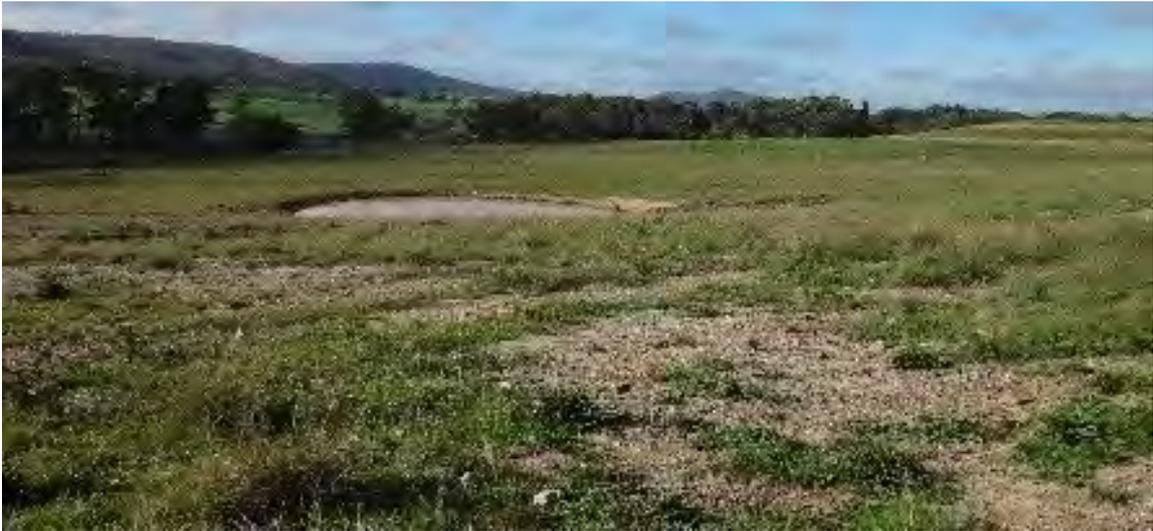
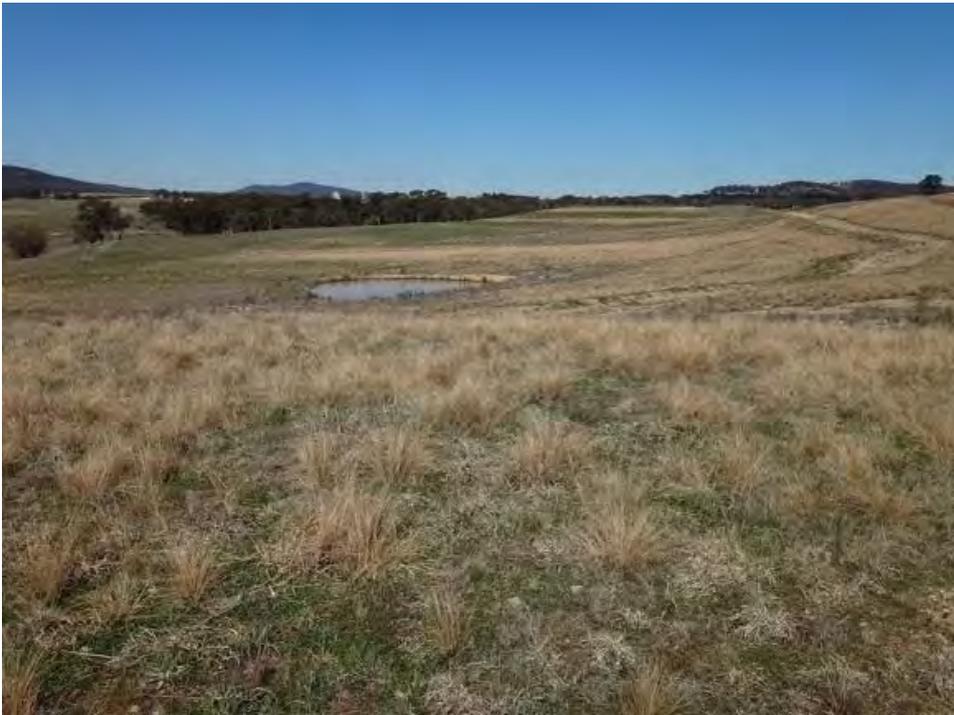
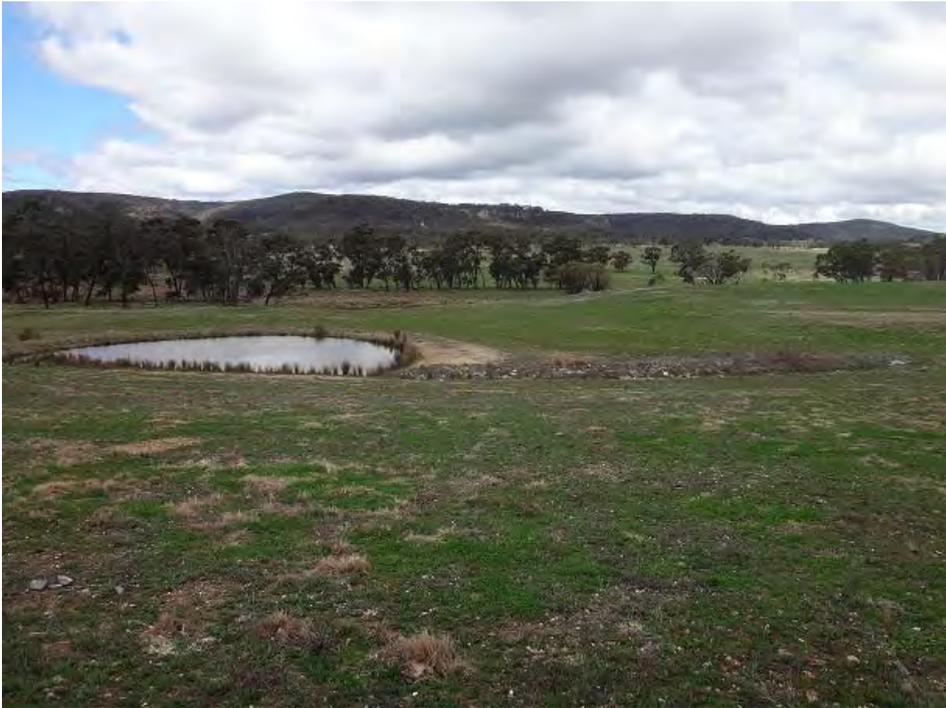
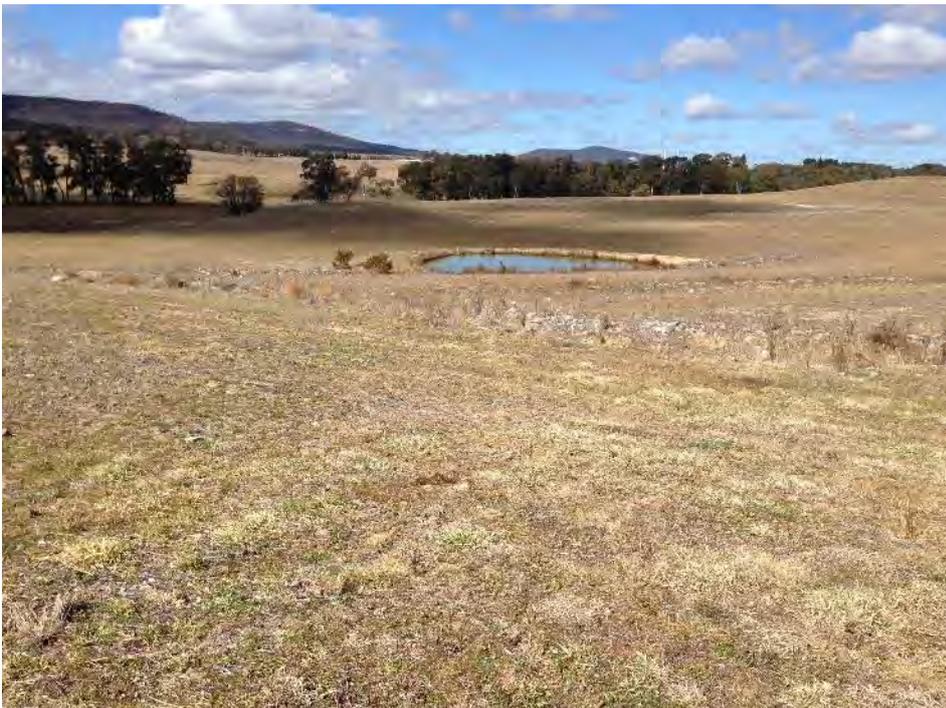
Transect 2 looking southeast 2014

Transect 2 looking southeast 2015

**Transect 2 looking southeast 2016**

**Transect 2 looking southeast 2017**

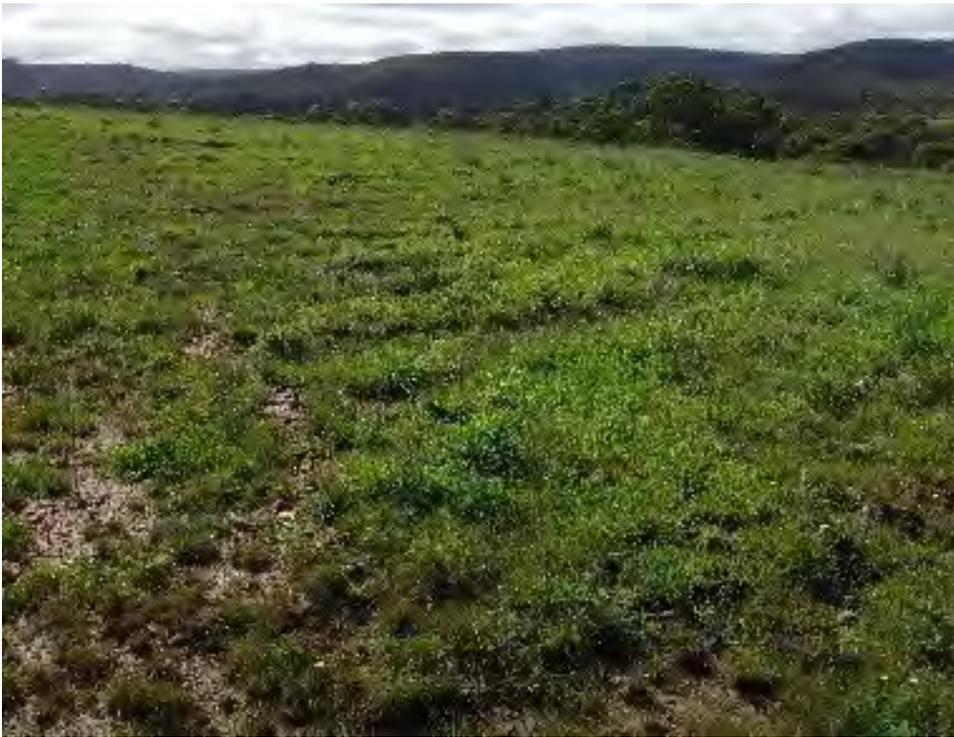
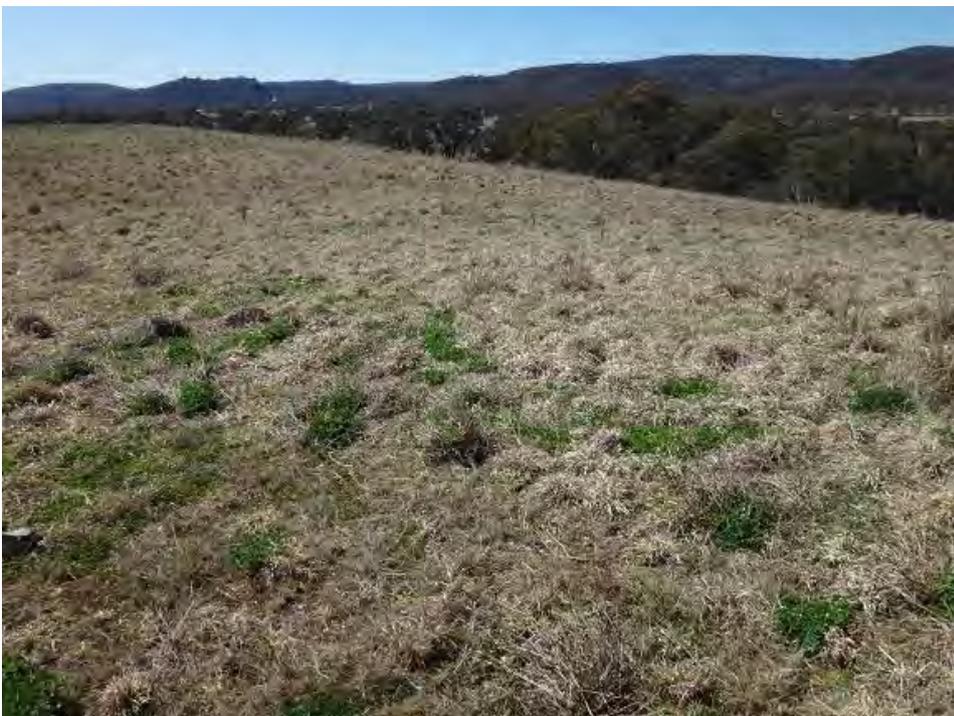
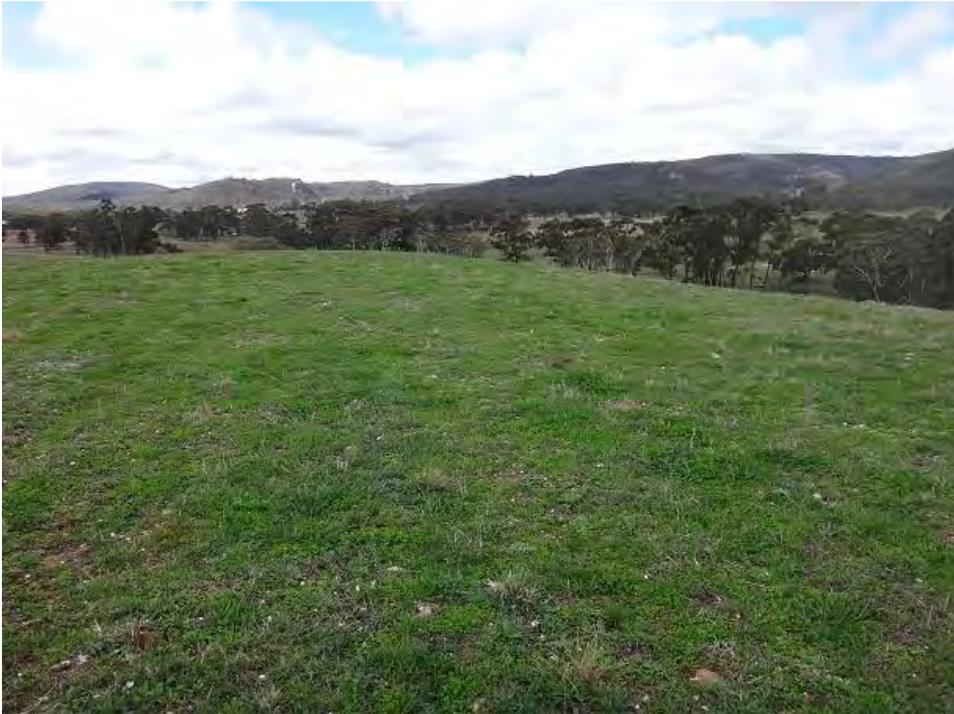
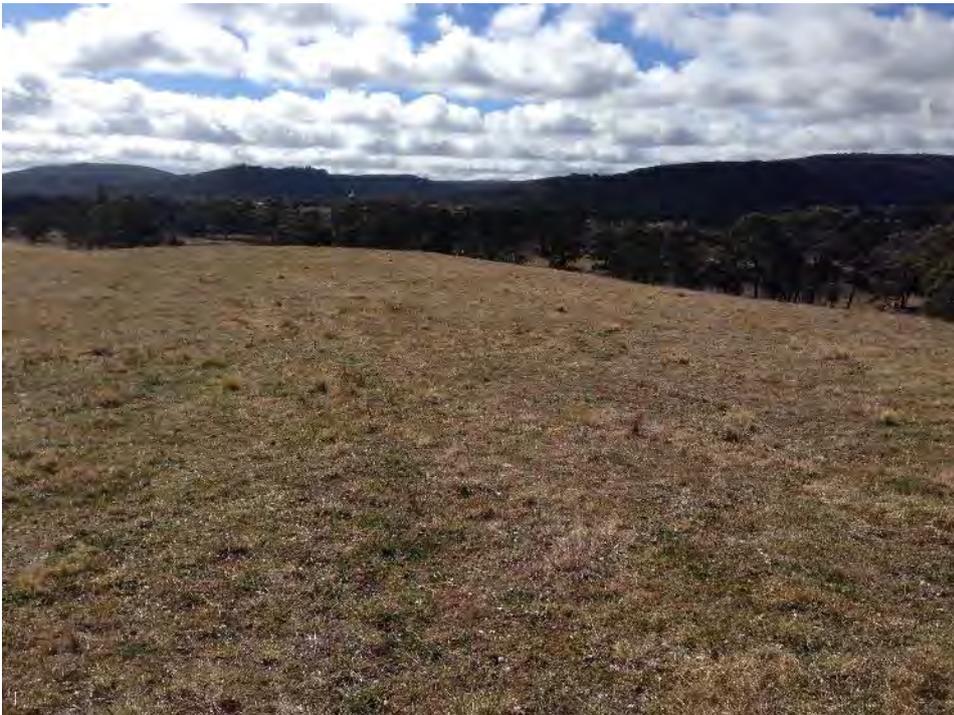
Transect 3 looking southwest 2014

Transect 3 looking southwest 2015

**Transect 3 looking southwest 2016**

**Transect 3 looking southwest 2017**

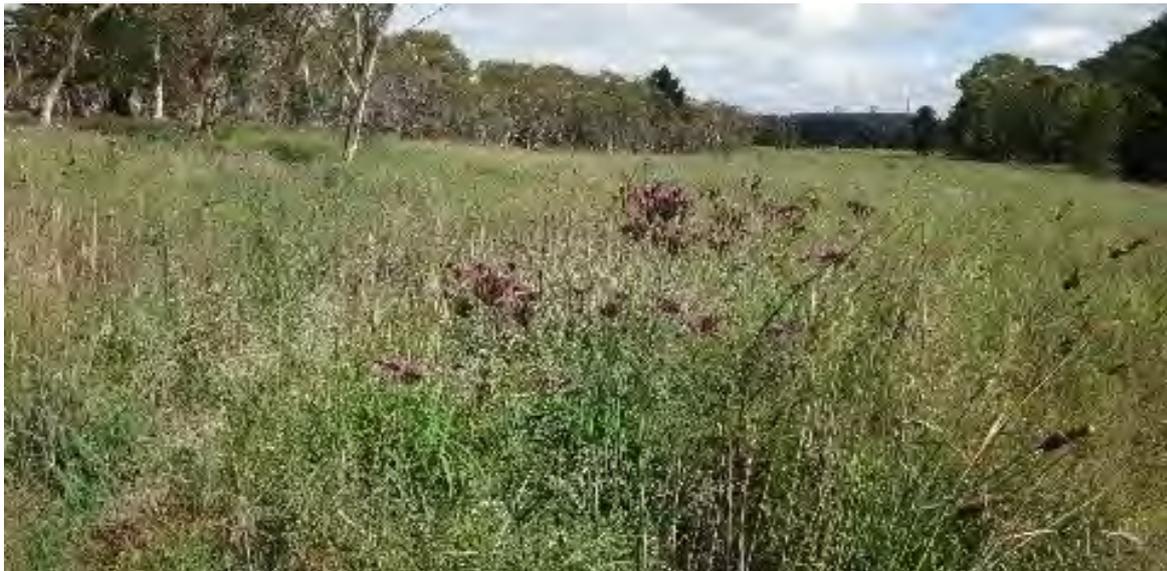
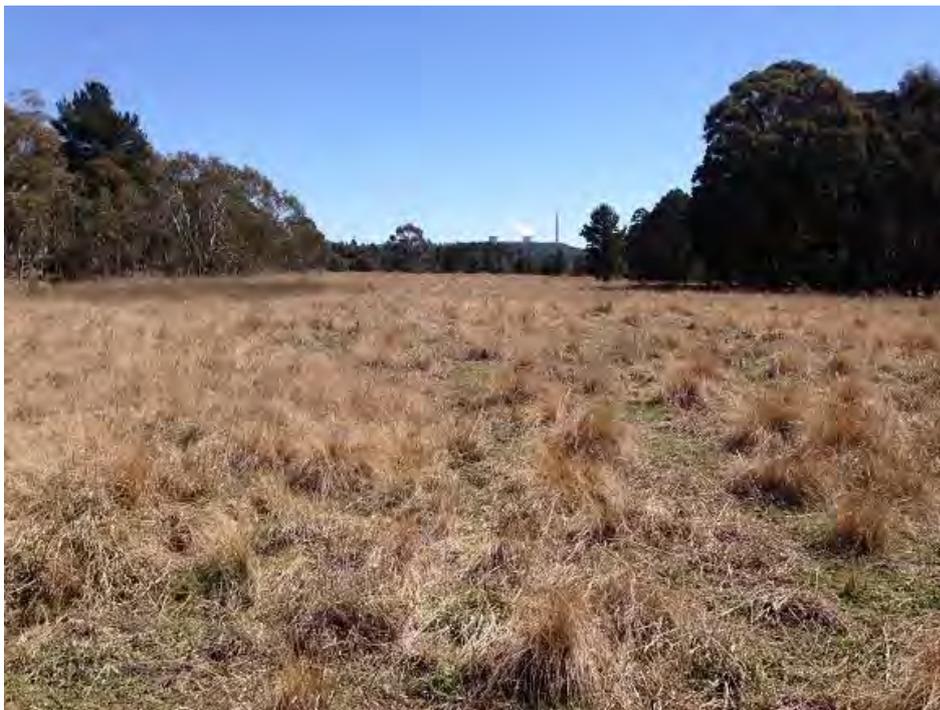
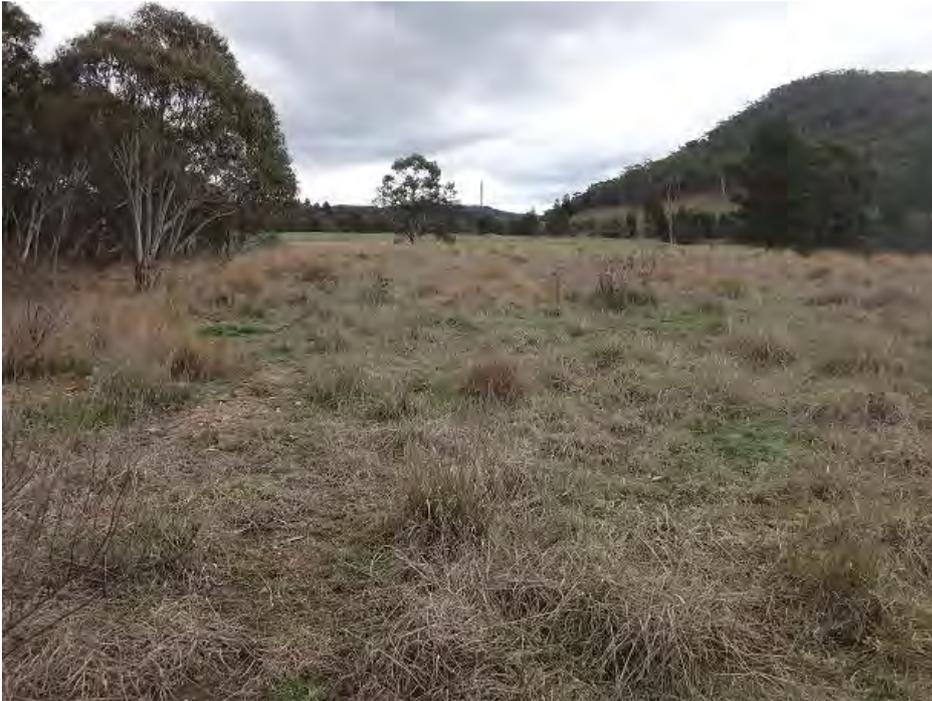
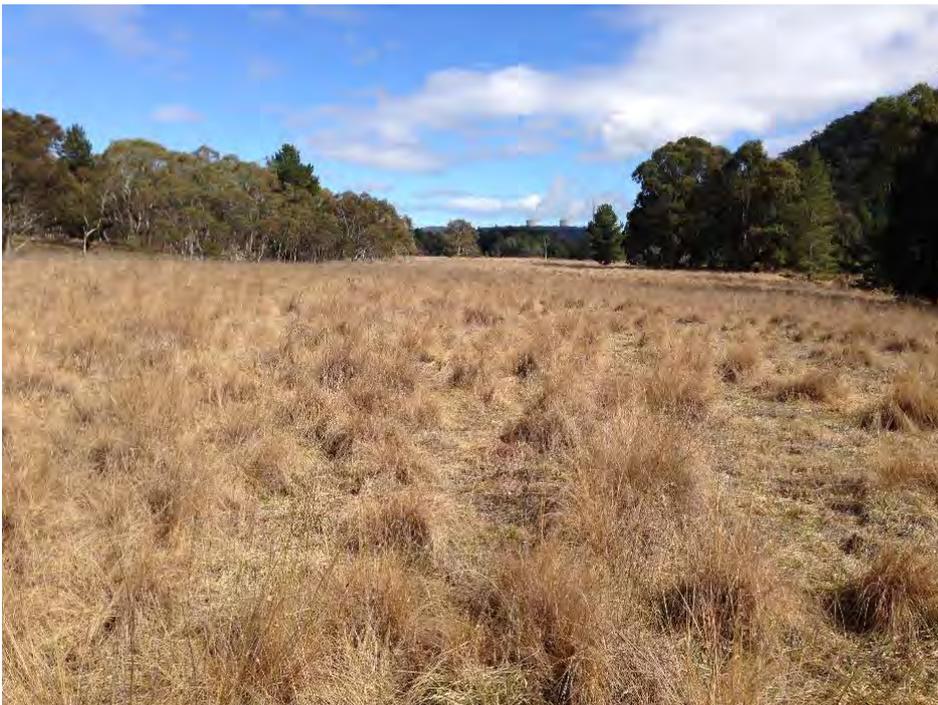
Transect 4 looking west 2014

Transect 4 looking west 2015

**Transect 4 looking west 2016**

**Transect 4 looking west 2017**

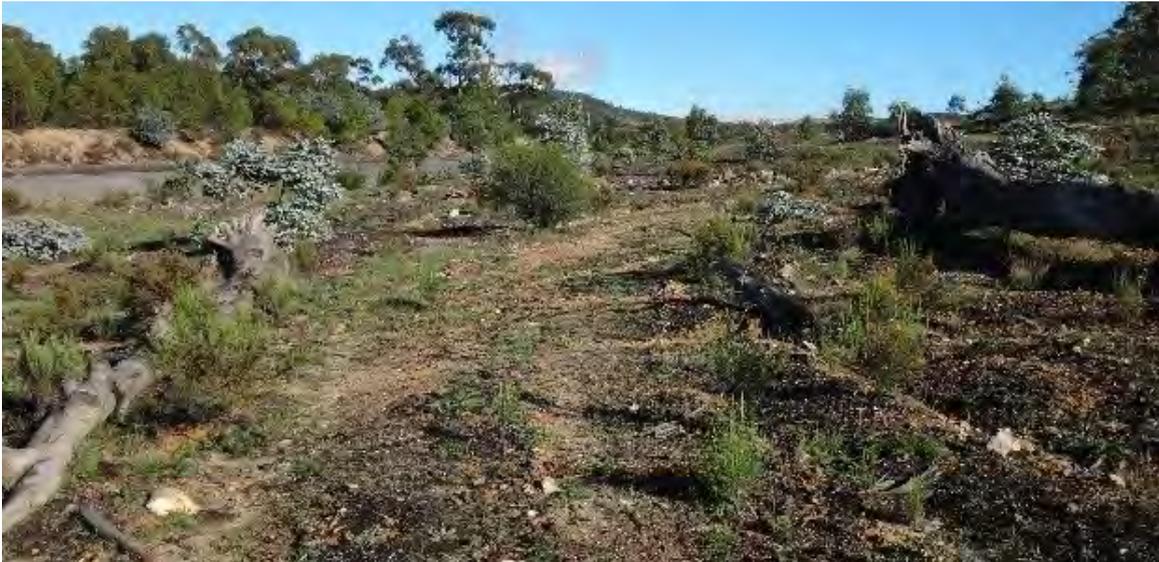
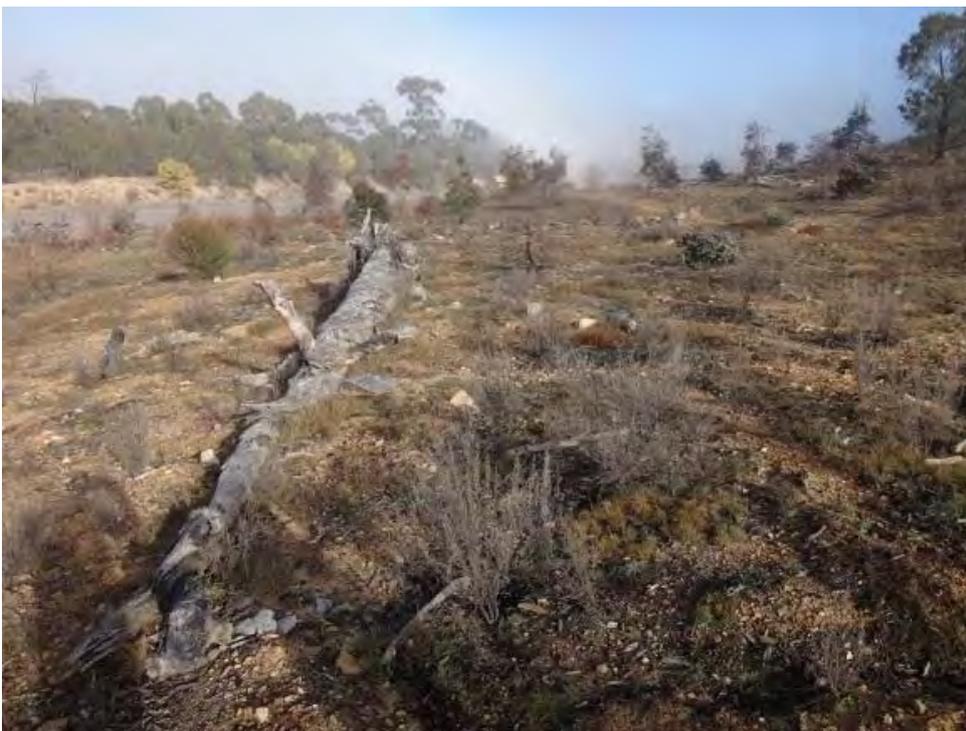
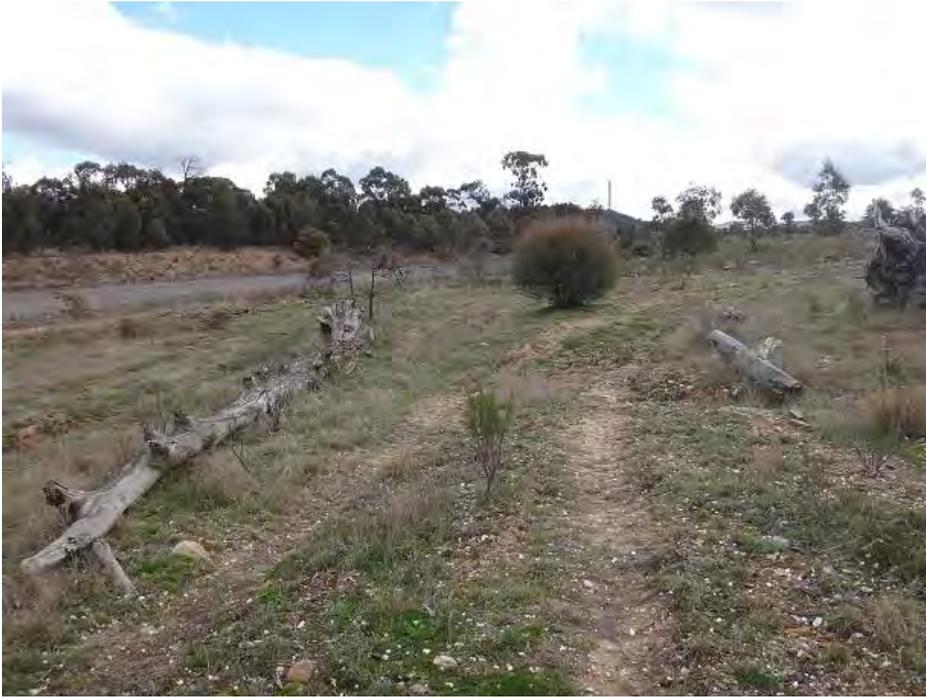
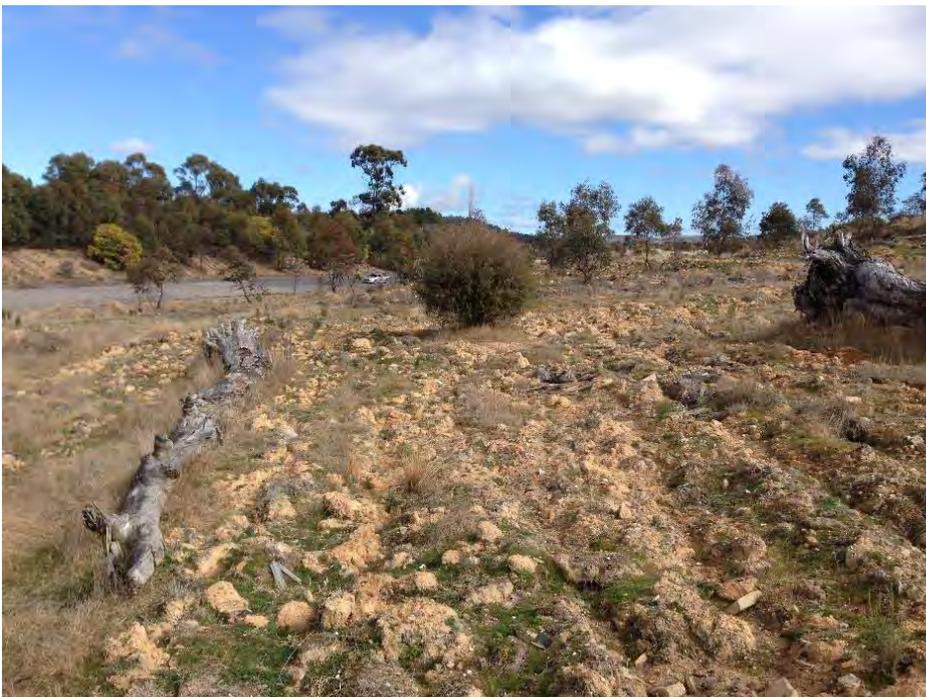
Transect 5 looking west 2014

Transect 5 looking west 2015

**Transect 5 looking west 2016**

**Transect 5 looking west 2017**

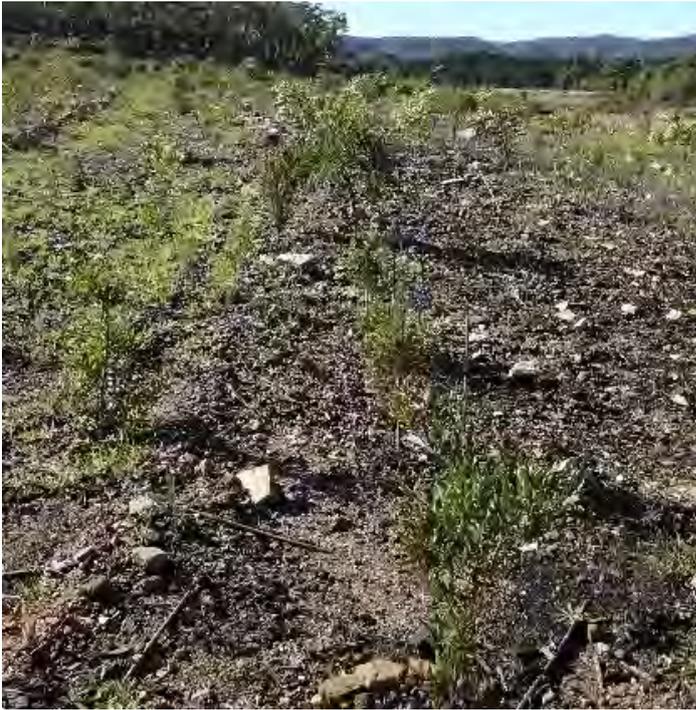
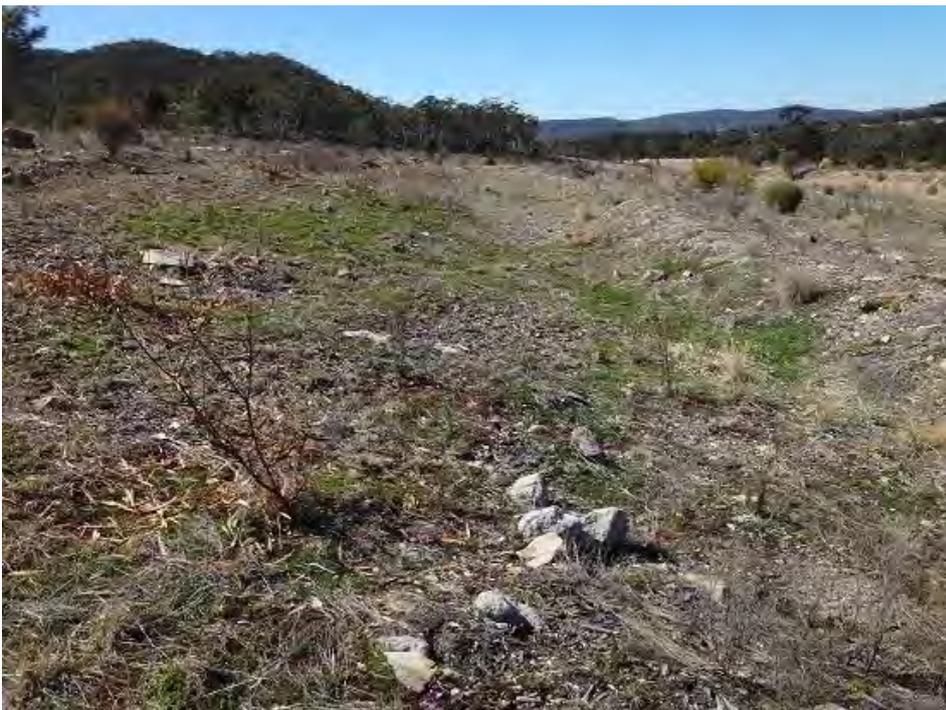
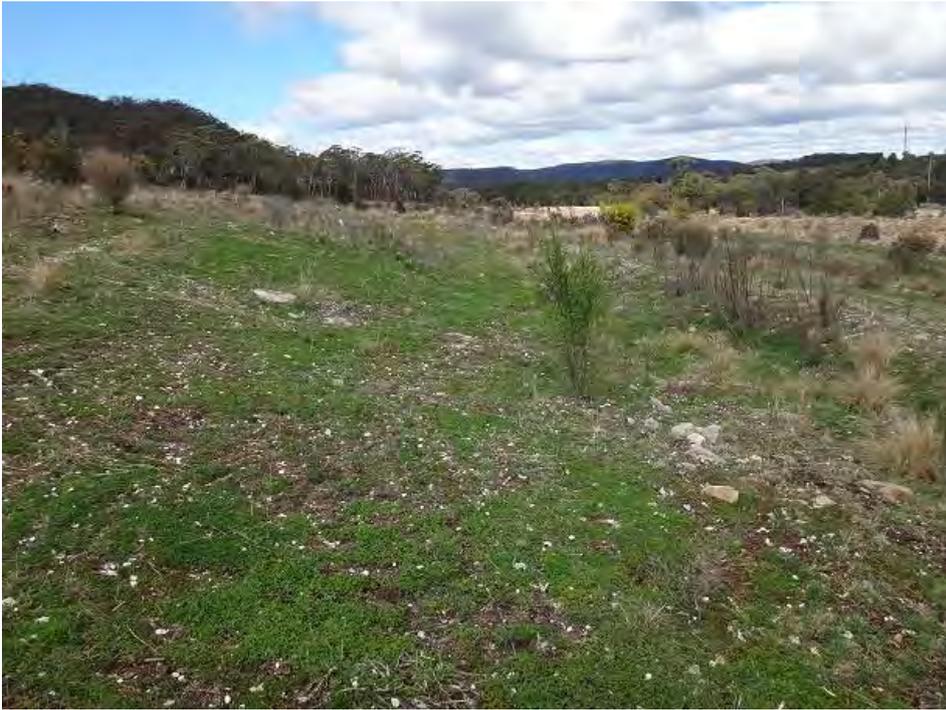
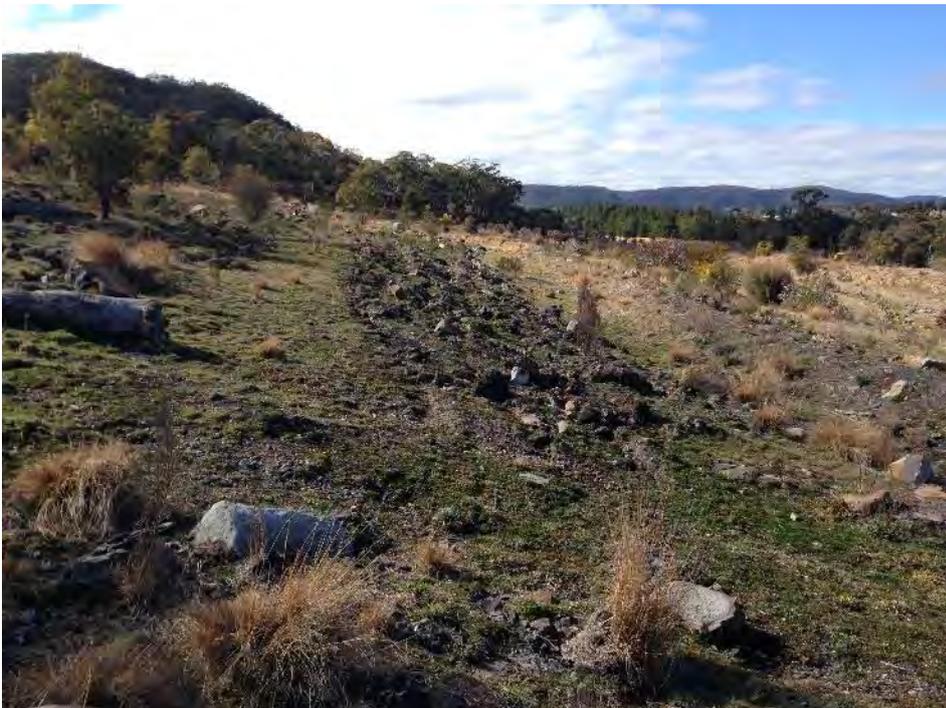
**Transect 6 looking east 2014**

**Transect 6 looking east 2015**

**Transect 6 looking east 2016**

**Transect 6 looking east 2017**
