# PINE DALE MINE ANNUAL REVIEW 2020

**Prepared by Enhance Place Pty Ltd  
Revision 1.2 – 12 February 2021**

This Annual Review has been prepared pursuant to Schedule 5, Condition 3 of the Project Approval 10\_0041, and in accordance with the Annual Review Guideline developed by the NSW Department of Planning and Environment (Ref [1]).

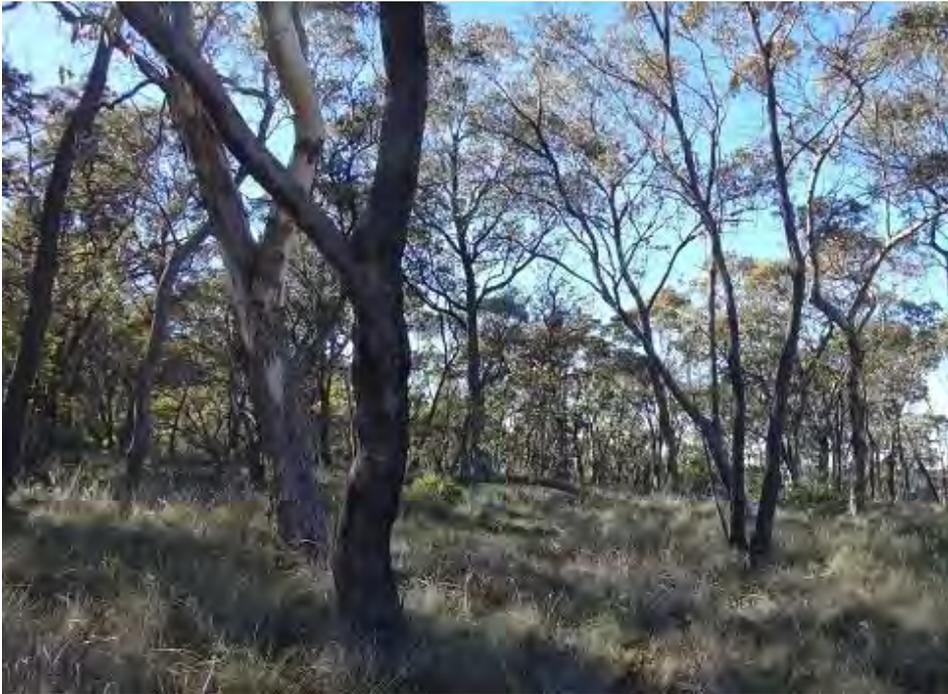
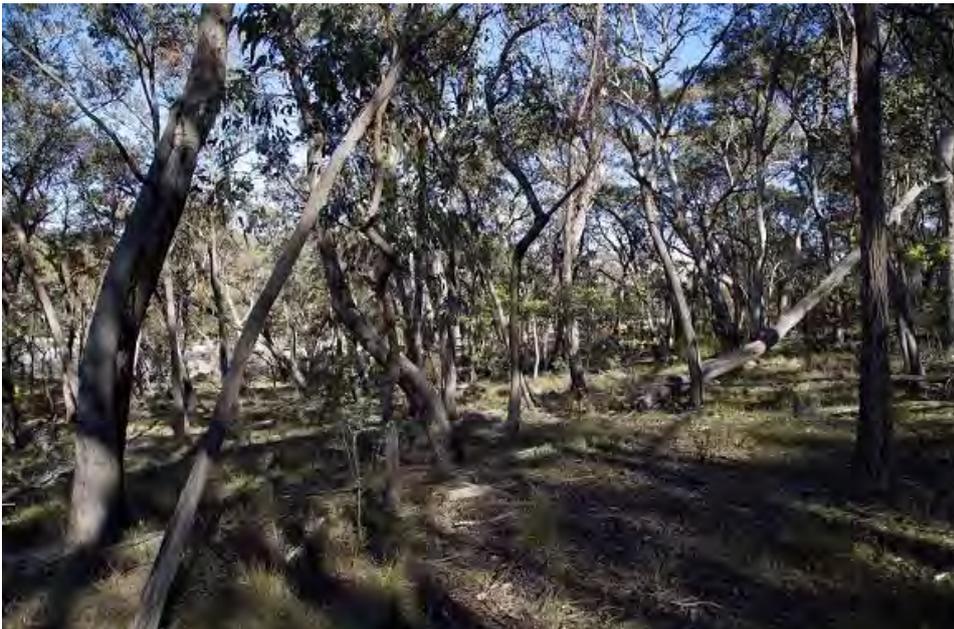
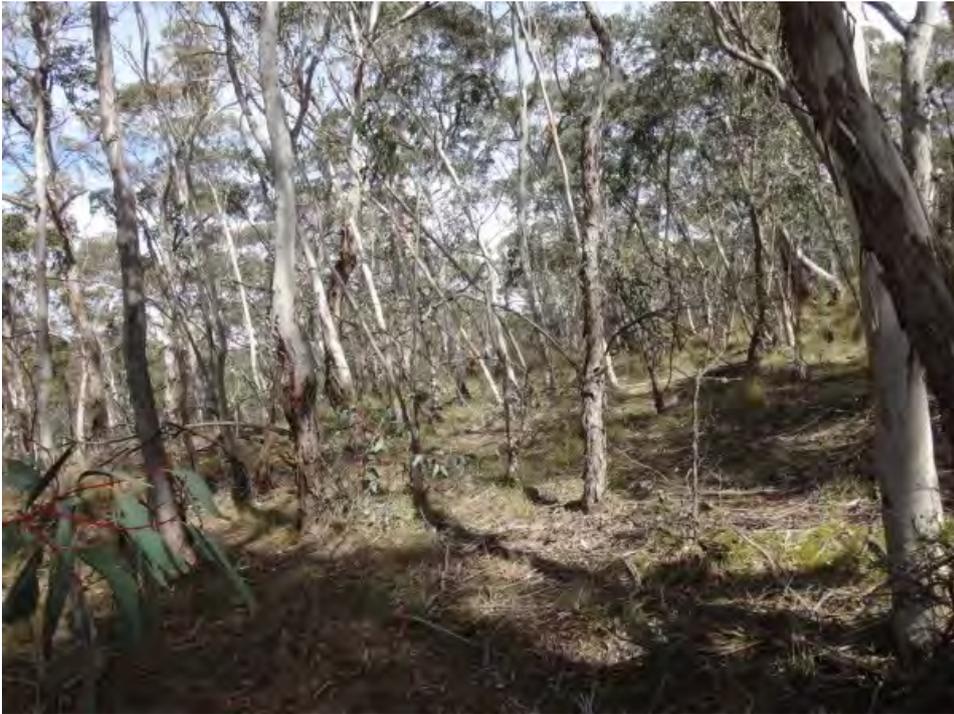
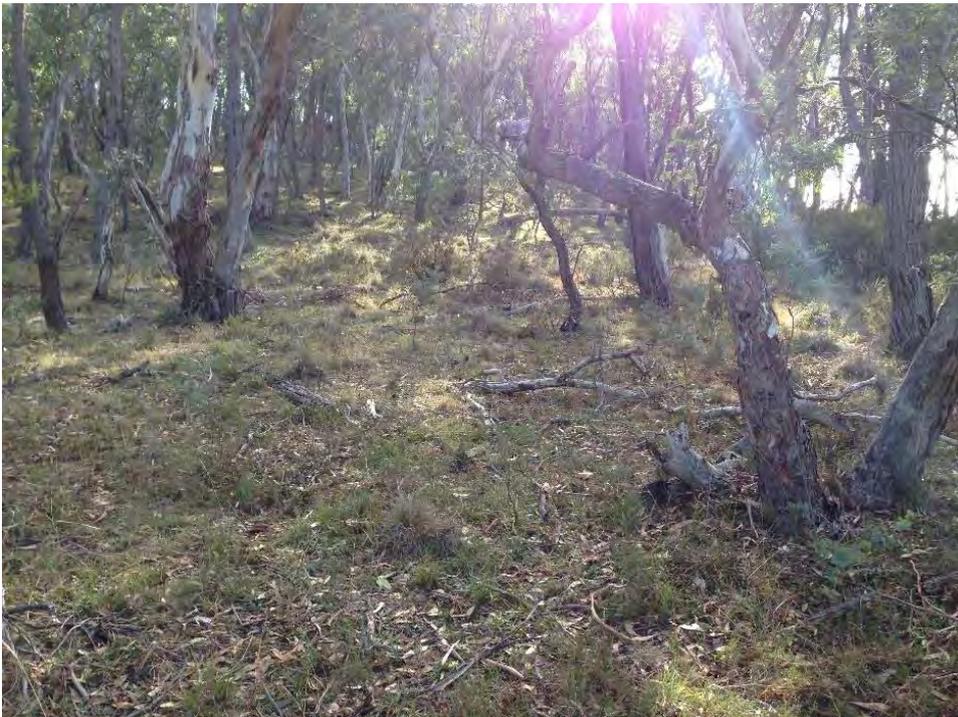
**Transect 7 looking east 2014**

**Transect 7 looking east 2015**

**Transect 7 looking east 2016**

**Transect 7 looking east 2017**

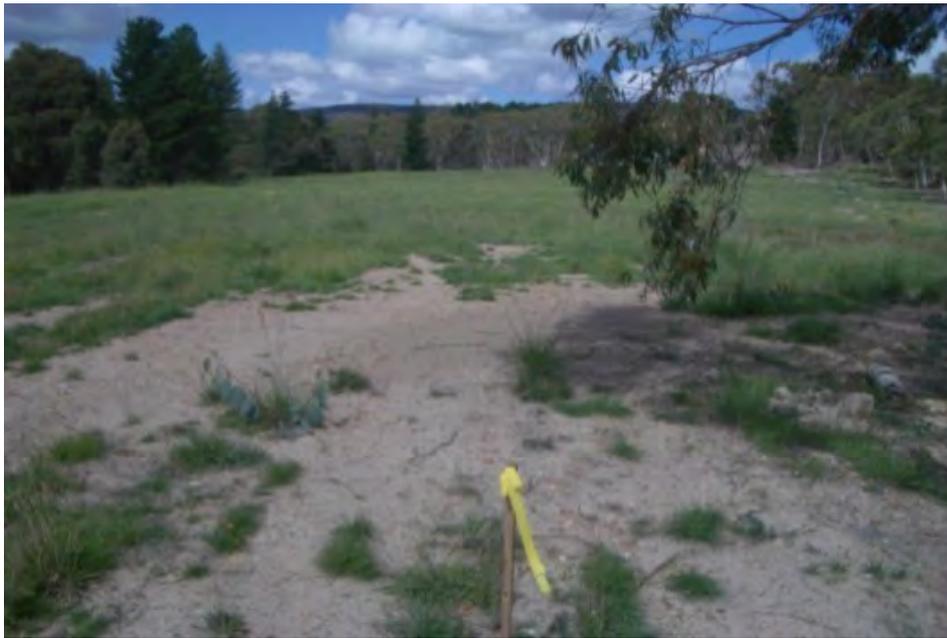
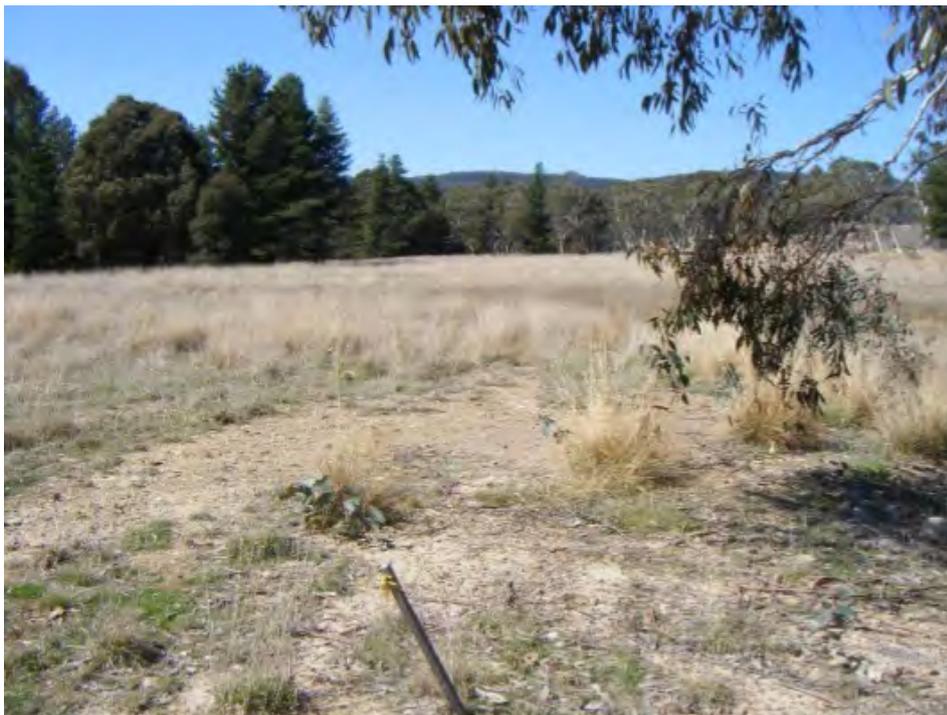
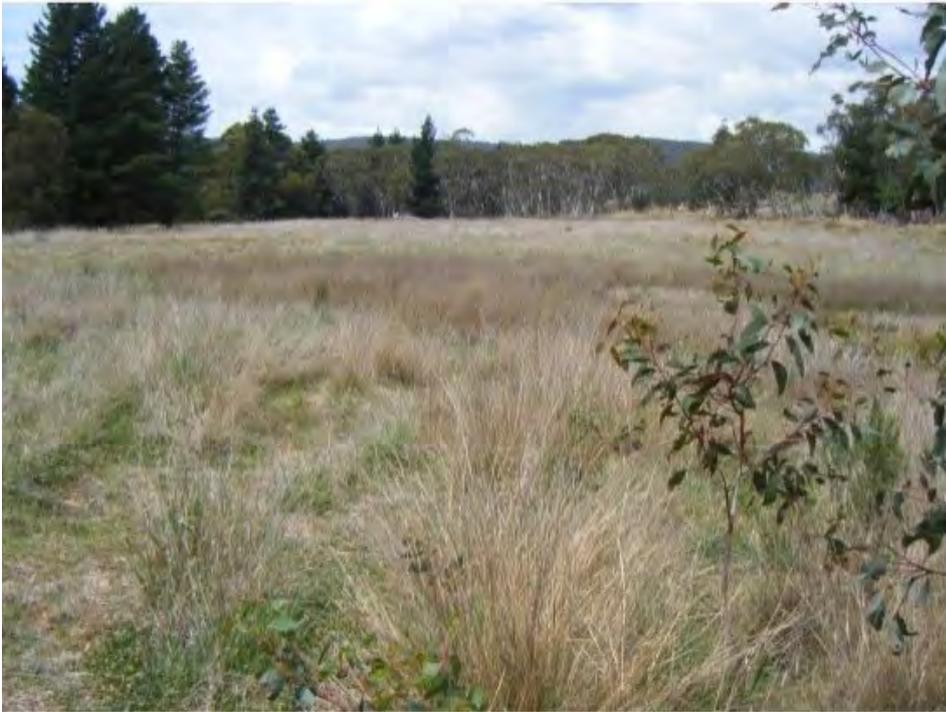
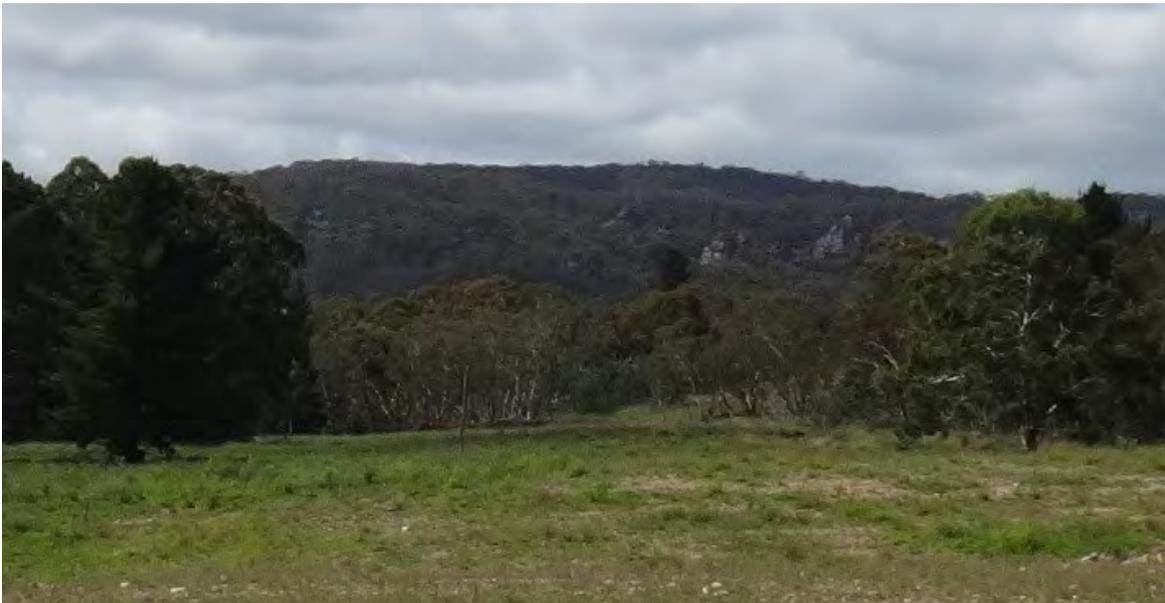
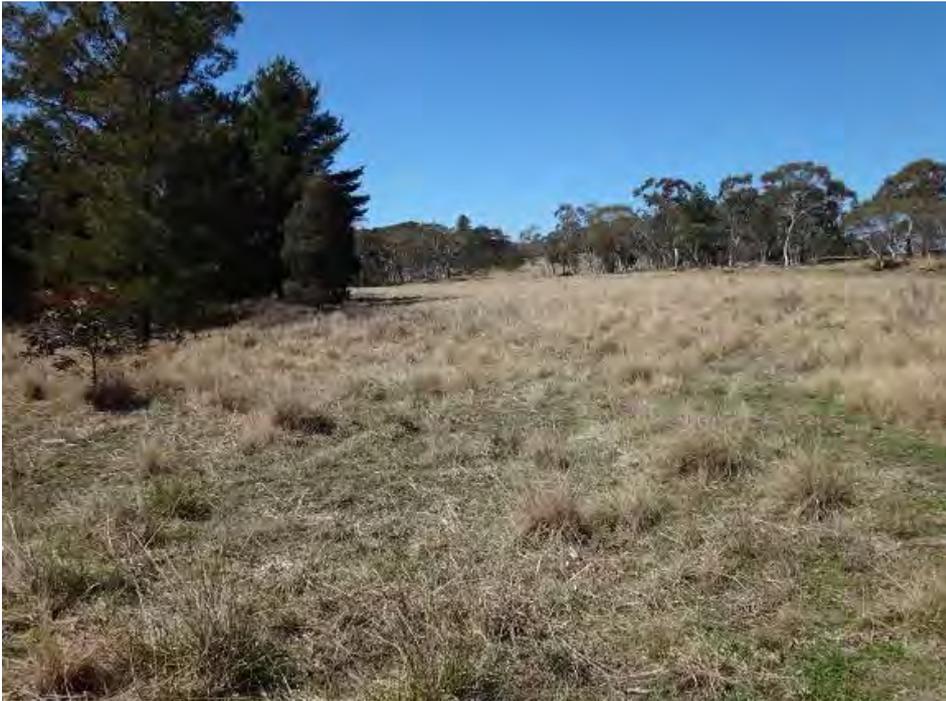
**Quadrat 1 February 2010 (Cunningham 2012)**

**Quadrat 1 September 2011 (Cunningham 2012)**

**Quadrat 1 November 2012 (Cunningham 2012)**

**Quadrat 1 April 2014**

**Quadrat 1 September 2015**

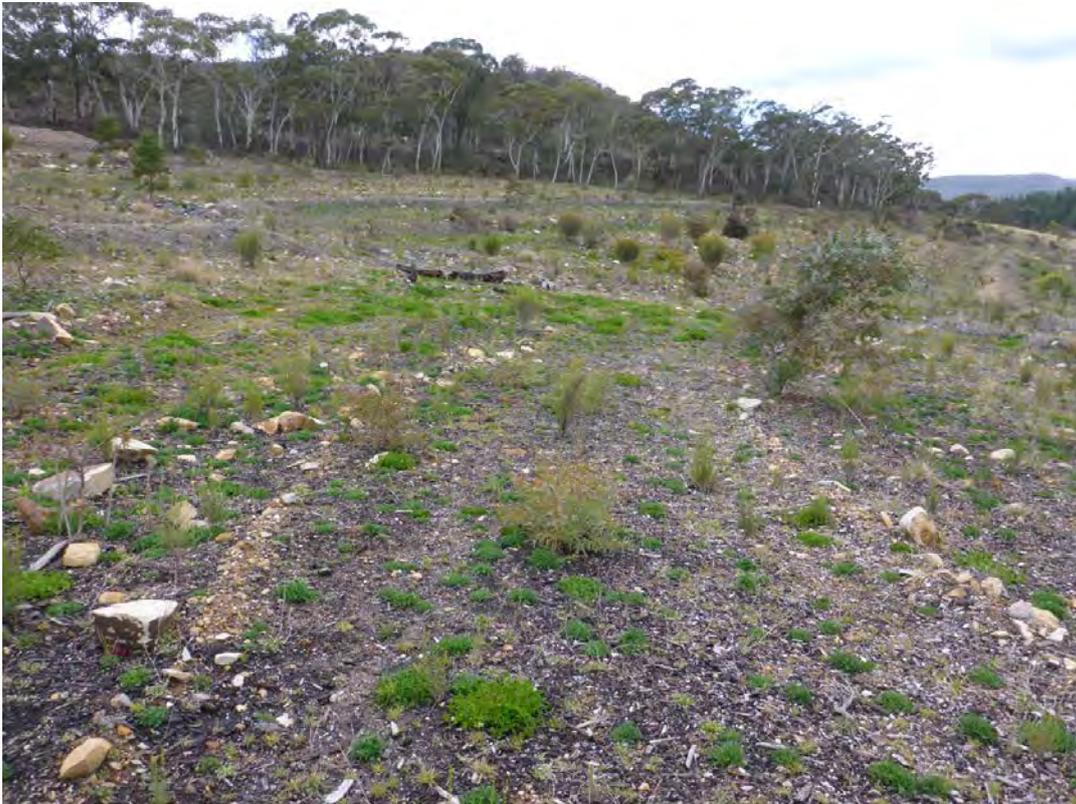
**Plate 1: Rehabilitated Site PD5 September 2014**

Increased growth of eucalypts can clearly be seen while groundcover consists of couch, phalaris and fescue perennial grasses with greater than 80% groundcover.

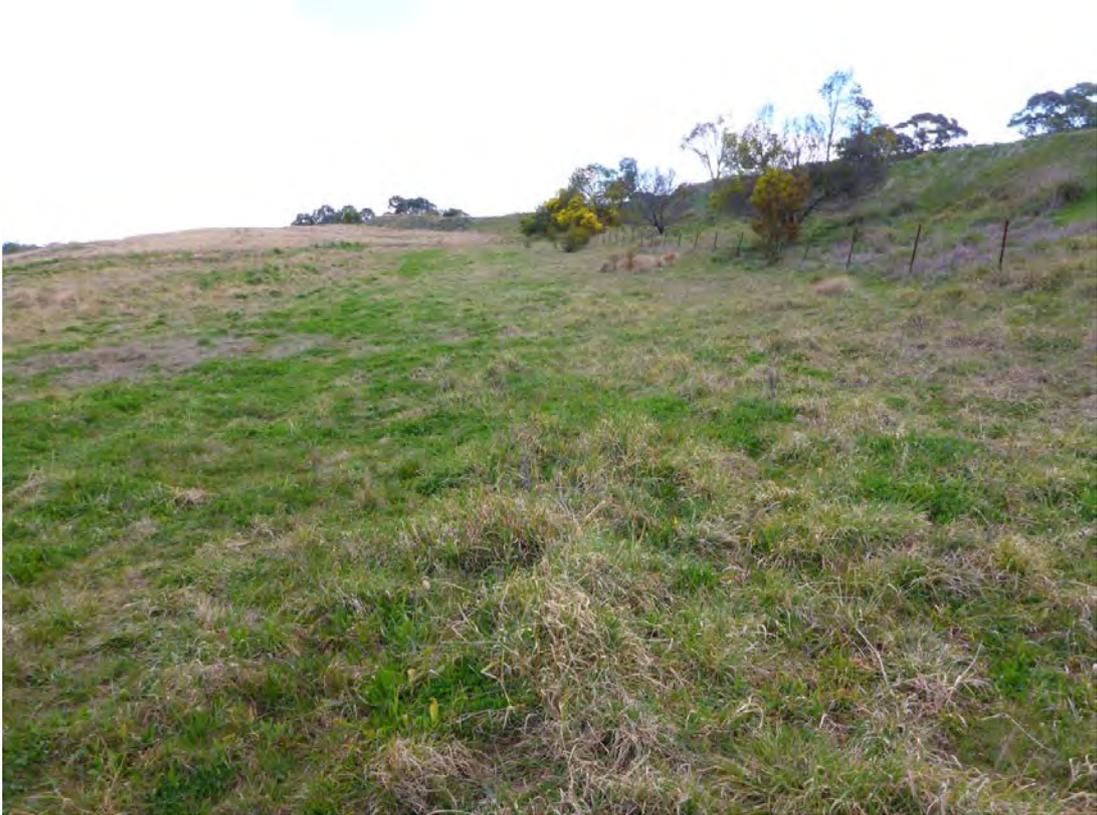
**Plate 3: Analogue Site PD3 September 2014**

Site PD3 has not been disturbed by mining activity and has not been rehabilitated. Site PD3 is considered to be representative of pre-mining grazing land use conditions in regards to soil profile and vegetation cover for this area. It is considered an analogue site for Area C.

Topsoil consists of a sandy clay loam over a medium clay subsoil. This area supports a perennial grass and clover pasture, including cocksfoot, tall fescue, phalaris, sub clover, with some annual ryegrass. These pasture species have a winter and spring growth habit, with the difference in pasture mass clearly evident between the 2014 (September) and 2018 (March) inspections.

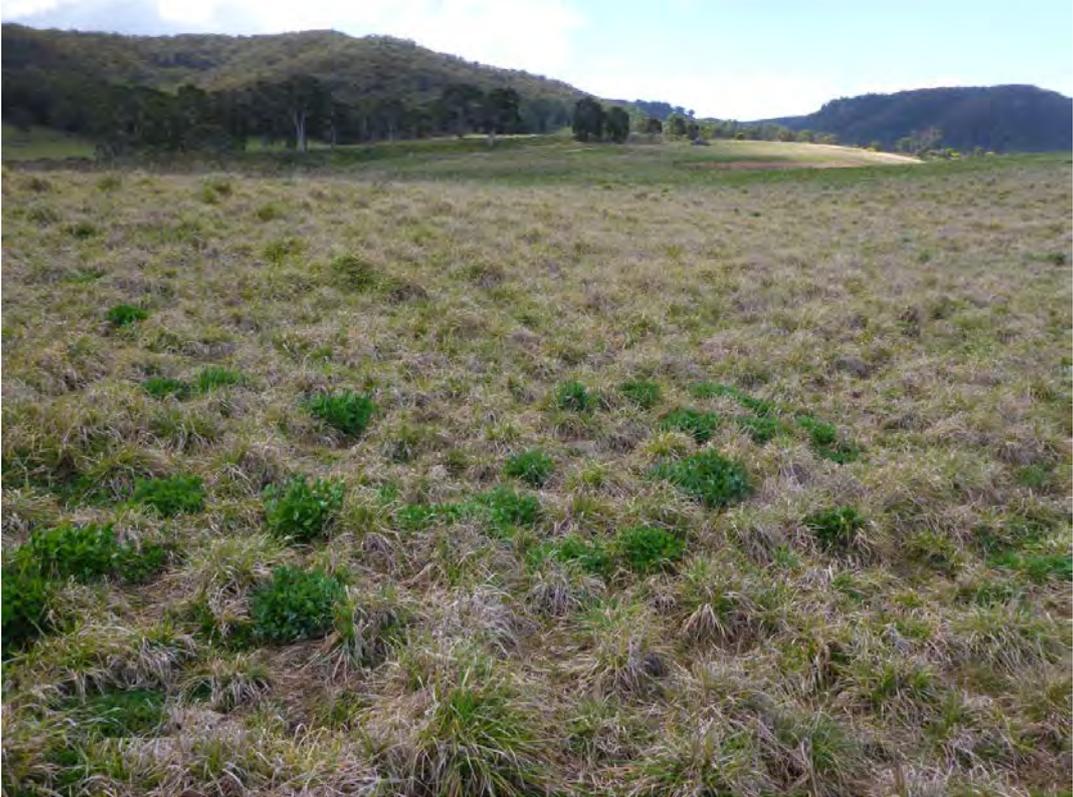
**Plate 5: Rehabilitated Site PD1 September 2014**

Pasture at Site PD1 is dominated by perennial cocksfoot and paspalum grass pasture with some sub clover and arrowleaf clover present in the sward, with greater than 90% groundcover. There is no African lovegrass present. Again the difference in pasture growth between autumn and spring can clearly be seen.

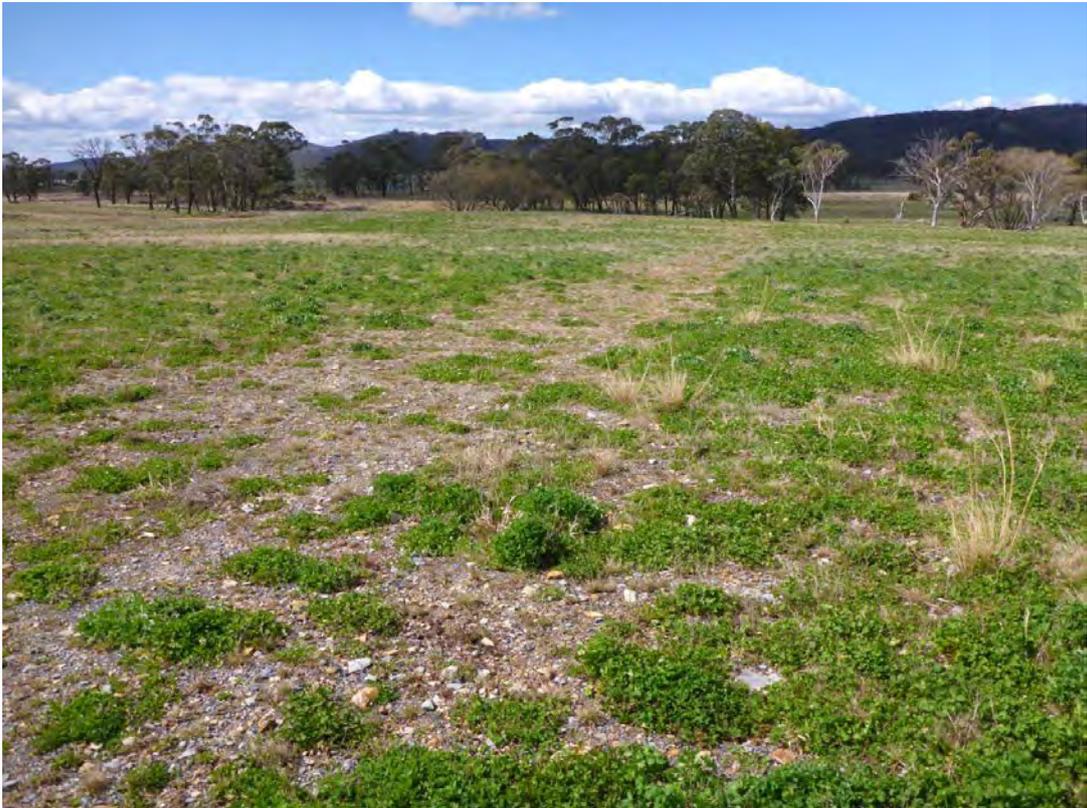
**Plate 7: Rehabilitated Site PD2 September 2014**

**Plate 7** and **Plate 8** show the general landscape setting for Site PD2 within Area C at Pine Dale Mine during the 2014 and 2018 inspections.

Pasture at Site PD2 is dominated by perennial cocksfoot and paspalum grass pasture with the herb plantain and some arrowleaf clover present in the sward, with greater than 80% groundcover. There are isolated African lovegrass tussocks present which comprise less than 5% of the pasture sward. Significant increase in perennial grass groundcover can be seen between the two inspection periods.

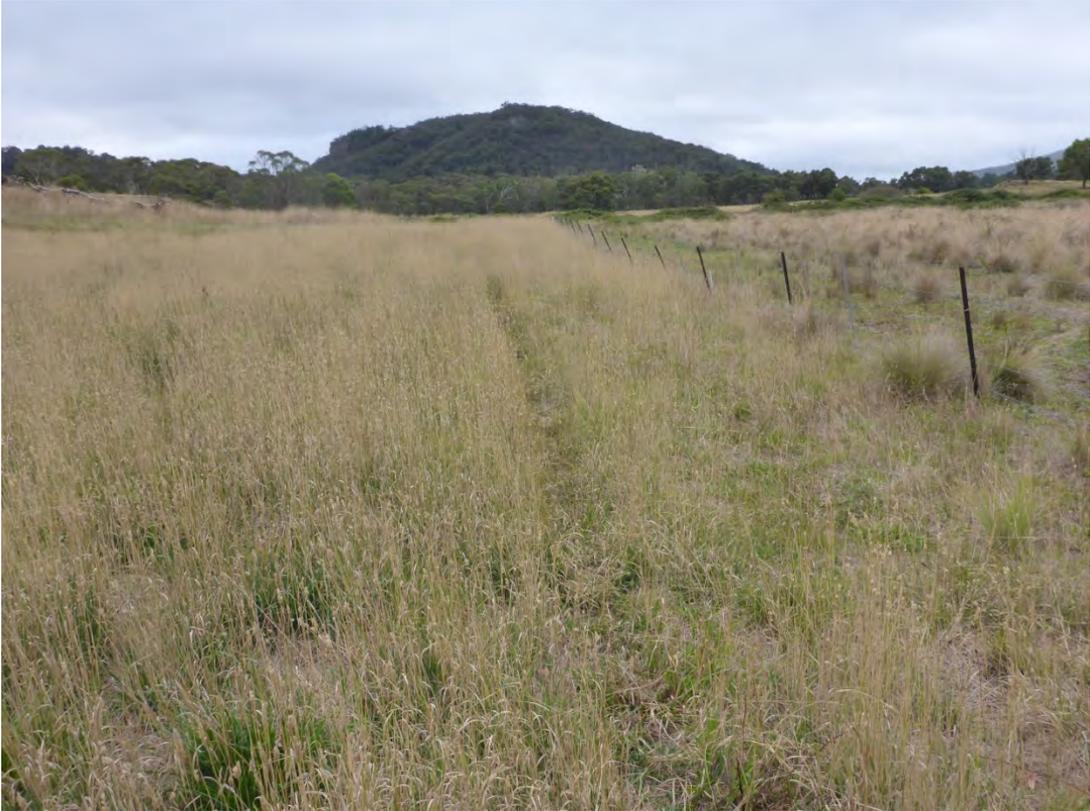
**Plate 9: Analogue Site PD6 March 2018**

**Plate 9** shows the general landscape setting for Site PD6 within Area C at Pine Dale Mine during the 2018 inspection. Pasture at Site PD6 is dominated by the perennial grasses phalaris and fescue

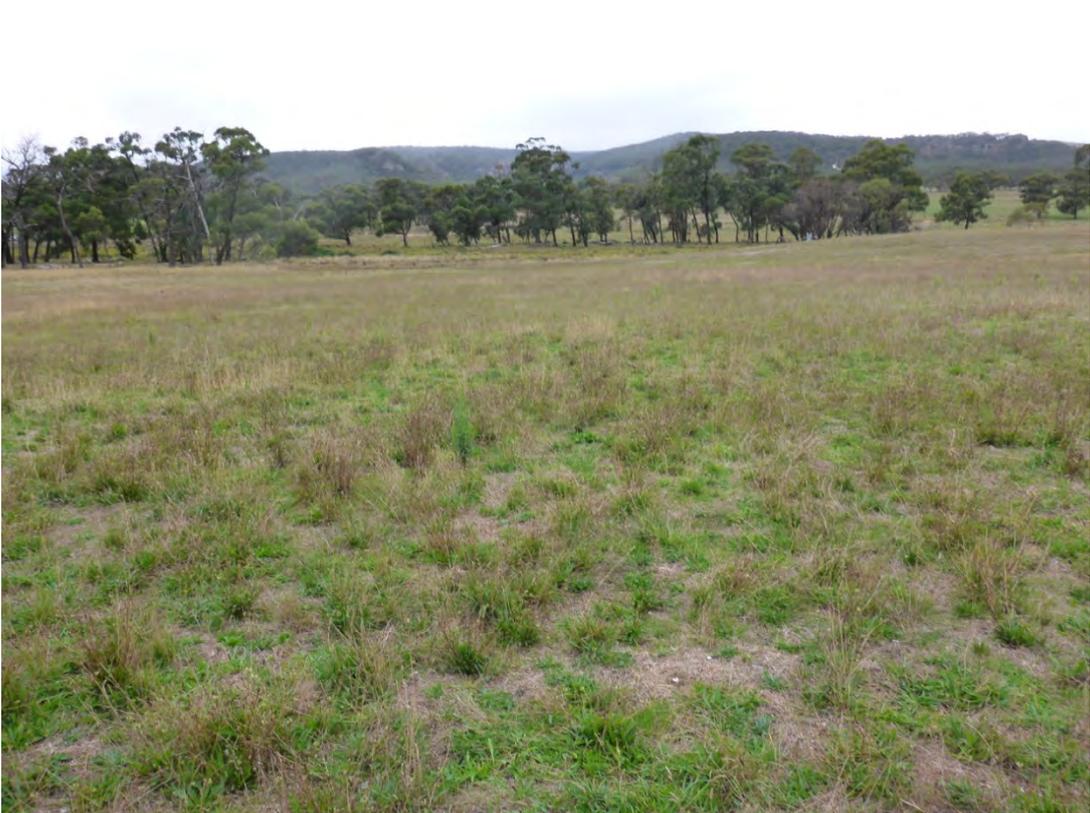
**Plate 10: Rehabilitated Site PD7 March 2018**

**Plate 10** shows the general landscape setting for Site PD7 within Area C at Pine Dale Mine during the 2018 inspection. Pasture at Site PD6 is dominated by perennial grasses phalaris, fescue and paspalum along with the herb plantain and arrowleaf clover. There is greater than 90% groundcover with only isolated tussocks of African lovegrass, which comprises less than 5% of the pasture sward.

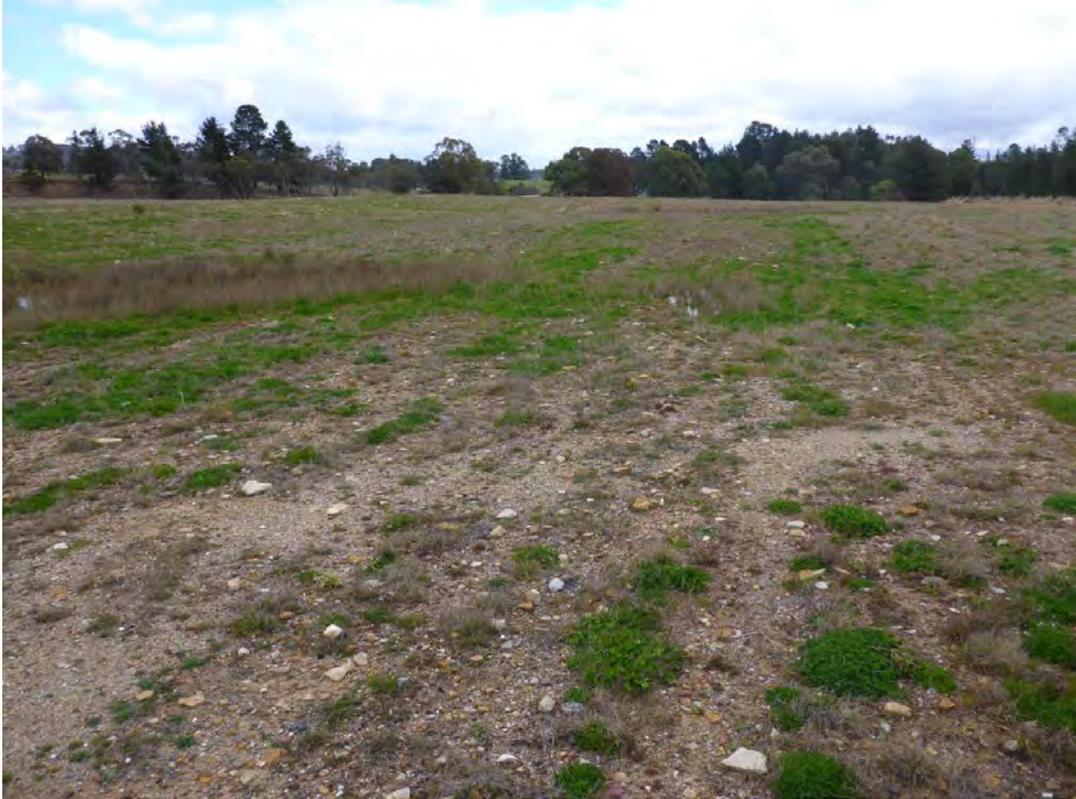
**Plate 11: Rehabilitated Site PD4 September 2014**

**Plate 11** and **Plate 12** show the general landscape setting for Site PD4 within Area 8 at Pine Dale Mine during the 2014 and 2018 inspections.

Pasture at Site PD4 is dominated by perennial grasses cocksfoot, fescue and paspalum with some arrowleaf clover present in the sward, and greater than 90% groundcover. There are isolated African lovegrass tussocks present which comprise less than 5% of the pasture sward. Significant increase in perennial grass groundcover can be seen between the two inspection periods.

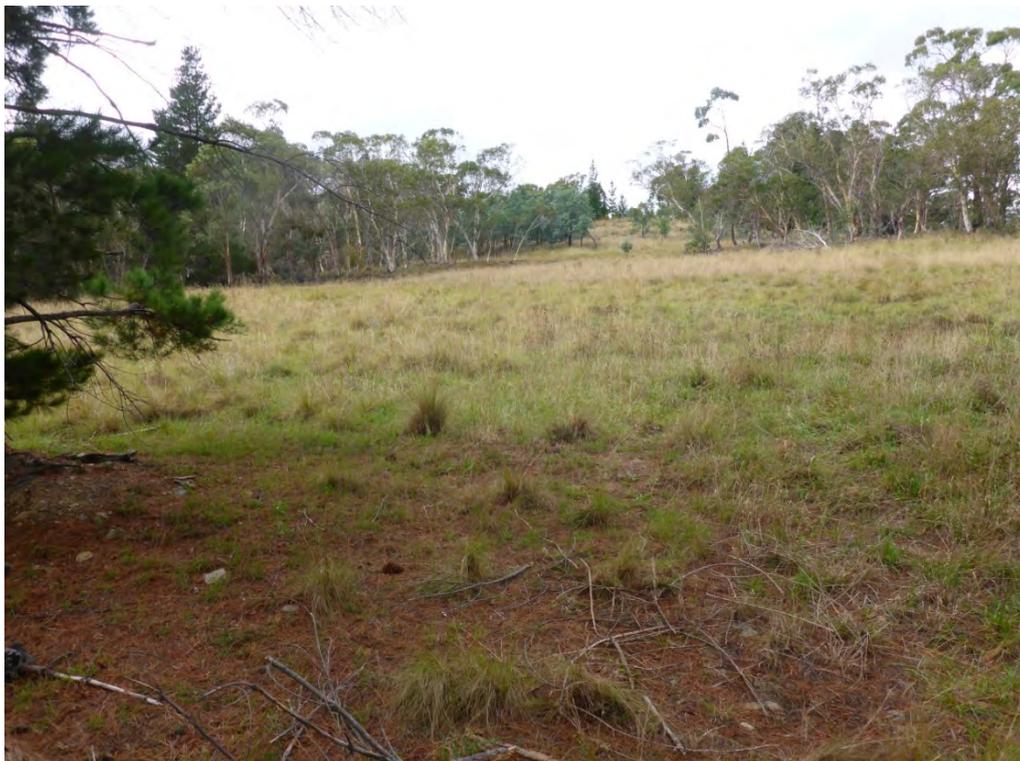
**Plate 13: Analogue Site PD8 March 2018**

**Plate 13** shows the general landscape setting for Site PD8 within Area 8 at Pine Dale Mine during the 2018 inspection. Pasture at Site PD8 is dominated by perennial phalaris and fescue with some arrowleaf clover present in the sward, with greater than 90% groundcover. There are isolated African lovegrass tussocks present which comprise less than 5% of the pasture sward.

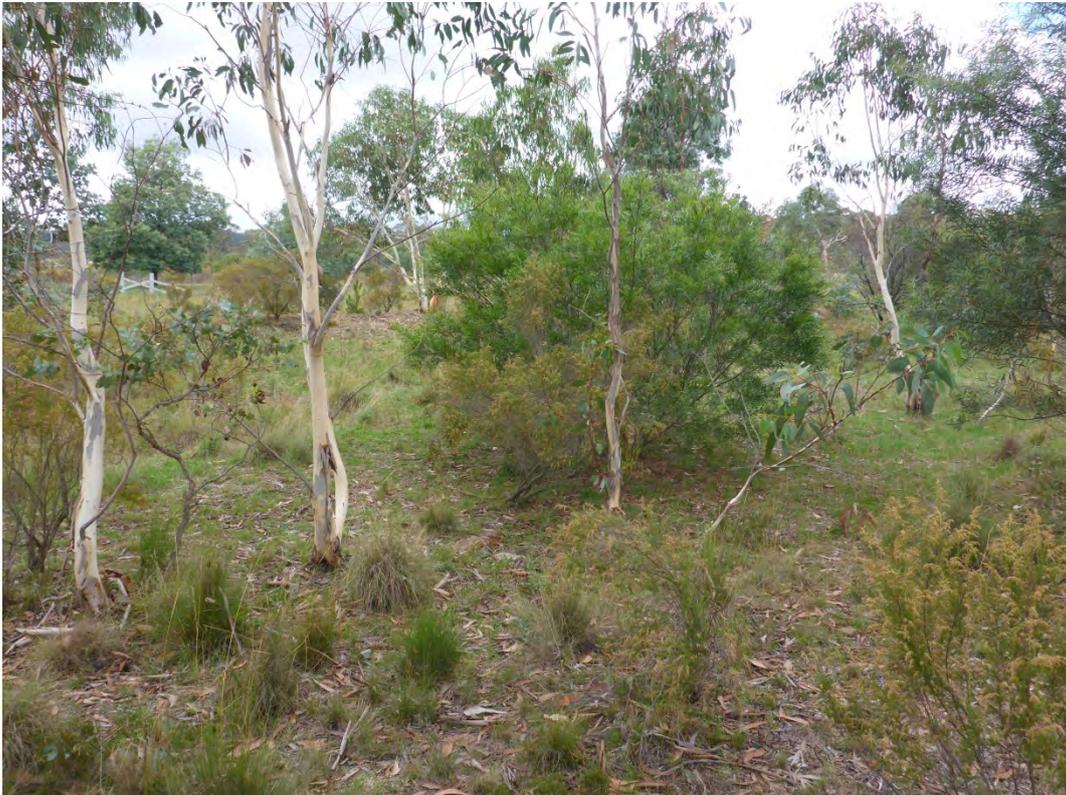
**Plate 14: Analogue Site EP4 March 2018**

**Table 16** below shows soil nutrient levels at Site EP4 from the 2018 inspection. Site EP4 was chosen as an analogue site for the Morris Property as it is undisturbed by mining did not receive any of the Morris Property treatment, being located between eucalypt trees and not accessed by fertiliser spreading equipment. **Plate 14** shows the general landscape setting for analogue Site EP4

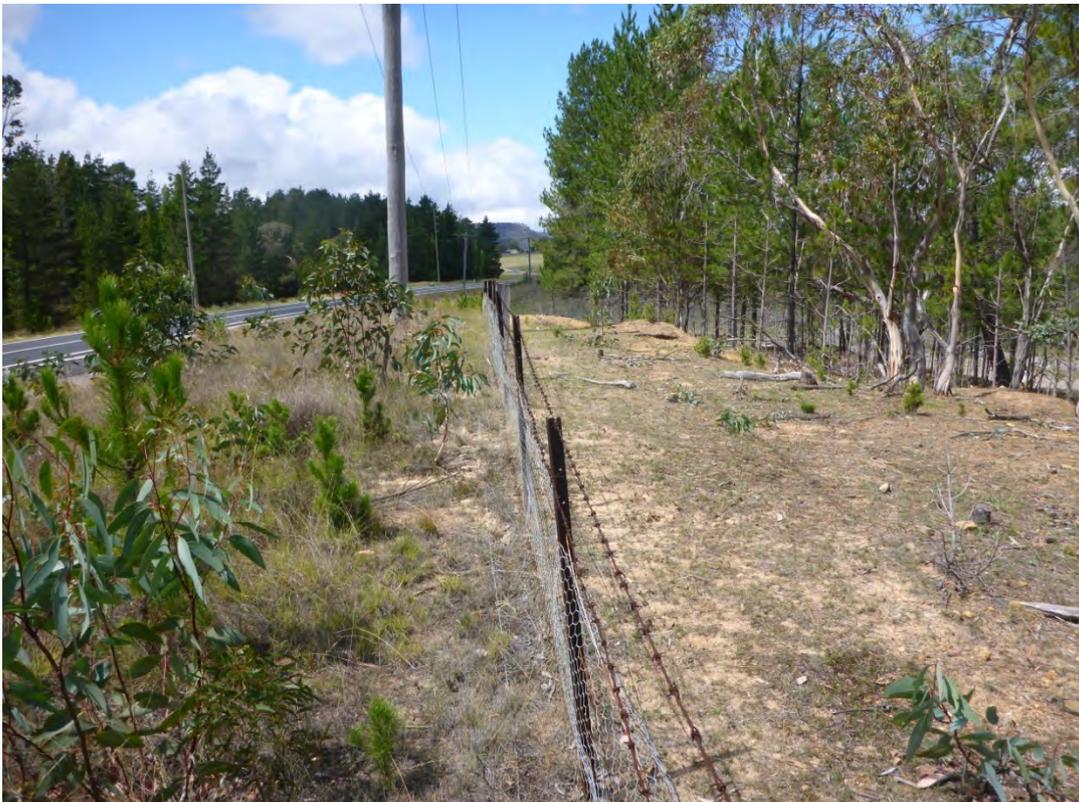
**Plate 15: Analogue Site EP6 March 2018**

**Table 17** below shows soil nutrient levels at Site EP6 from the 2018 inspection. Site EP6 was chosen as an analogue site for the Morris Property as it is undisturbed by mining and also located in a roadside reserve and not accessed by fertiliser spreading equipment. **Plate 15** shows the general landscape setting for analogue Site EP6.

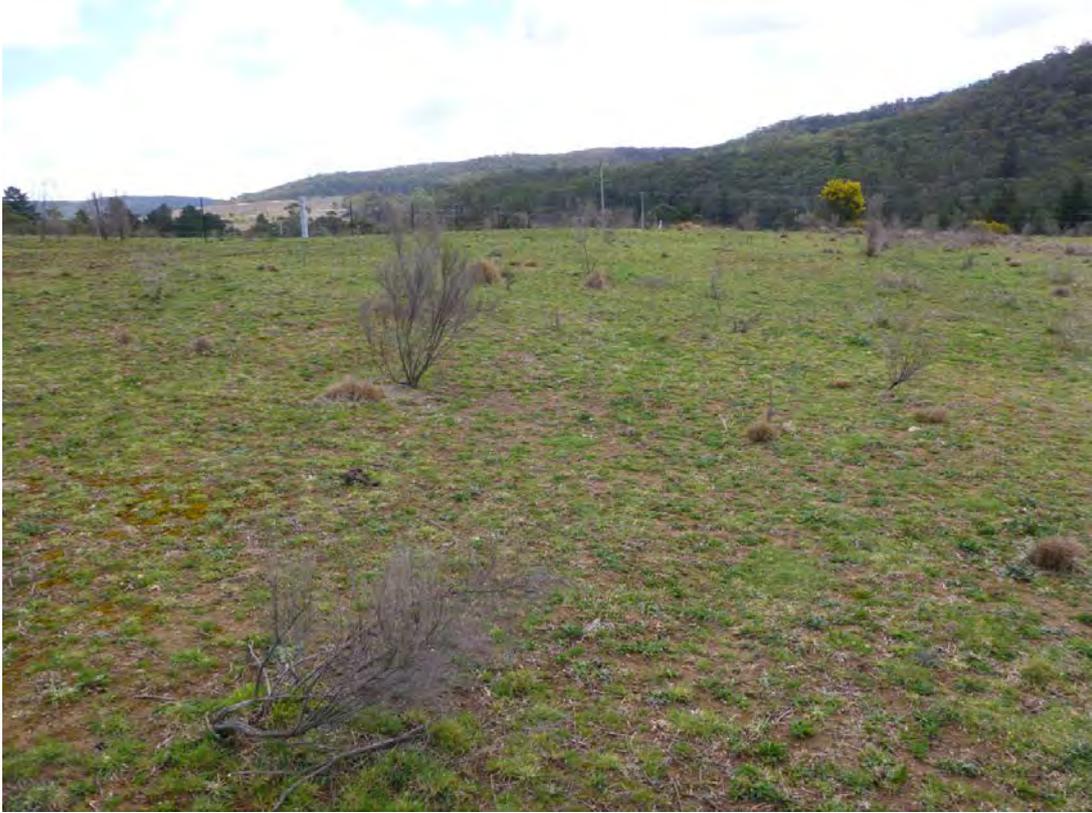
**Plate 16: Rehabilitated Site EP1 September 2014**

**Plate 16** and **Plate 17** show the general landscape setting for Site EP1 within the Morris Property at Enhance Place Mine during the 2014 and 2018 inspections.

Overgrazing is still a major land management issue here, however increase in perennial grass pasture density have been achieved nonetheless.

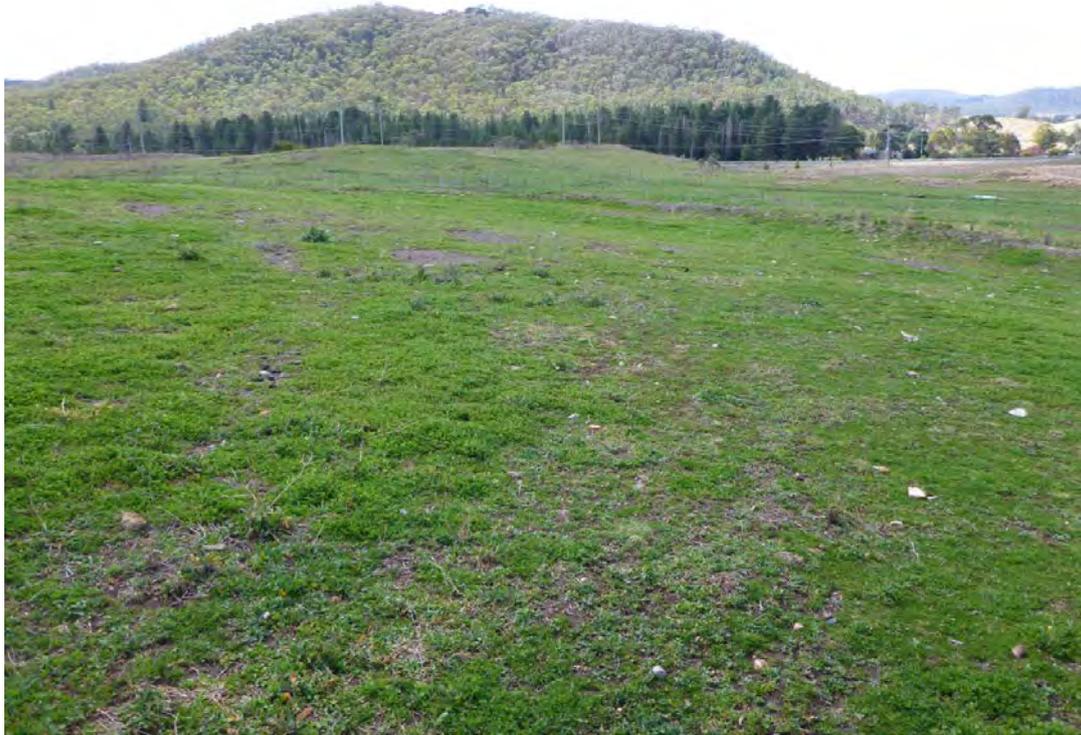
**Plate 18: Rehabilitated Site EP3 September 2014**

**Plate 18** and **Plate 19** show the general landscape setting for Site EP3 within the Morris Property at Enhance Place Mine during the 2014 and 2018 inspections.

Overgrazing is still a major land management issue here, however increase in perennial grass pasture density have been achieved nonetheless.

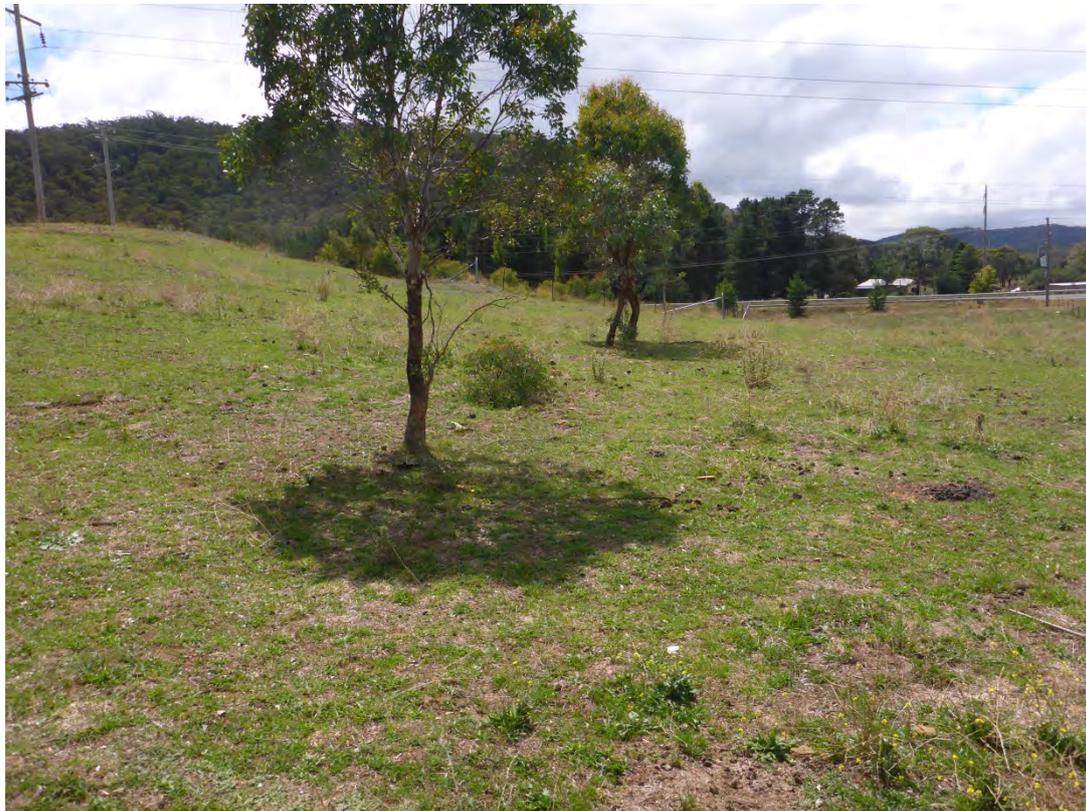
**Plate 20: Rehabilitated Site EP5 March 2018**

**Plate 20** shows the general landscape setting for Site EP5 within the Morris Property at Enhance Place Mine during the 2018 inspections. Pasture at Site EP5 is dominated by perennial grasses fescue and phalaris, the herb plantain with some medic present in the sward, and greater than 90% groundcover.

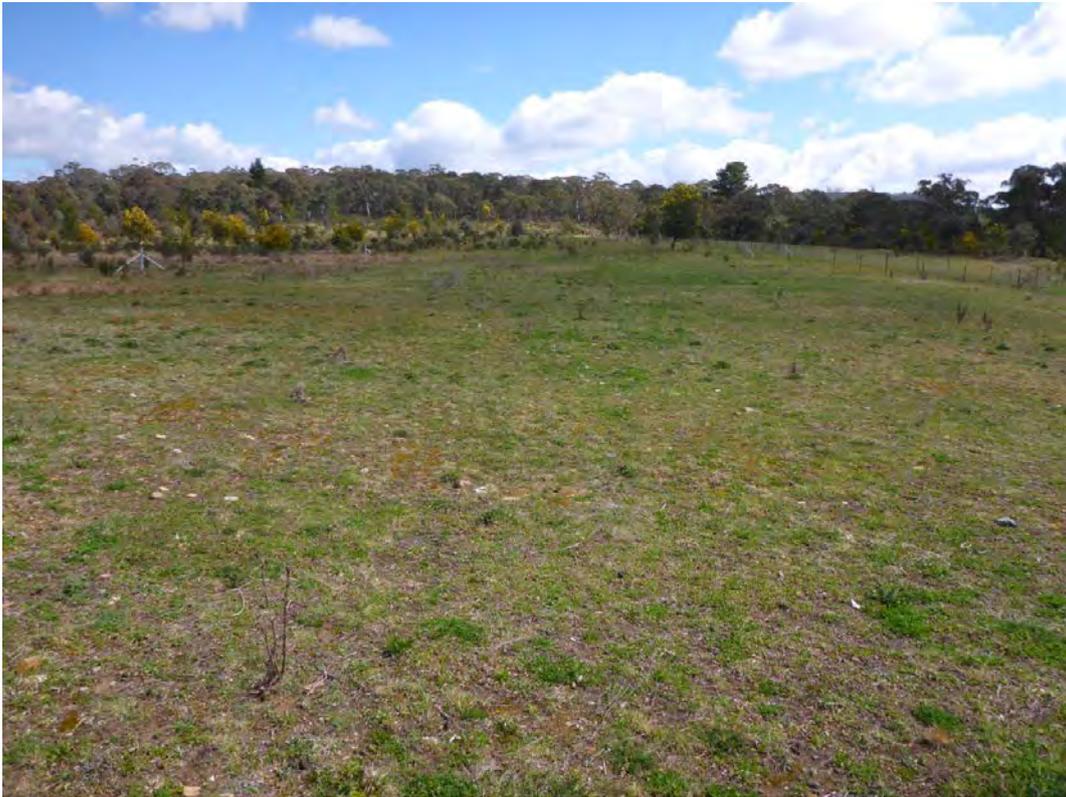
**Plate 21: Rehabilitated Site EP2 September 2014**

The Crown Land Block adjacent to the Morris property is grazed only by kangaroos with domestic stock being excluded. In 2014 EP2 had sufficient groundcover and a desirable pasture species composition with no further remediation work recommended.

**Plate 21** and **Plate 22** show the general landscape setting for Site EP2 within the Morris Property at Enhance Place Mine during the 2014 and 2018 inspections, with greater than 80% groundcover.
