**EnergyAustralia  
Yallourn Mine**

**SUSTAINABILITY REPORT**

**1 JULY 2015 TO 30 JUNE 2016**

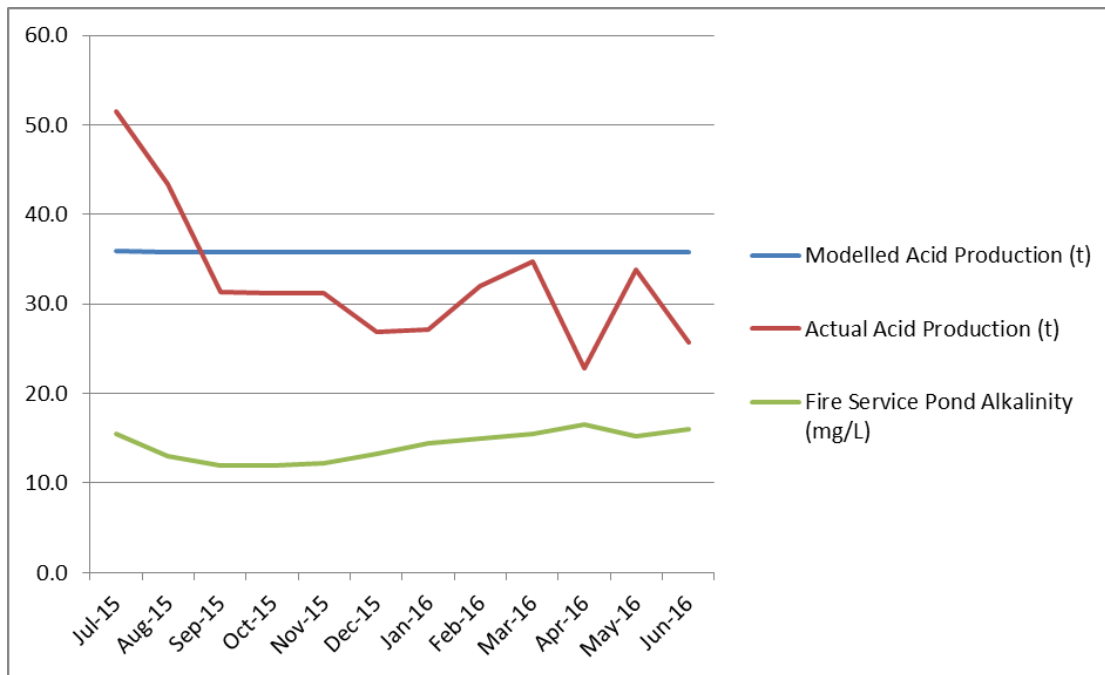
**Figure 1: Acidity and Alkalinity Monitoring during 2015/16**

In addition to pH monitoring, an acidity alkalinity balance model has been developed to model and track the acid production and alkalinity intake within the Yallourn Mine. Results from this monitoring are shown below with acid production levels lower than modelled for 2015/16 and Fire Service Pond alkalinity rising, making pH more resistant to impacts from acid generation.

Monitoring of acid production from acid sulphate soils is completed on a monthly basis. This monitoring showed that no water treatment was required for acid sulphate soil management during 2015/16 due to pH and Fire Service Pond alkalinity (greater than 7 mg/L) being above target and rising throughout the reporting period.

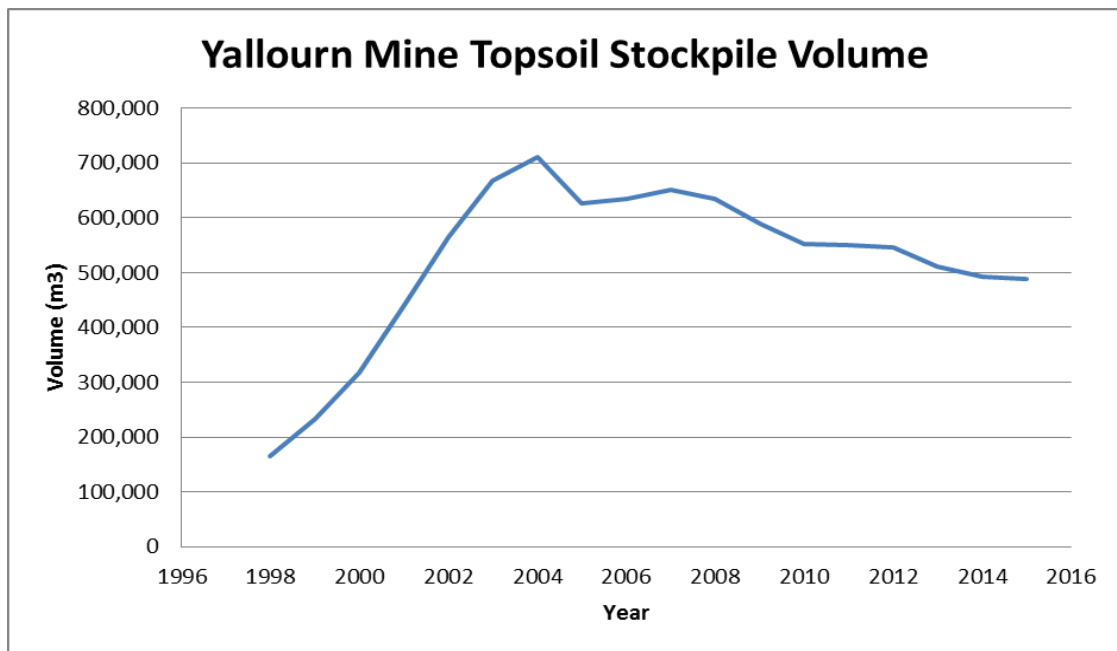
**Figure 2 - Yallourn Mine Progressive Topsoil Stockpile Volumes**

Total stockpile volumes have now peaked and will progressively reduce over time as topsoil is required for on-going future rehabilitation works.

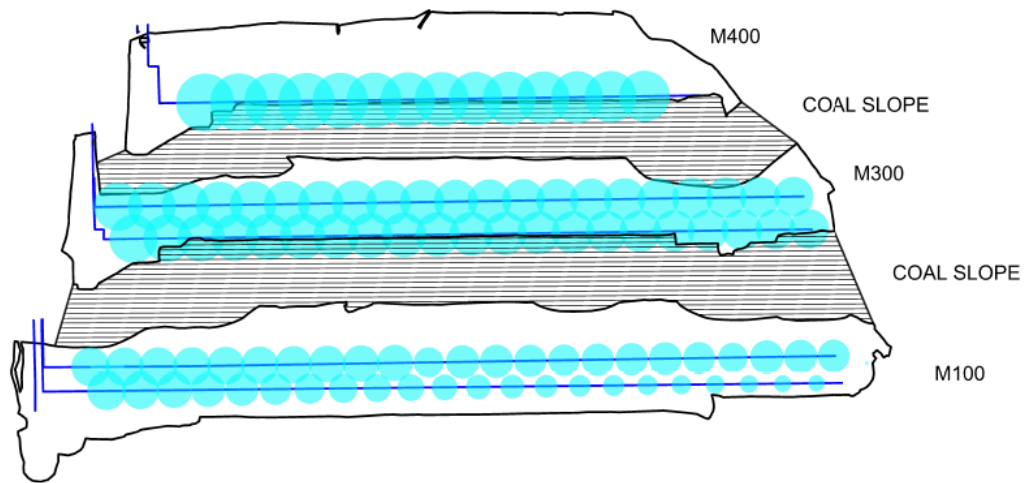
Fixed Spray Coverage for Maryvale Operating Area in December 2015 when all sprays on at the same time.

**Figure 3: Coal Bench Coverage when all Sprays On at the Same Time**

The annual Fire Service Wet Test was completed in 2015 which confirmed compliance with internal requirements for spray coverage over coal, storage volumes and system flow rates.

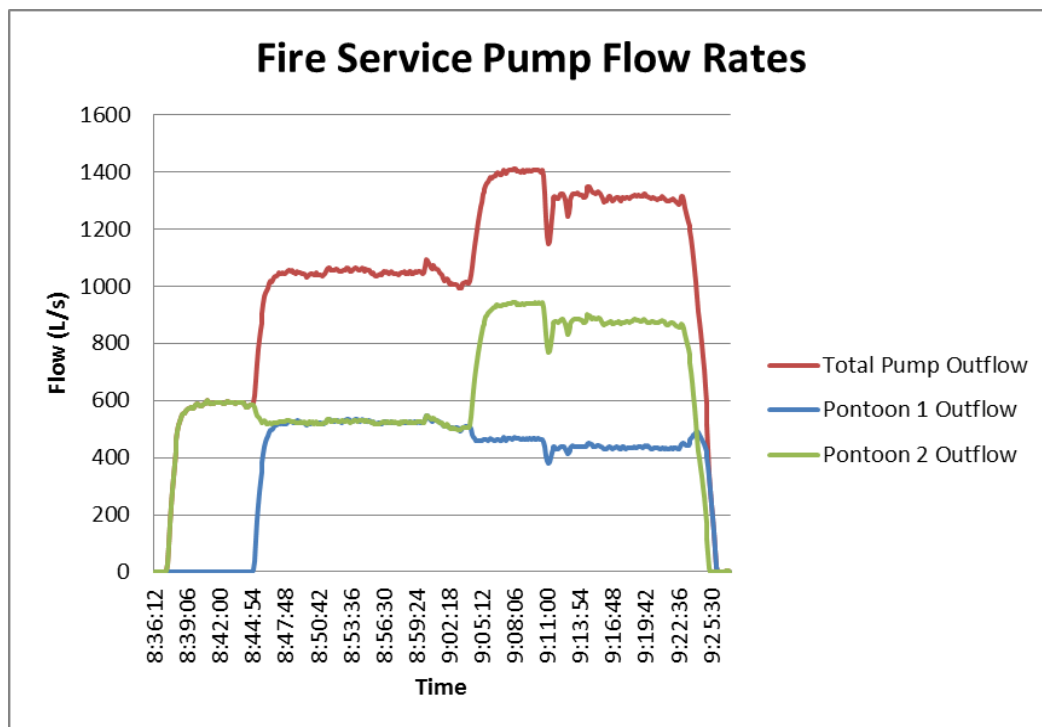
**Figure 4: Fire Service Pump Flow Rates during Annual Test**

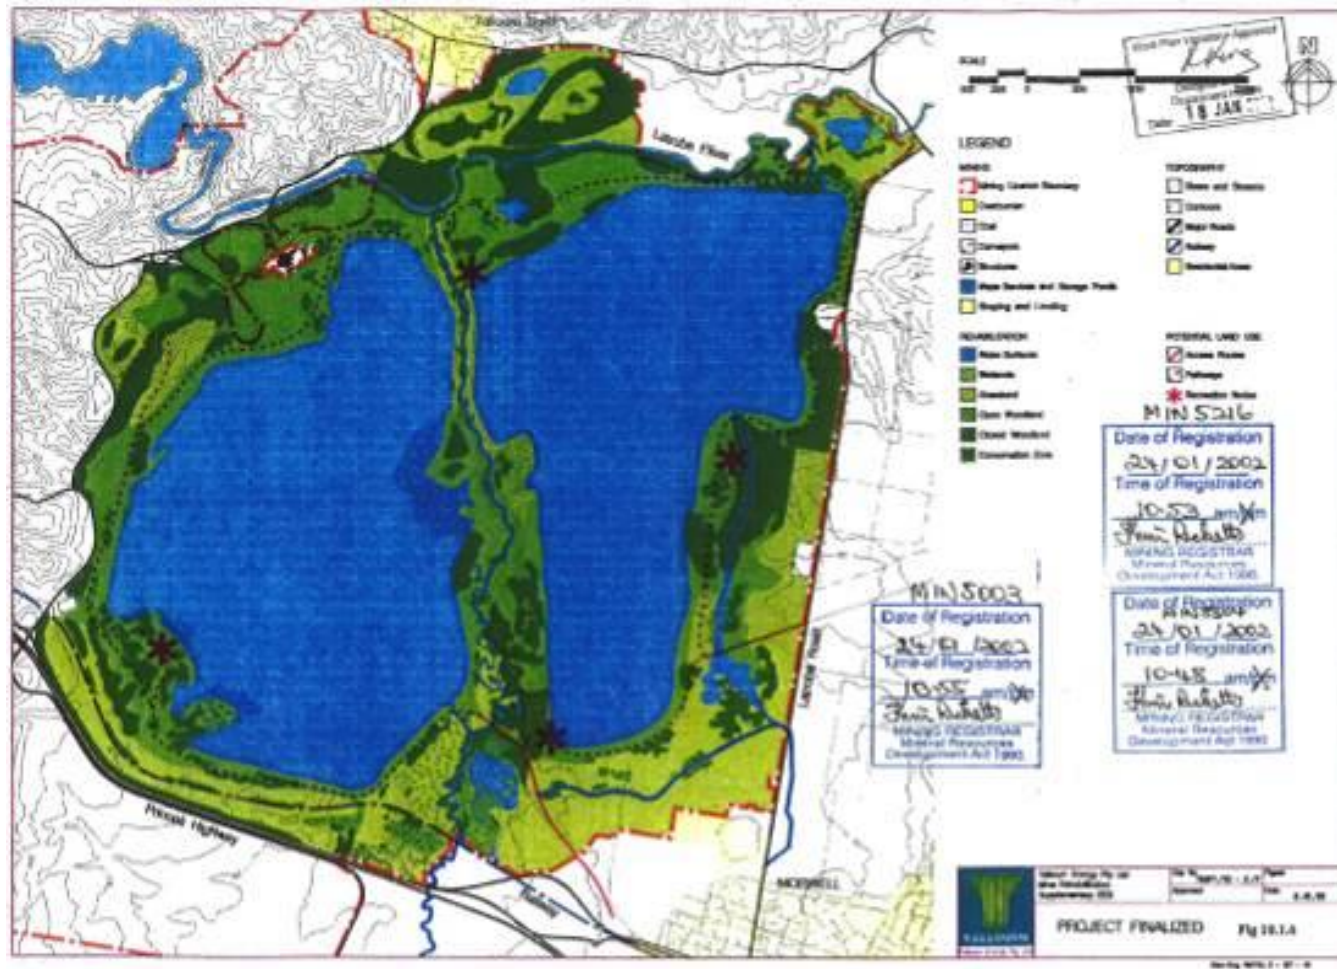
Figure 5: Approved Rehabilitation Master Plan Concept

Since 2002, many operational procedures have changed to allow more effective rehabilitation for the final landform whilst increasing progressive opportunities. Examples include progressive shaping of overburden and mine batters, with changes to overburden dumping procedures ensuring that coal and acid sulphate soils are well buried. Progressive rehabilitation measures assist in minimising geotechnical, fire and environmental risk whilst also providing opportunities through habitat creation and grazing lands.

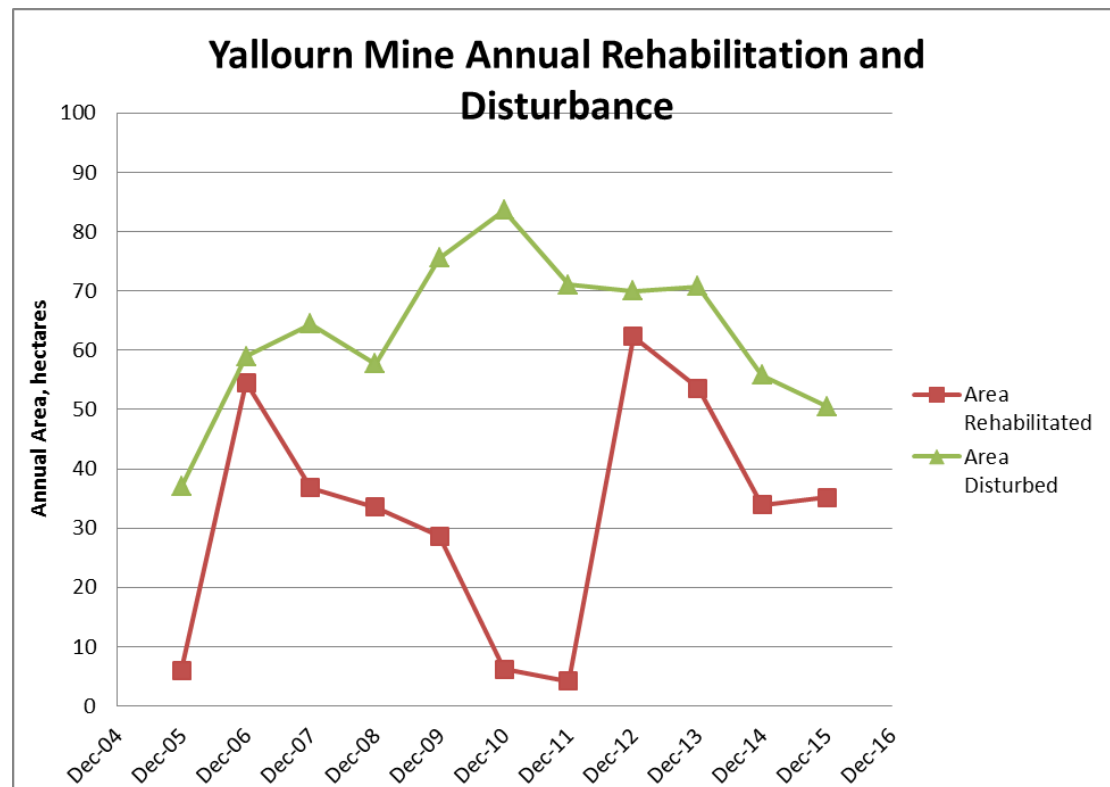
Figure 6: Yallourn Mine Annual Disturbance and Rehabilitation Area

Yallourn Mine has internal progressive rehabilitation targets which are based on calendar year reporting. These targets include the area progressively rehabilitated and rehabilitating more land than that year's disturbance. For the last 11 calendar years these targets have been reached, although no targets are set for financial year periods.

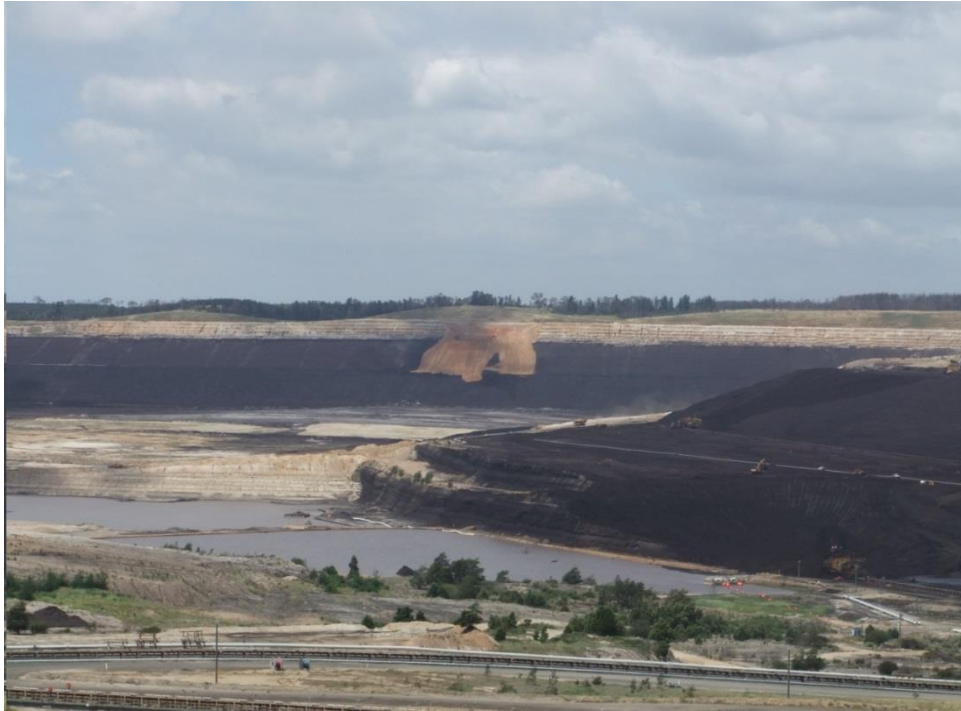
The major rehabilitation work was conducted on the East Field Extension Latrobe Road batter and East Field Extension Southern Batter where approximately 500,000 cubic metres of overburden has been cut and dozer shaped over the permanent coal batter. Within these works a detailed drainage plan was constructed with slots draining both surface rainfall runoff and also groundwater from the series of horizontal bores drilled into the coal batter. In April a five hectare section of the available shaped overburden and coal coverage footprint was topsoiled and grassed successfully, this also included repairing a washout from the 2015 works. In May an eight hectare section of the Latrobe Road Batter was also topsoiled and grassed, the total grassed area is now approximately 18 hectares. The figures below show the progress in the Latrobe Road Batter rehabilitation with significant coal coverage and grassed areas rolling into the natural landscape.

**Figure 8: Latrobe Road Batter, December 2014**

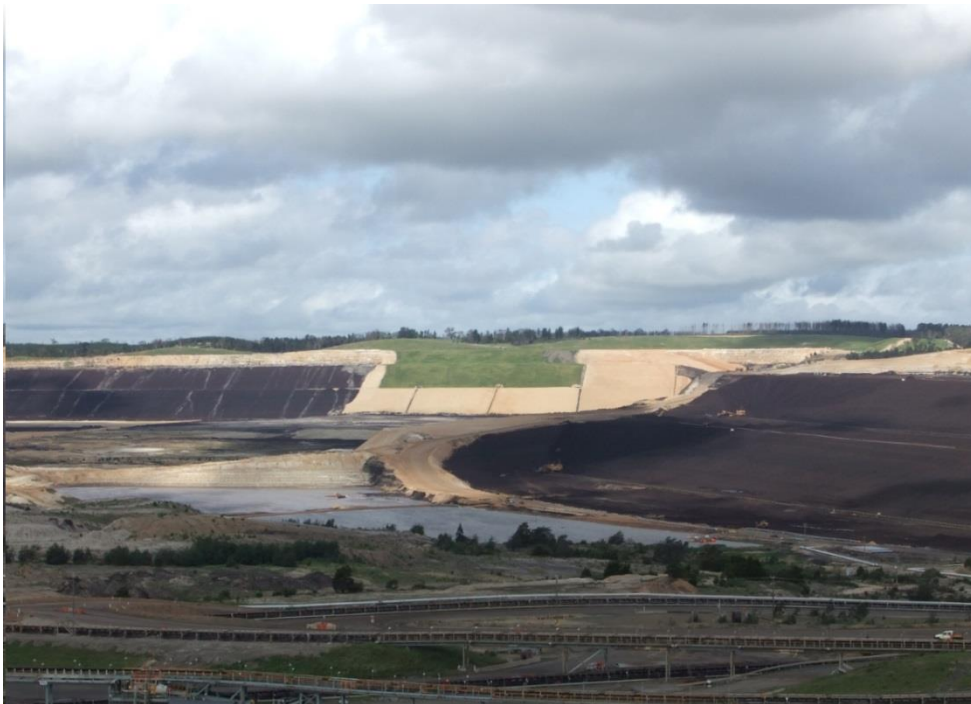
**Figure 9: Latrobe Road Batter, October 2015**

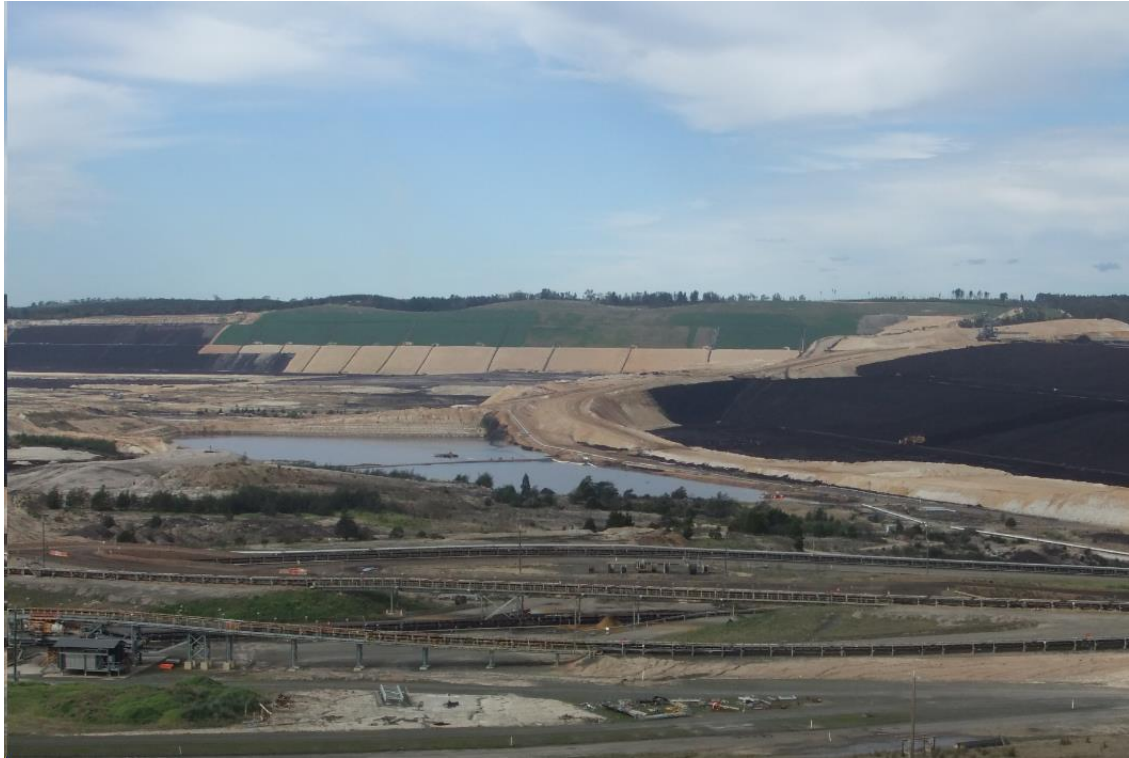
**Figure 10: Latrobe Road Batter, August 2016**

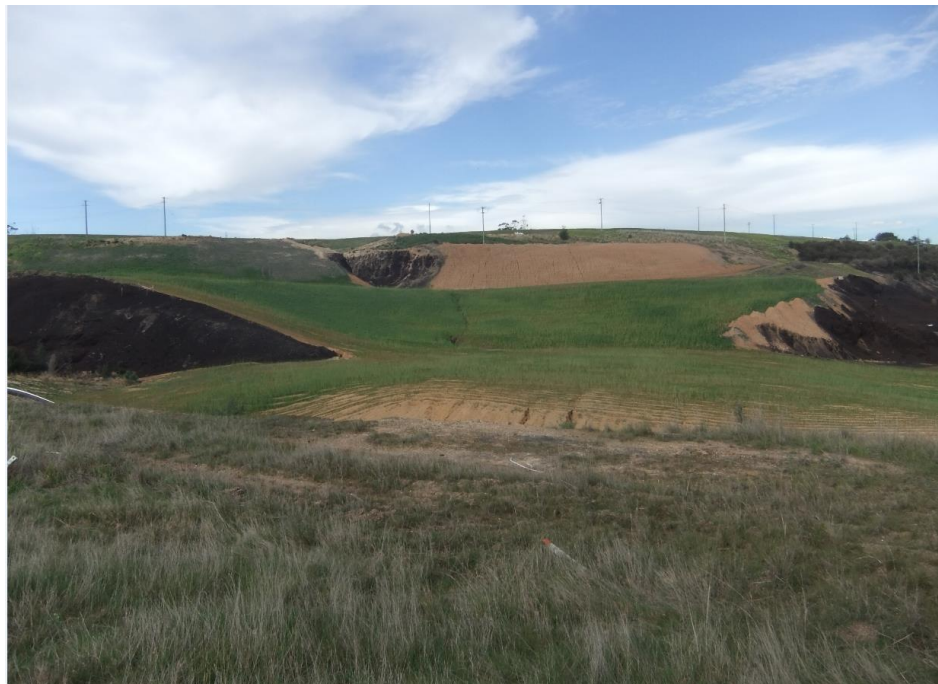
A second final batter and loose coal section was also capped and grassed at the Fire Service Pond Siphon Batter with a 2.2 hectare section completed in April. This rehabilitation work reduces the area of exposed coal within the mine. Some low risk erosion is present on the steeper sand sections which will be monitored and repaired if required.

**Figure 11: Fire Service Pond Rehabilitation Works, August 2016**

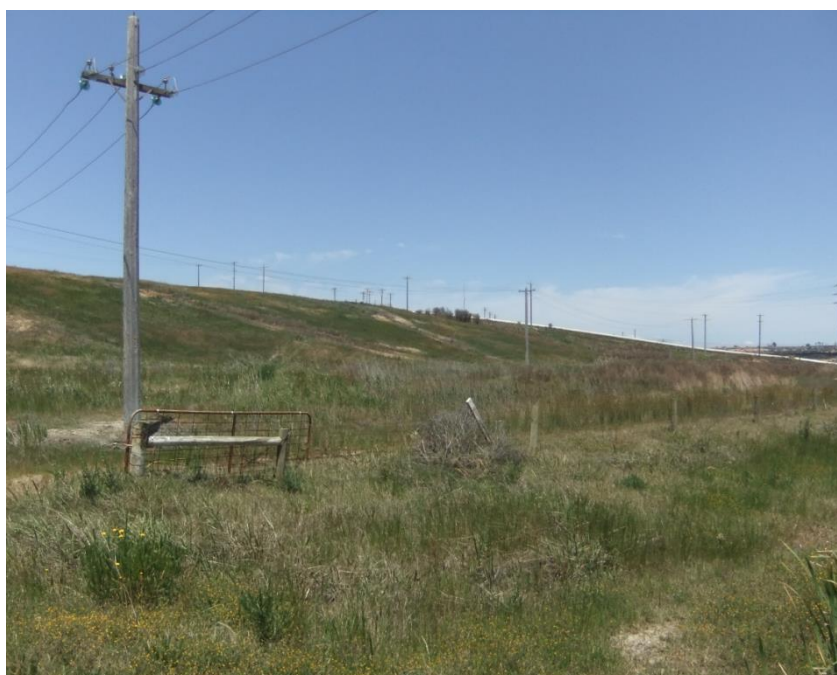
A four hectare section on the Mid Field Dump was claimed for rehabilitation after mulching and weed control. Shaping works had been completed in the past however the vegetation profile was almost exclusively woody weeds including blackberry and broom. Following mulching of the area monitoring showed that pasture grass was self-establishing. Broom and Blackberry seed will remain in the soil so increased weed control is planned to maintain the area to an interim stabilisation standard.

**Figure 12: Mid Field Dump Rehabilitation, August 2016**
