PINE DALE MINE ANNUAL REVIEW 2023

Prepared by Enhance Place Pty Ltd
22 February 2024

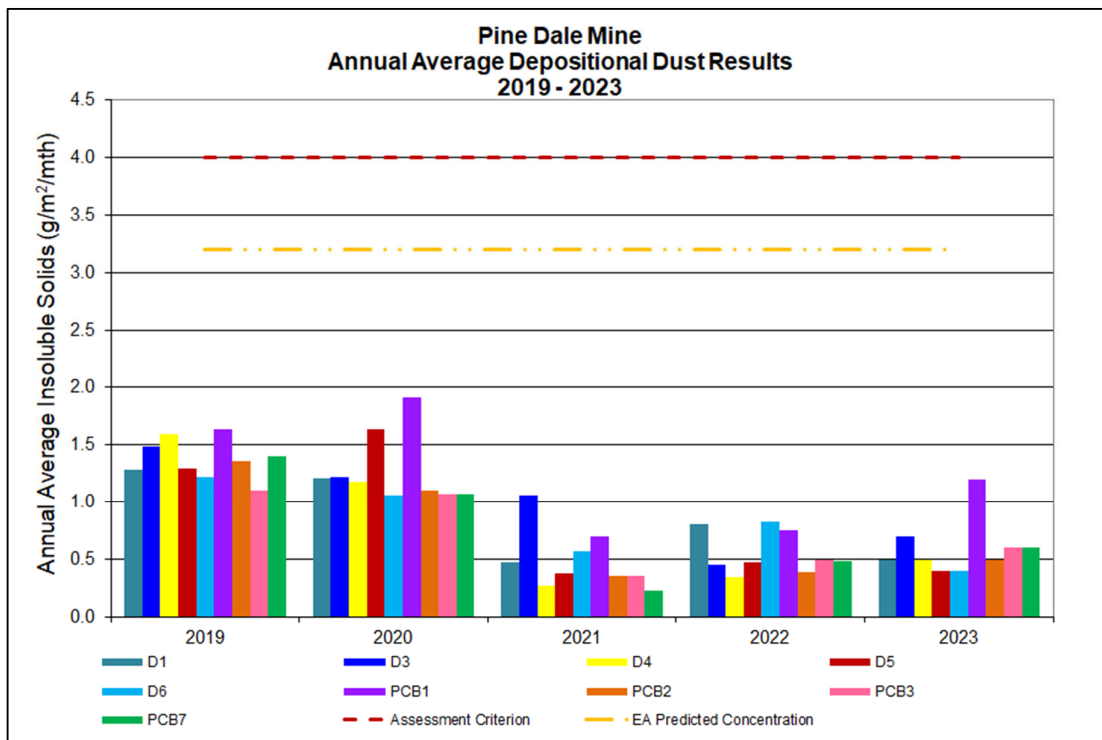
An examination of the historical data (**Table 5-3**) indicates most dust monitoring locations show the 2023 annual averages slightly higher to those from 2022. The substantial decrease in the 2021 & 2022 annual averages deposited dust concentrations when compared to the 2019 & 2020 historical data is not considered to be due to a change in site activities at PDM as the mine has been in care and maintenance since 2014, rather it is considered to be influenced by the increased rainfall following prolonged dry conditions and associated correlation with dust storms and bushfires (observed during late 2019 and early 2020).

Figure 5-1 *Depositional dust data: 2019 – 2023*

The 2023 annual average deposited dust concentrations are shown to be significantly lower than the concentrations predicted in the site Environmental Assessment annual average criterion of 3.2g/m²/month annual average (refer **Table 5-1**), noting that the prediction was for an operational mine.

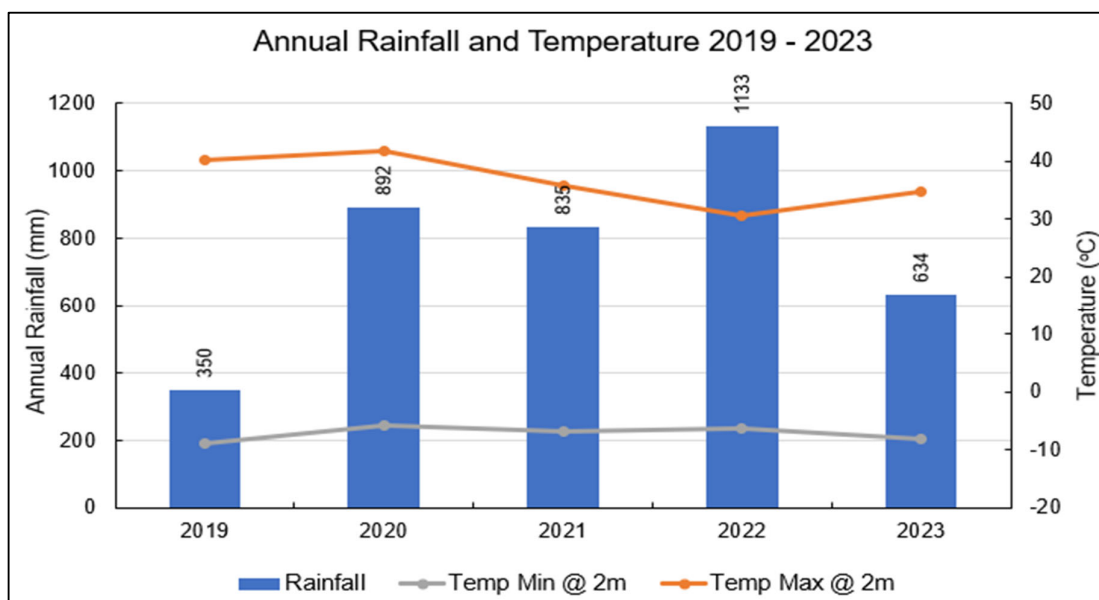
The total annual rainfall and the minimum and maximum temperature at 2m from 2019 to 2023 are shown graphically in **Figure 5-2**.

Figure 5-2 Annual Temperature and Rainfall Summary: 2019 – 2023

PDM received 634mm of rainfall across 185 rainfall days during the 2023 reporting period. During the last five (5) years, there was a significant decrease in 2023 annual rainfall compared to the previous year (2022) and a lesser decrease from the preceding two (2) years (2020-2021) while rainfall during this reporting period was observed to be higher than that recorded in 2019 (**Figure 5-2**).

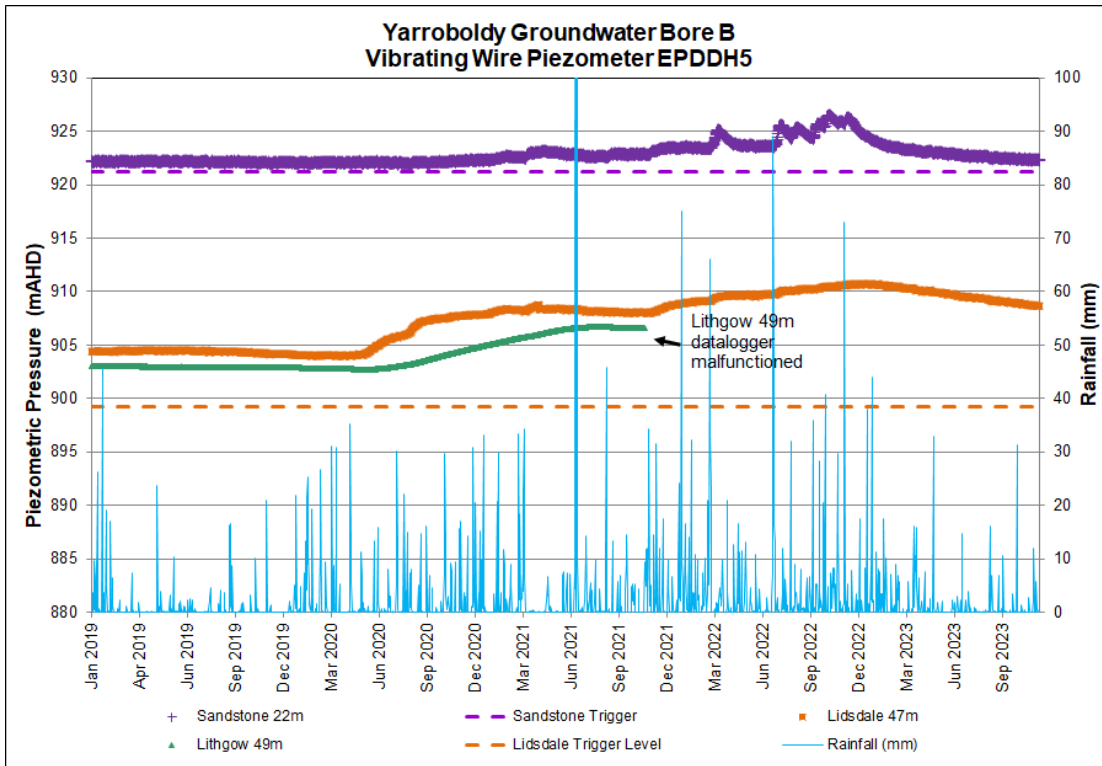
A groundwater level hydrograph for Bore B along with rainfall from 2019 to 2023 is shown in Figure 6-7 noting that there was no data available at Lithgow aquifer for Bore B since March 2022 due to a logger malfunction. A hydrograph for Bore C along with rainfall from 2019 to the point of battery failure (September 2022) is presented in Figure 6-8 noting that there may be some data captured between May and November 2023 which has not yet been downloaded. If captured, this data will be provided with the data from the 2024 monitoring period.

Figure 6-7 Yarroboldy Bore B Hydrograph and Rainfall 2019 – 2023

The groundwater levels at Bore B at the various aquifers have shown some variation in response to rainfall trends, however the response is generally minimal during the period January 2019 – May 2020. Following the decrease in rainfall during the 2023 reporting period, the Lidsdale and Sandstone seam show a decrease in water level. The water levels have not fallen below the groundwater trigger levels (refer **Figure 6-7**). There is no data available for the Irondale seam during the last five (5) years as the water level has fallen below the sensor height.

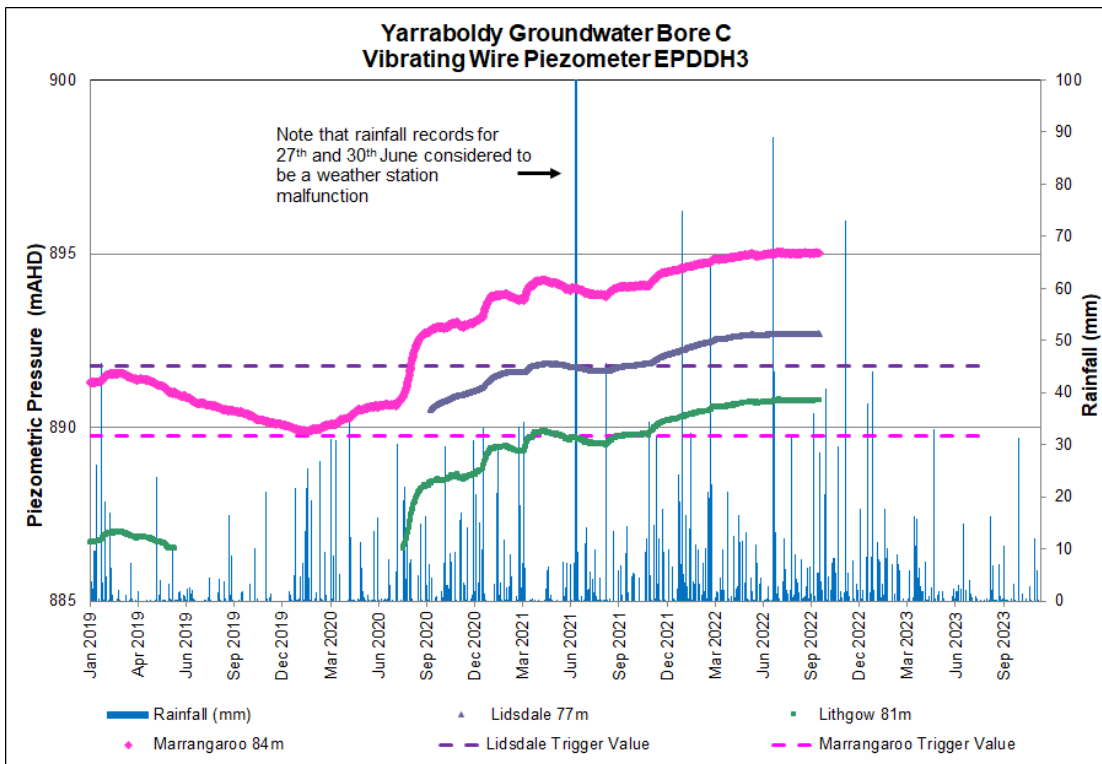
Figure 6-8 Yarroboldy Bore C Hydrograph and Rainfall 2019 – 2023

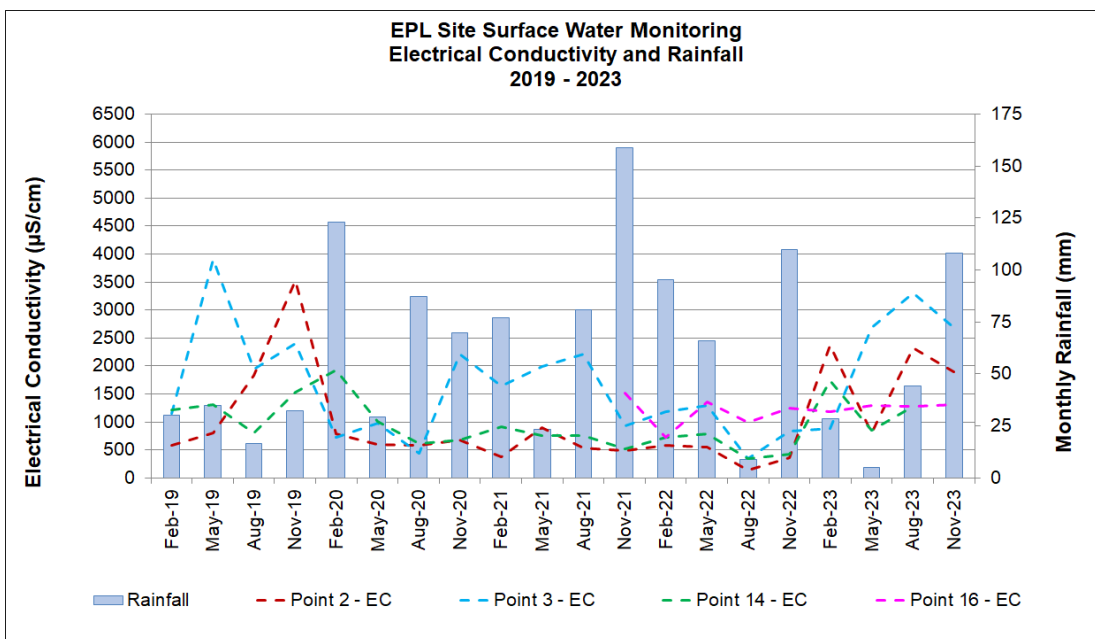
Figure 6-10 Surface water at EPL monitoring points: Rainfall and Electrical Conductivity (2019 – 2023)

During the 2019 – 2023 monitoring period, pH has remained generally stable at both EPL Point 2 and EPL Point 3 although with fluctuations. A decreasing trend was observed at both EPL Point 14 and EPL Point 16 with some fluctuations. The pH is generally neutral in the surface water samples and slightly acidic at EPL Point 16.

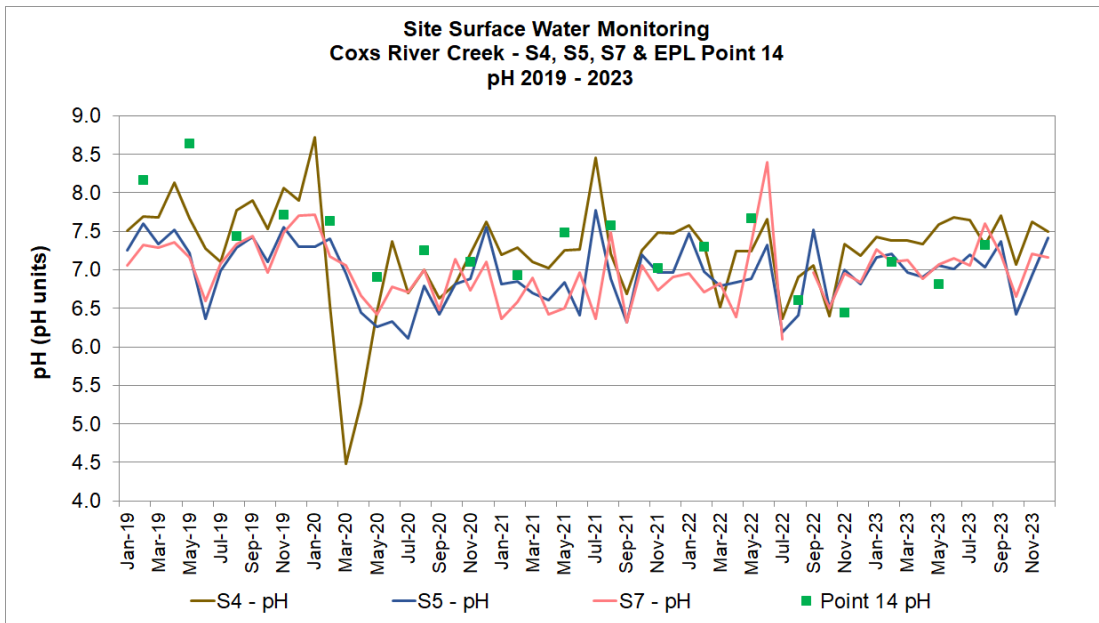
Figure 6-13 S4, S5, S7 and EPL Point 14 pH Results 2019 – 2023 (noting that EPL Point 14 was dry in November 2023 such that no sample was collected)

During the last five (5) years, pH values in Coxs River (**Figure 6-13**) are higher (more alkaline) upstream of Blue Lake (i.e., S4) compared to those of S5 and S7 and overall similar to those in Wangcol Creek. There is good correlation between the three (3) sampling and overall, the pH trend is generally stable for all locations during the last five (5) years although there are some significant fluctuations. The cause of the significant spike in acidity at S4 in March 2020 is unknown however this location is upstream of the confluence with Wangcol Creek and as such does not receive any water from PDM and therefore the results are indicative of impacts from other areas of the catchment.

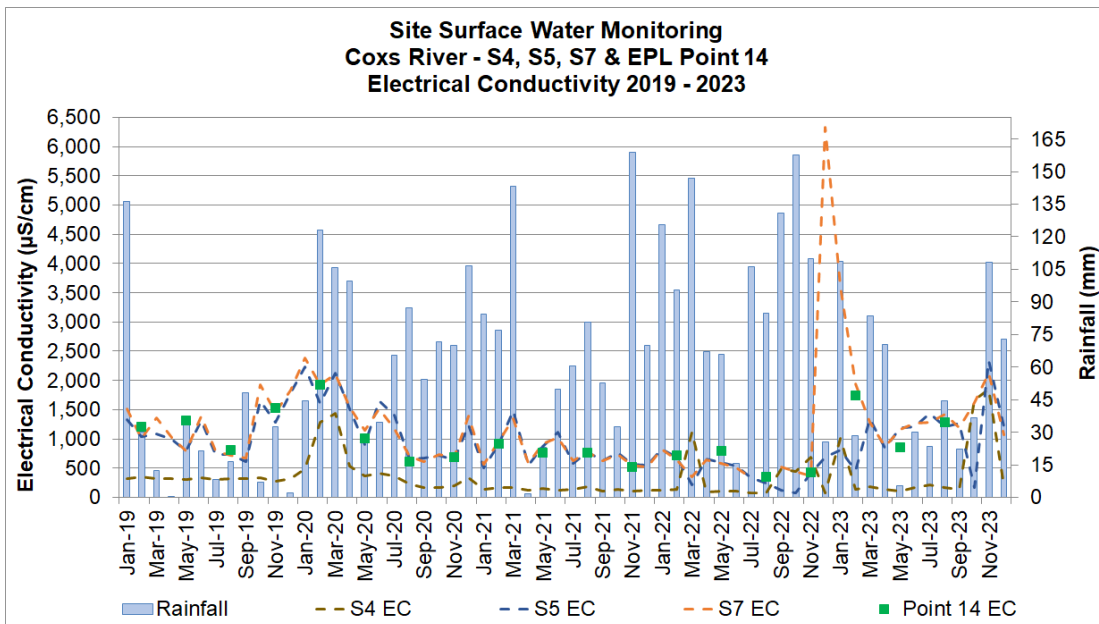
Figure 6-14 S4, S5, S7 and EPL Point 14 Electrical Conductivity Results & Rainfall 2019 – 2023 (noting that EPL Point 14 was dry in November 2023 such that no sample was collected)

Electrical conductivity concentrations in Coxs River during the last five (5) years (refer **Figure 6-14**) is lower upstream of Blue Lake (i.e., S4) compared to those in S5 and S7; S5 and S7 are generally very well correlated with the exception of late 2022 and early 2023, and October 2023. The cause of the concentration spike at S4 in February and March 2020 is considered to be likely due to erosion of land burnt in the 2019 / 2020 bushfires and the decreasing trend from that point is considered likely due to revegetation of the catchment. The cause for the significant spike at S6 in December 2022 is unknown; it is almost $1,000\mu\text{S}/\text{cm}$ more and two (2) months later than that observed in Wangcol Creek (S6) and as such the concentrations are considered to be representative of overall conditions within the catchment.

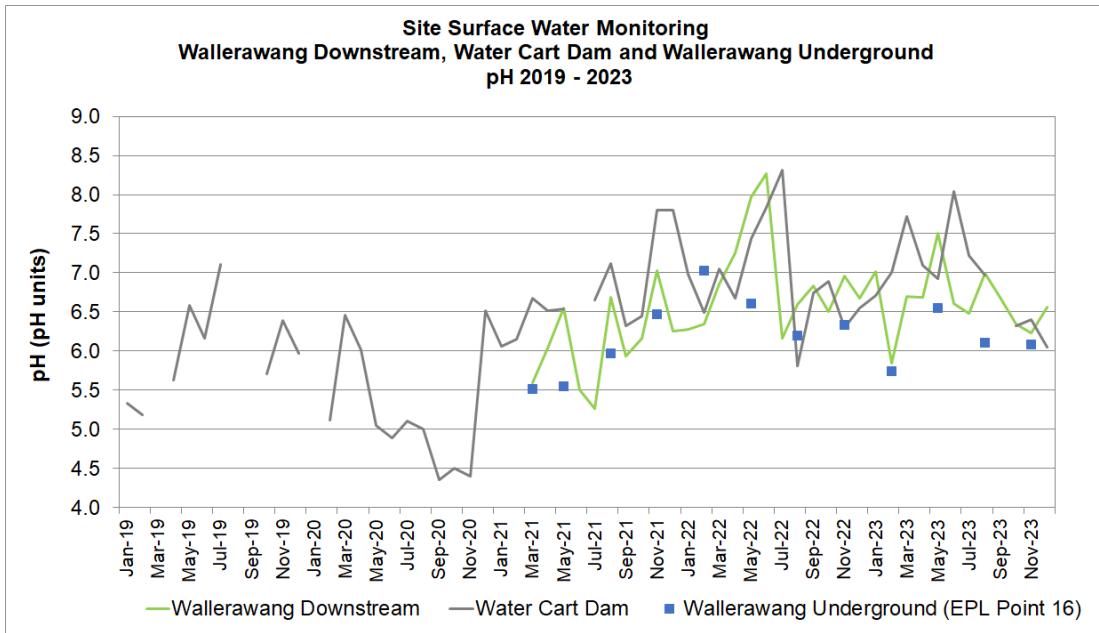
Figure 6-15 Wallerawang Downstream, Water Cart Dam and Wallerawang Underground pH Results 2019 - 2023 (noting that data gaps are when Water Cart Dam was dry and dates prior to the commencement of sampling at Wallerawang Downstream and Underground)

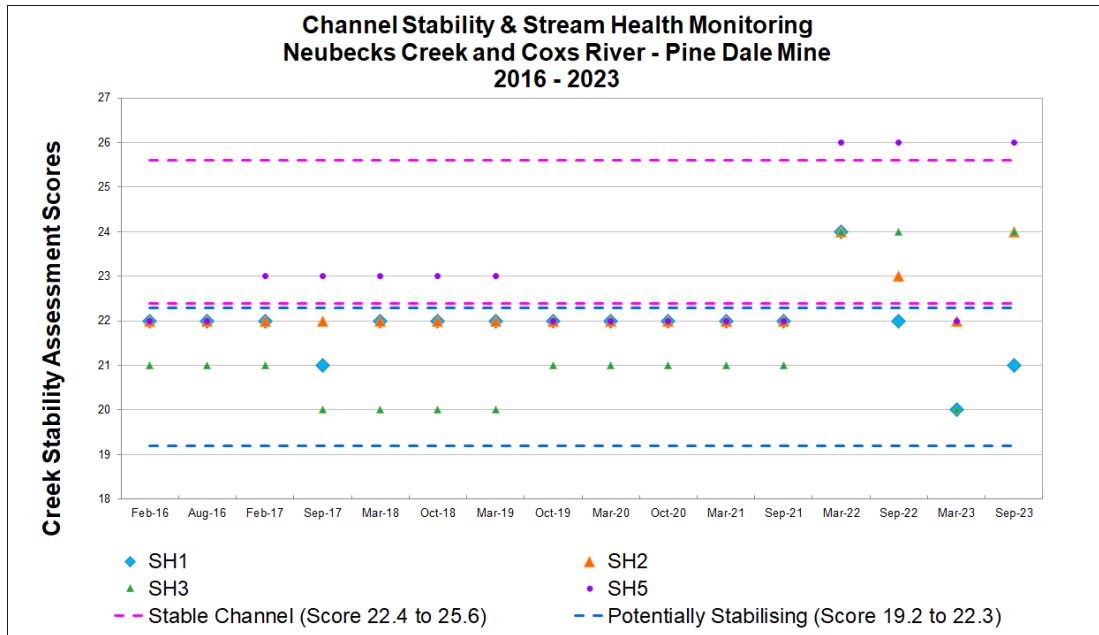
Location SH1 was considered 'potentially stabilising', locations SH2 and SH3 were considered 'stable', and SH5 was considered 'very stable' during the 2023 assessment, noting that the stability at SH3A is based on the presence of spray-concrete lining.

Figure 6-17 Channel Stability and Stream Health Scores during 2016 – 2023

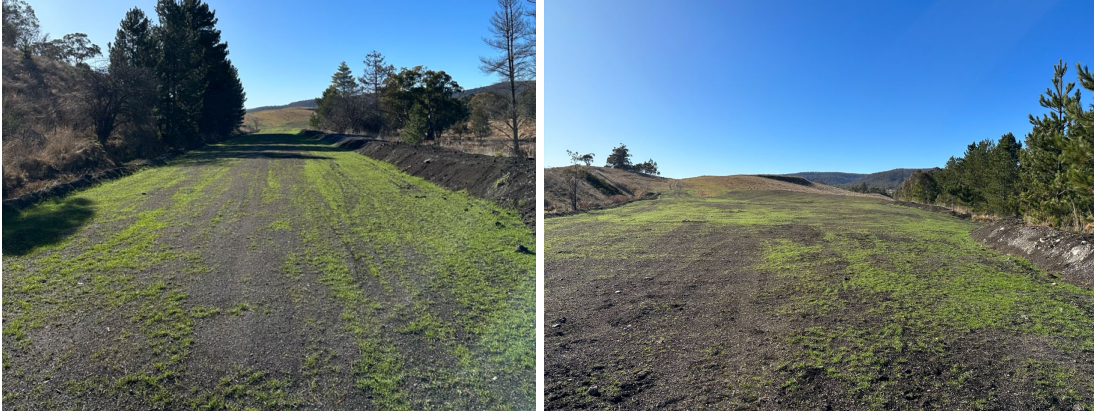
Maintenance rehabilitation works undertaken within the reporting period comprised topsoiling and mulching of the eastern portion of ML1578 in February / March 2023. Photographs of the area as per 19 July 2023 are presented in **Photograph 7-1**.

Photograph 7-1 *Rehabilitated area within ML1578 looking east, July 2023.*

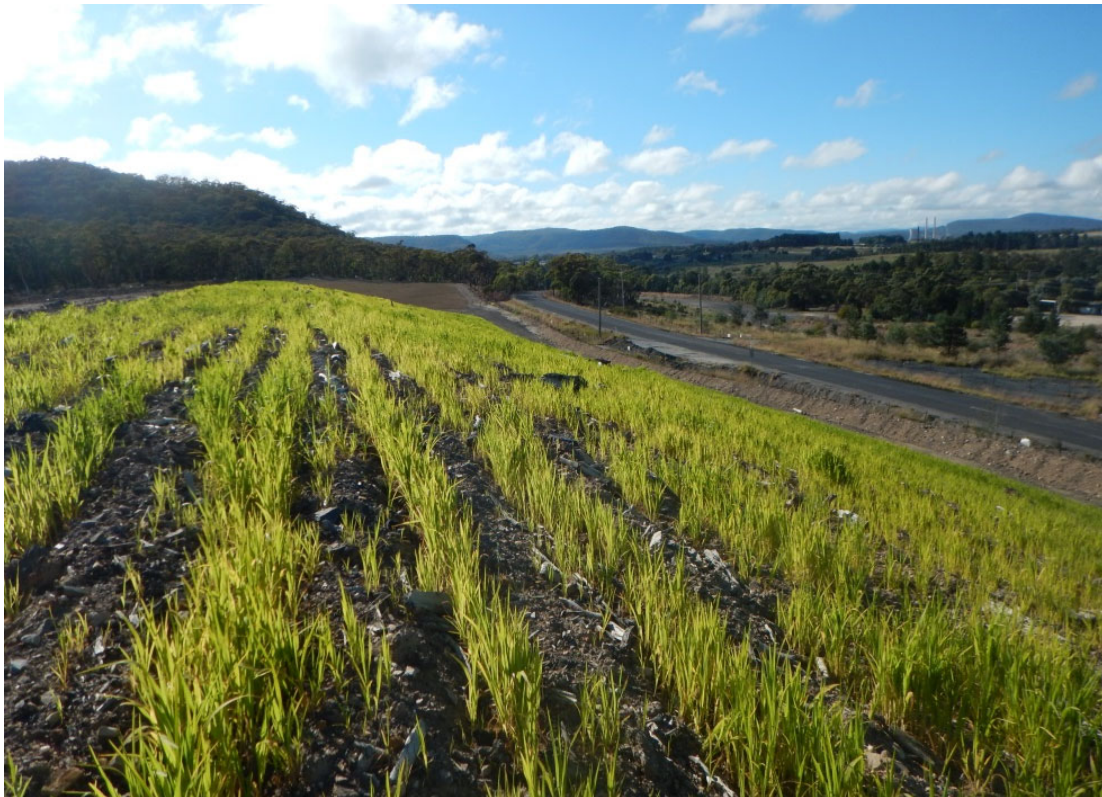
The amenity bund located along the southern boundary of the Yarraboldy Extension was re-profiled in 2014, with the southern batter having a gradient of 18° to minimise erosion and enhance establishment of seedlings. Following the application and tilling of topsoil, a native species grass and tree species seed mix was applied followed by mulch (refer **Photograph 7-2**).

Photograph 7-2 *Amenity Bund looking east following application of mulch and native mix 2015.*

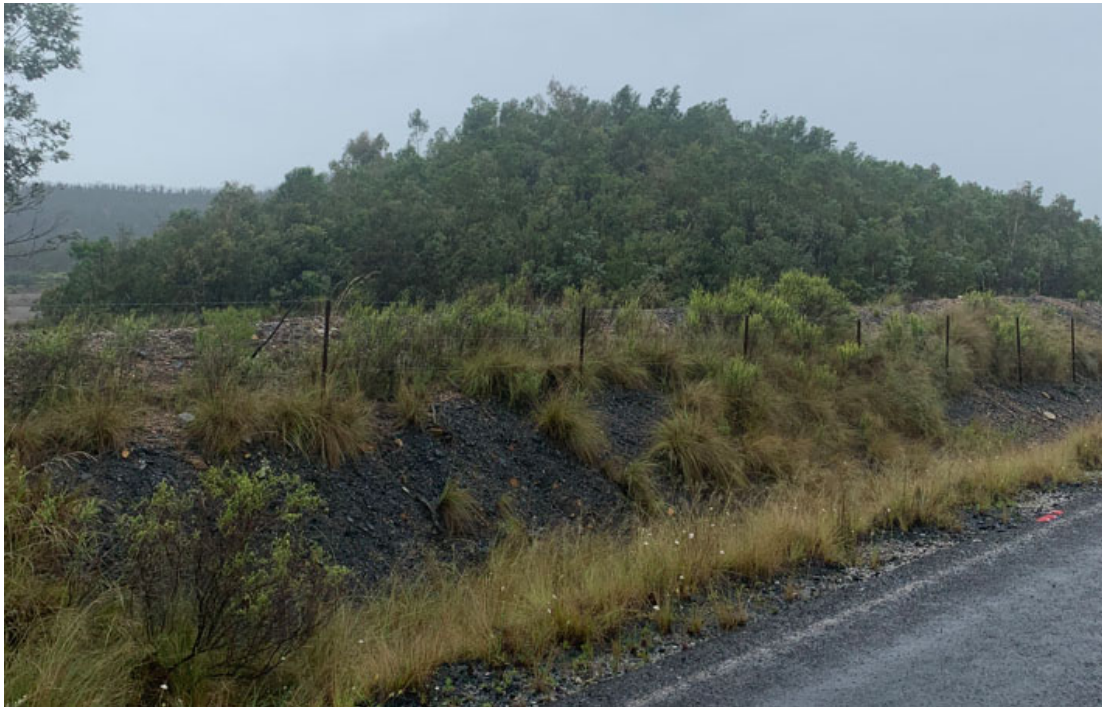
During the reporting period, maintenance works was not required to be undertaken in the Yarraboldy Extension. No rehabilitation maintenance activities were undertaken. Current vegetative cover on the bund is shown in **Photograph 7-3**.

Photograph 7-3 *Amenity Bund looking northeast, January 2024*

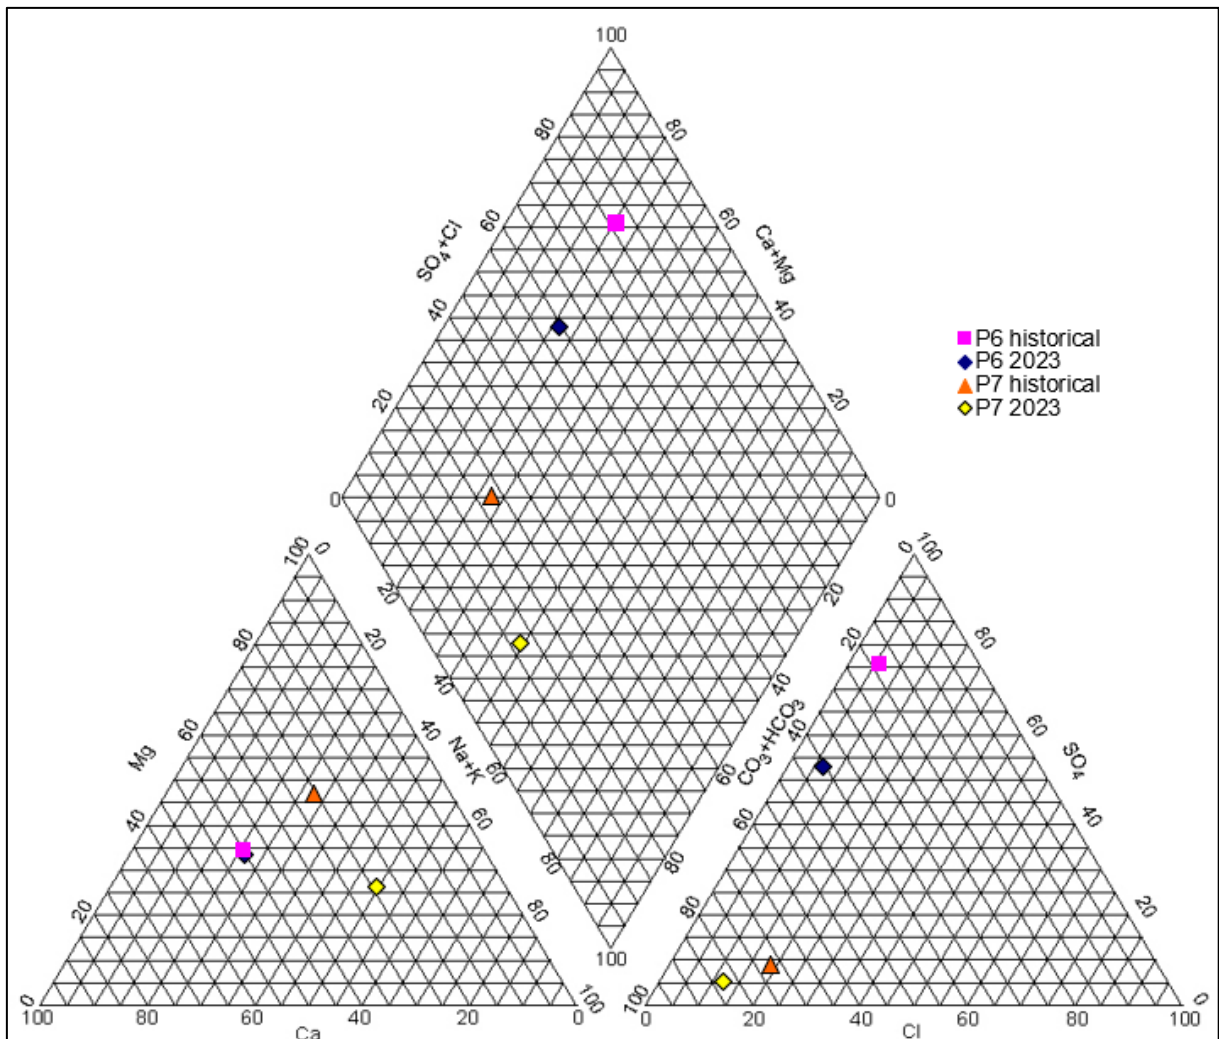
Figure 6 Piper Plot comparing results of 2023 monitoring to historical data

Based on the above **Figure 6** alterations were observed in the chemistry of P6 and P7 in comparison to historical data. The magnitude of these changes varies depending on the specific cation/anion involved. It is noted that, due to the absence of any excavation, injection of water or extraction of water at PDM, that the change in groundwater level and chemistry is not considered likely to be as a result of activities at PDM.

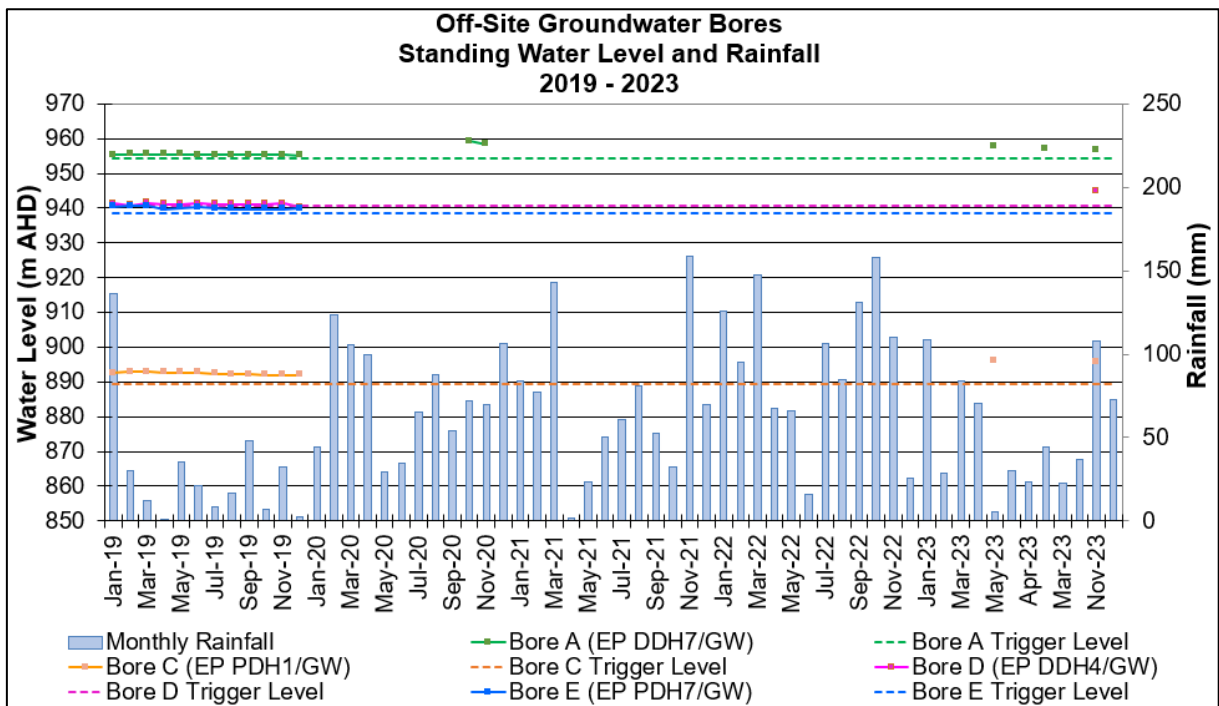
The water level within Bore A, Bore C and Bore D are generally shown (refer **Figure 7**) to be above their respective water level and there is an increasing trend for all the bores in the last five (5) years based on the available data.

Figure 7 Standing water level and rainfall 2019 – 2023

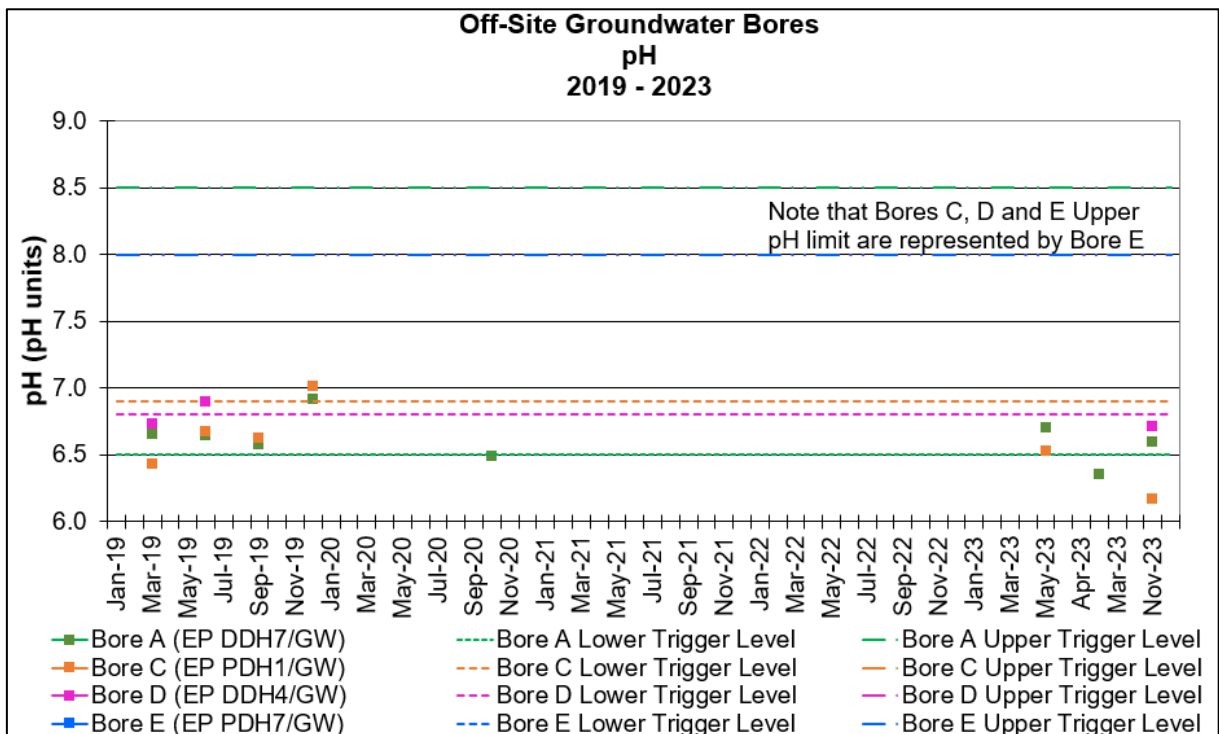
Figure 8 pH in off-site groundwater bores 2019 – 2023

The groundwater samples collected from off-site bores during the reporting period are generally outside the respective pH trigger level ranges (Figure 8), as below:

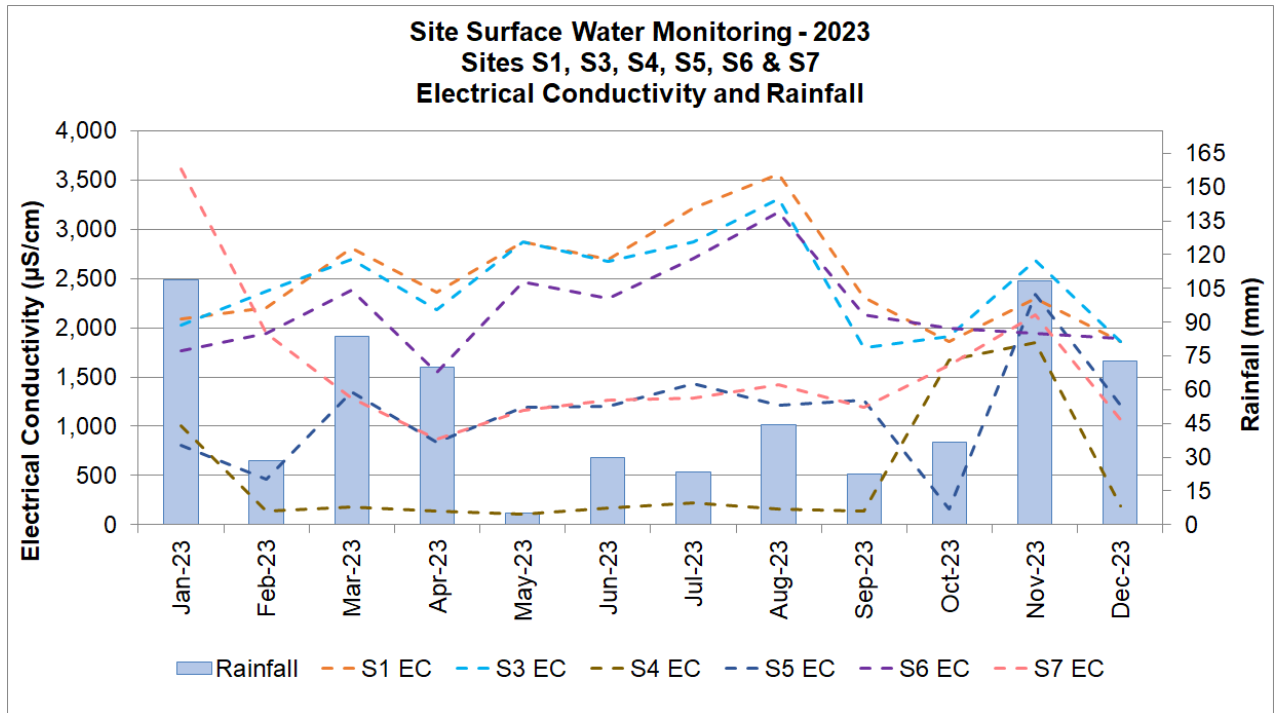
The variation of electrical conductivity with rainfall is presented in **Figure 17**: while electrical conductivity theoretically increases in response to decreased rainfall, some results were significantly higher than the majority of results in a month of significant rainfall. As such it is considered that there are other contributions to the salinity of the water, potentially including sediment which is eroded by rainfall from the catchment.

Figure 17 Site Surface Water Electrical Conductivity and Monthly Rainfall

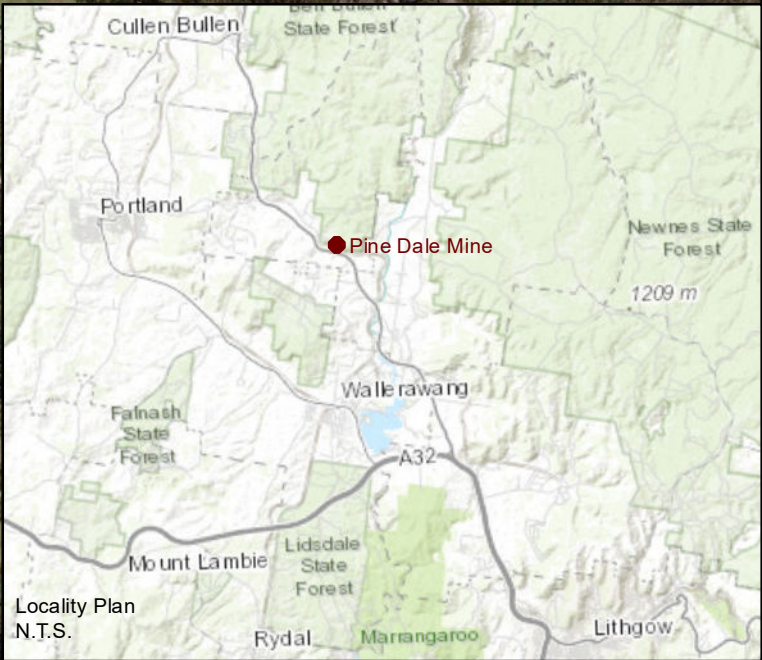
PINE DALE MINE ENVIRONMENTAL MONITORING LOCATION PLAN

CLIENT	Enhance Place Pty Ltd	RCA Ref	6880-1899-App. B
DRAWN BY	FB	SCALE	1:24,000 (A3)
APPROVED BY	FB	DATE	22/01/2024
		DRAWING	1
		REV	0
		OFFICE	NEWCASTLE

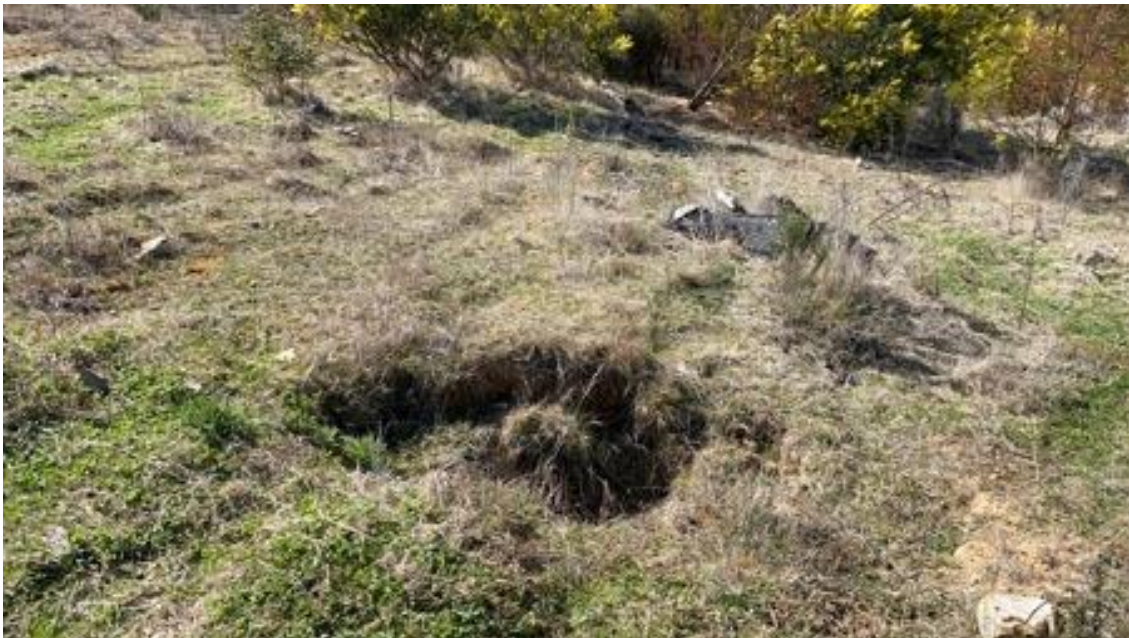
The presence and extent of active surface erosion within transect areas is recorded in Appendix A. There are no significant erosion features that compromise landform stability or public safety (including gullying or tunnelling) within the pasture rehabilitation areas. A sink hole was observed adjacent to Transect 5 (Figure 2).

Figure 2 Sink hole adjacent to Transect 5

During the reporting period, an assessment of rehabilitation areas was completed. Rehabilitation areas are generally stable in both the pasture and treed revegetation areas, whilst weed presence continues to be adequately controlled. It is recommended to continue weed management and monitoring of performance indicators over the 2024 reporting period. Installation of nesting boxes has also been recommended as per previous years, subject to trees being suitable size and age for the installation. Minor slumping at Transect 5 was identified and will be stabilised as recommended.

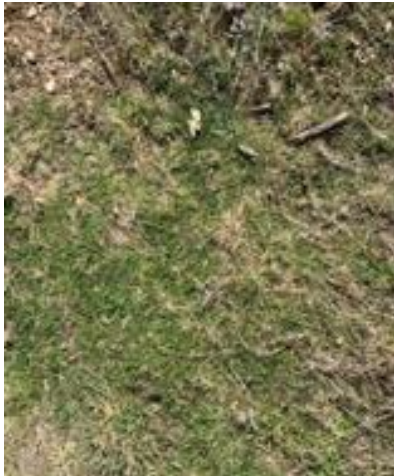
Species composition at pasture rehabilitation areas – Pasture rehabilitation areas were established with a mix of ~70% perennial grasses and ~20% annual legumes consistent with species composition at the analogue pasture site. Examples of analogue pasture and rehabilitated pasture at Area C are shown in Figure 3 and Figure 4.

Figure 3 Pasture composition at analogue site

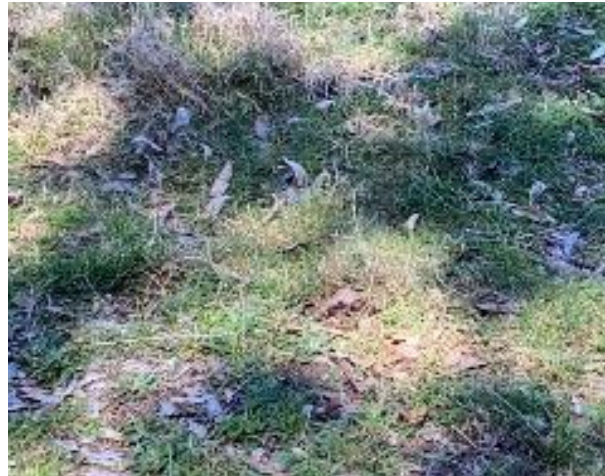
Figure 4 Pasture composition Area C

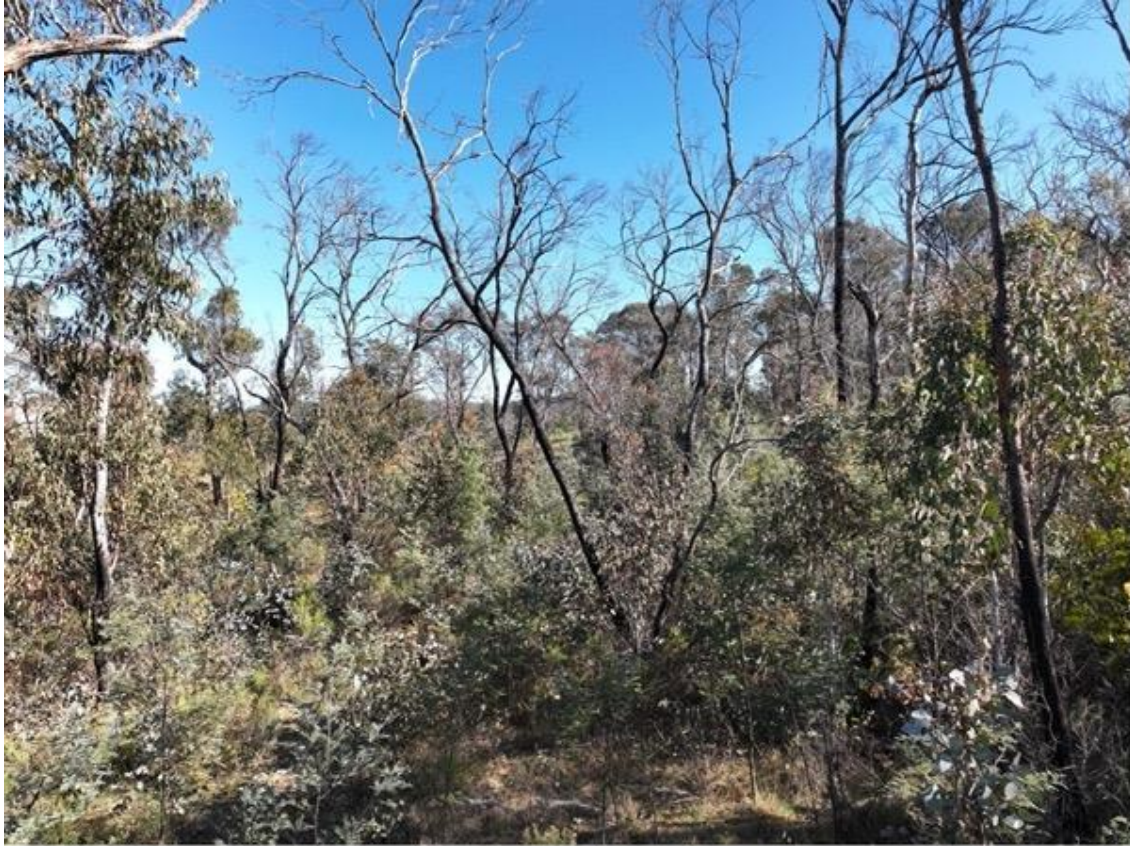
The treed analogue site was affected by fire in 2020 which resulted in the loss of groundcover, shrubby understorey and canopy. Natural regeneration is occurring and is characterized by an increase in shrubby vegetation and juvenile tree growth evident in Figure 5.

Figure 5 Natural regeneration of the treed analogue site

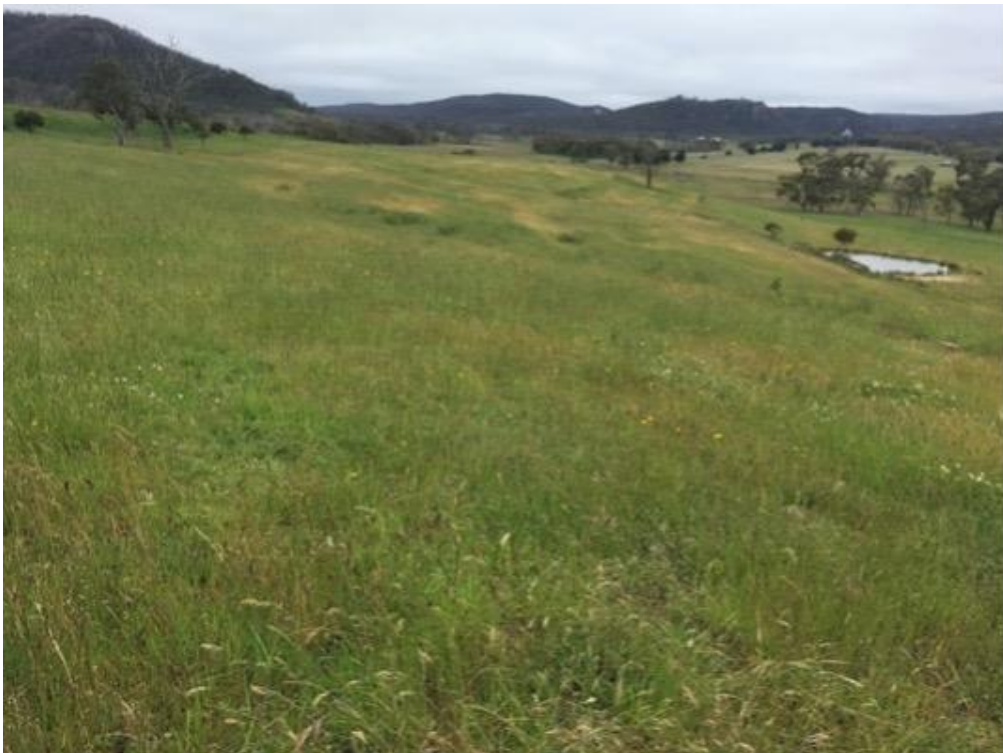
Transect 1 looking east 2021 note that the transect 1 photo-monitoring point was inaccessible to the presence of livestock
