PINE DALE MINE ANNUAL REVIEW 2024

Prepared by Enhance Place Pty Ltd 27 February 2025

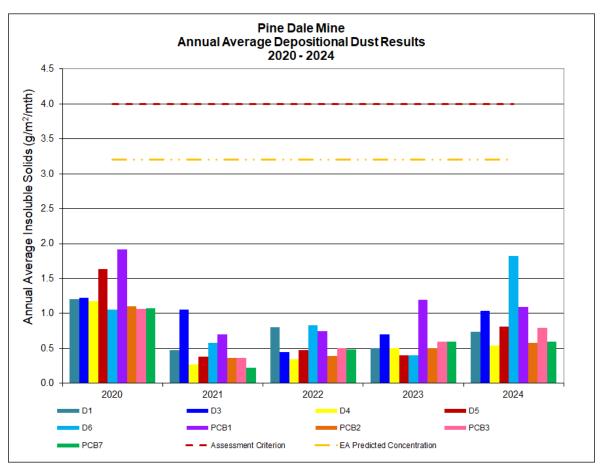
Figure 5-1 Depositional dust data: 2020 – 2024

The 2024 annual average deposited dust concentrations are shown to be significantly lower than the concentrations predicted in the site Environmental Assessment annual average criterion of 3.2g/m²/month annual average (refer **Table 5-1**), noting that the prediction was for an operational mine.

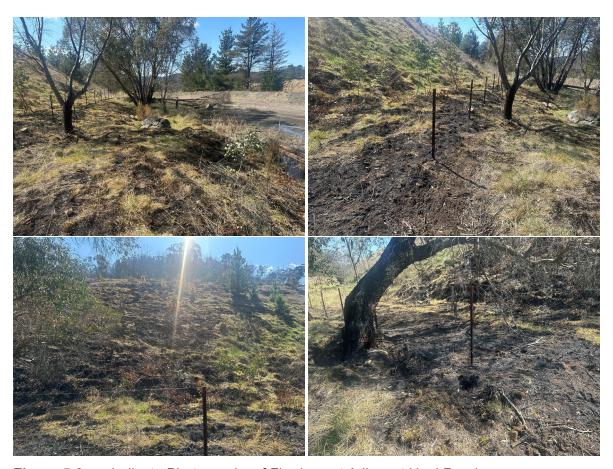
Figure 5-3 Indicate Photographs of Fire Impact Adjacent Haul Road

During the 2024 reporting period there were no bush fire events at PDM however there was a grass fire on 2nd September 2024 along the Castlereagh Highway which extended into the lease area; indicative photographs along the Haul Road are presented in **Figure 5-3** below. The Rural Fire Service attended and extinguished the fire the day it started. Some damage to fencing was caused; this was repaired in December 2024. No rehabilitation was considered necessary.

The padlock on the gate from PDM to the Haul Road was found to be broken on 13 September 2024 during the inspection of the area impacted by bushfire (refer **Section 5.14**); this was considered to have been from Rural Fire Service making entry as part of fire fighting activities rather than due to trespassing. A new lock was placed and has remained intact since the replacement.

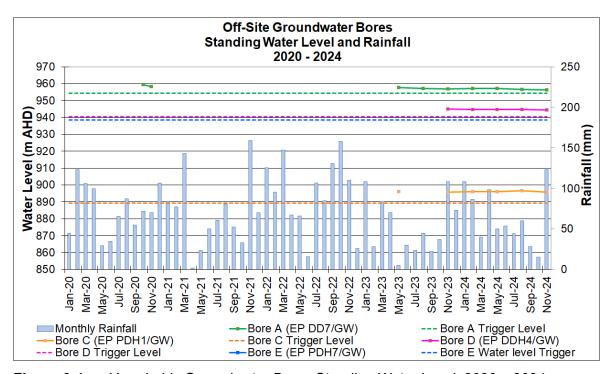
Figure 6-4 Yarraboldy Groundwater Bores Standing Water Level: 2020 – 2024

There is insufficient data to comment on the variation in standing water levels within the Yarraboldy groundwater bores over the five (5)-year period from 2020 to 2024. However, during reporting period 2024, the water levels in Bore A, Bore C, and Bore D were generally stable and higher than their respective levels. It is noted that the water levels are higher than those recorded in 2019.

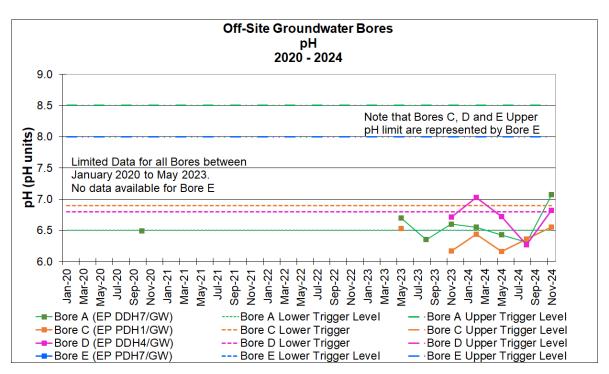
Figure 6-5 Yarraboldy Groundwater Bores pH: 2020 – 2024

There is insufficient data to comment on the variation of pH within the Yarraboldy groundwater bores over the five (5) years' period. However, during reporting period 2024, fluctuations were observed in the pH values at Bores A, B and D. The May and August results for Bores A and D, along with all of the results for Bore C were below (more acidic than) the lower limit of the respective approved trigger level range. There were no activities undertaken at PDM which have the potential to impact the groundwater in the Yarraboldy area; as such, the factors causing the variation of pH are considered outside the control of PDM.

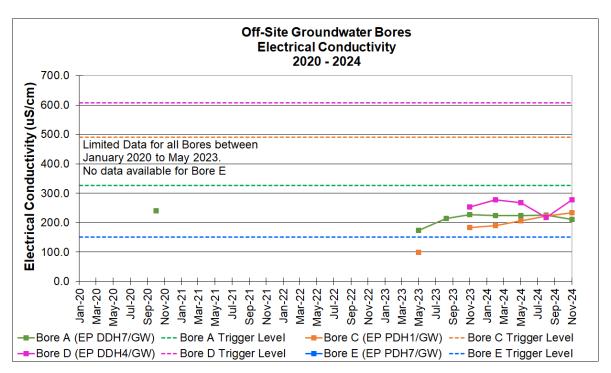
Figure 6-6 Yarraboldy Groundwater Bores Electrical Conductivity: 2020 – 2024

There is insufficient data to comment on the variation of electrical conductivity within the Yarraboldy groundwater bores over the five (5)-year period. However, during the reporting period of 2024, all bores indicated a slight increasing trend although well below the respective approved trigger levels. Similar to pH, in the absence of any activities at PDM which have the potential to impact the groundwater in the Yarraboldy area, the factors causing the variation of pH are considered outside the control of PDM.

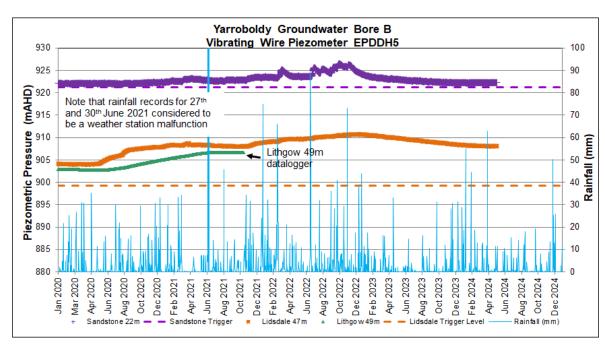
Figure 6-7 Yarraboldy Bore B Hydrograph and Rainfall 2020 – 2024

A groundwater level hydrograph for Bore B along with rainfall from 2020 to 2024 is shown in **Figure 6-7** noting that there was no data available at Lithgow aquifer for Bore B since November 2021 due to a logger malfunction. A hydrograph for Bore C along with rainfall from 2020 to the point of battery failure (September 2022) is presented in **Figure 6-8** noting that the Bore C logger status was retrieved for replacement in August 2024; a new unit will be installed in 2025.

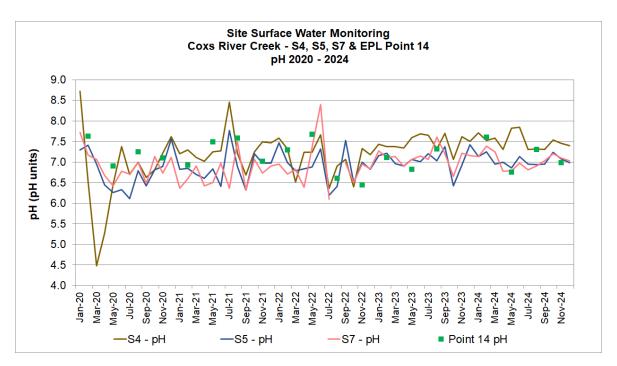
Figure 6-13 S4, S5, S7 and EPL Point 14 pH Results 2020 – 2024

During the last five (5) years, pH values in Coxs River (**Figure 6-13**) are higher (more alkaline) upstream of Blue Lake (i.e., S4) compared to those of S5 and S7 and overall similar to those in Wangcol Creek. Overall, the pH trend is generally stable for all the monitoring locations (noting some large fluctuations). The cause of the significant spike in acidity at S4 in March 2020 is unknown however this location is upstream of the confluence with Wangcol Creek and as such does not receive any water from PDM and therefore the results are indicative of impacts from other areas of the catchment.

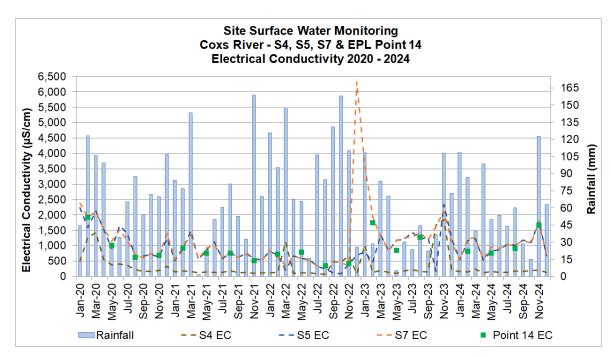
Figure 6-14 S4, S5, S7 and EPL Point 14 Electrical Conductivity Results & Rainfall 2020 – 2024 (noting that EPL Point 14 was dry in November 2023 such that no sample was collected)

Electrical conductivity concentrations in Coxs River during the last five (5) years (refer **Figure 6-14**) is lower upstream of Blue Lake (i.e., S4) compared to those in S5 and S7; S5 and S7 are generally very well correlated with the exception of late 2022 and early 2023 and October 2023. The cause of the concentration spike at S4 in February and March 2020 is considered to be likely due to erosion of land burnt in the 2019 / 2020 bushfires and the decreasing trend from that point is considered likely due to revegetation of the catchment. The cause for the significant spike at S7 in December 2022 is unknown; it is almost $1,000\mu S/cm$ more and two (2) months later than that observed in Wangcol Creek (S6) and as such the concentrations are considered to be representative of overall conditions within the catchment.

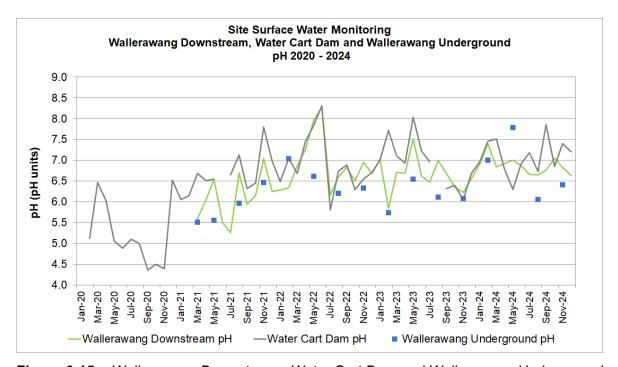
Figure 6-15 Wallerawang Downstream, Water Cart Dam and Wallerawang Underground pH Results 2020 - 2024 (noting that data gaps are when Water Cart Dam was dry and dates prior to the commencement of sampling at Wallerawang Downstream and Underground)

pH and electrical conductivity for Wallerawang Downstream and Water Cart Dam have been plotted with the quarterly results for Wallerawang Underground as presented in **Figure 6-15** and **Figure 6-16** below.

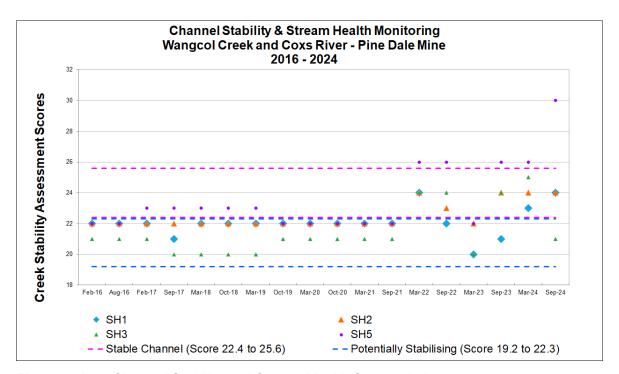
Figure 6-17 Channel Stability and Stream Health Scores during 2016 – 2024

Follow-up (six-monthly) assessments have been conducted at the same monitoring locations; results are presented **Figure 6-17**. Generally, the stability of all the locations have remained consistent or increased with the exception of decrease in classification based on a loss of vegetation in October 2019 presumed to be due to below average rainfall (drought conditions).

Locations SH1, SH2 and SH3 were considered 'stable', and SH5 was considered 'very stable' during the 2024 assessment, noting that the stability at SH3A is based on the presence of spray-concrete lining.

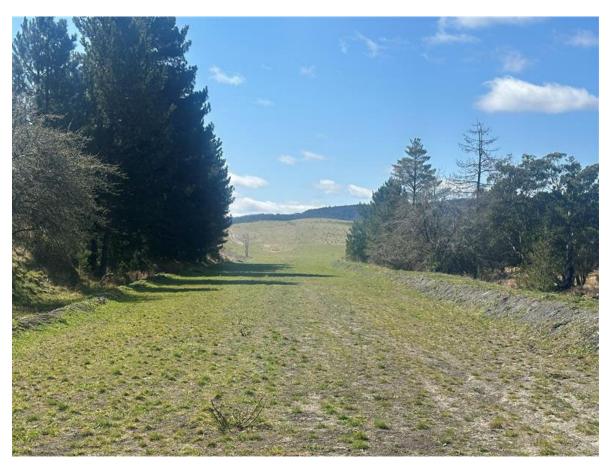
Maintenance rehabilitation works undertaken within the reporting period comprised topsoiling and mulching of the eastern portion of ML1578 in February / March 2023. A photograph of the area as per September 2024 is presented in **Photograph 7-1**.

Photograph 7-1 Rehabilitated area within ML1578 looking east in September 2024.

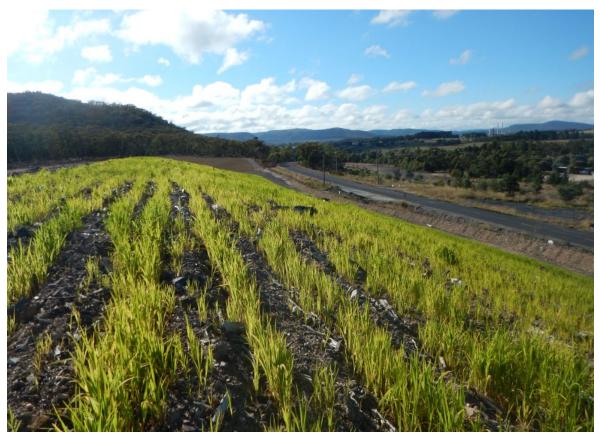
The amenity bund located along the southern boundary of the Yarraboldy Extension was re-profiled in 2014, with the southern batter having a gradient of 18° to minimise erosion and enhance establishment of seedlings. Following the application and tilling of topsoil, a native species grass and tree species seed mix was applied followed by mulch (refer **Photograph 7-2**).

Photograph 7-2 Amenity Bund looking east following application of mulch and native mix 2015.

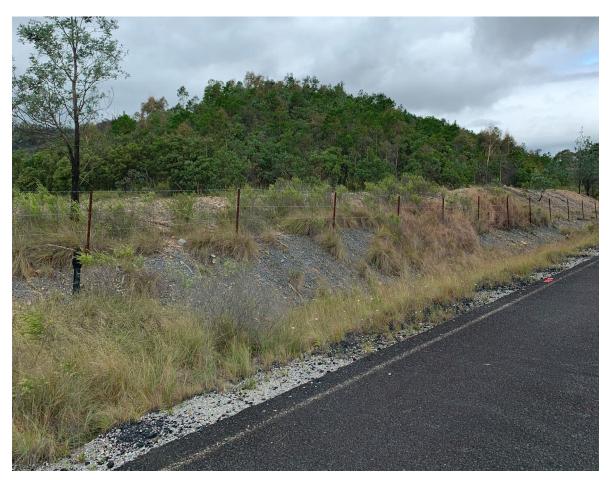
During the reporting period, maintenance works was not required to be undertaken in the Yarraboldy Extension. No rehabilitation maintenance activities were undertaken. Current vegetative cover on the bund is shown in **Photograph 7-3**.

Photograph 7-3 Amenity Bund looking northeast, January 2025

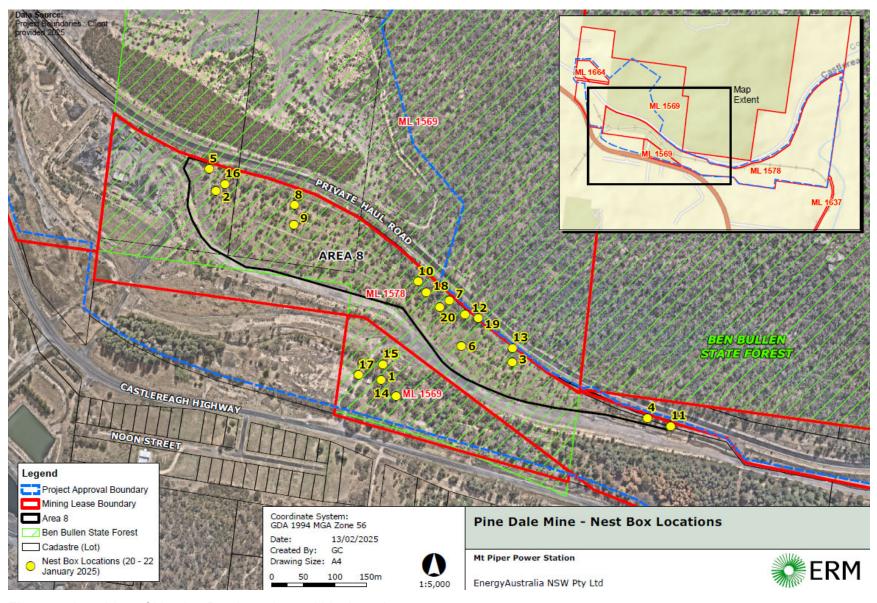
Figure 7-1 Map of Nesting Box Locations within Area A

It is noted that a total of twenty (20) nesting boxes were installed in Area A subsequent to the inspection for the rehabilitation report as per **Figure 7-1**; indicative photographs of the boxes are presented in **Photograph 7-4**.

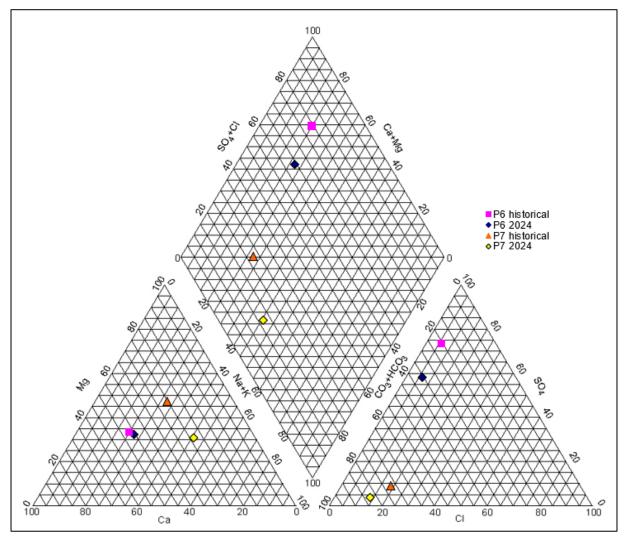
Figure 6 Piper Plot comparing results of 2024 monitoring to historical data

Based on the above **Figure 6** the chemistry of P6 and P7 remains altered in comparison to historical data, noting that the extent of variance has decreased from that identified during the previous reporting period. The magnitude of these variation differs depending on the specific cation/anion involved. It is noted that, due to the absence of any excavation, injection of water or extraction of water at PDM, that the change in groundwater level and chemistry is not considered likely to be as a result of activities at PDM.

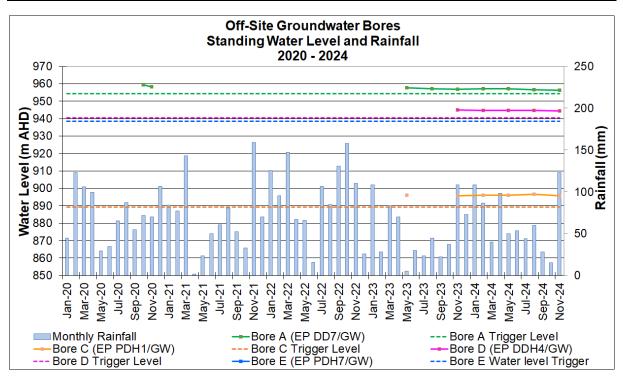
Figure 7 Standing water level and rainfall 2020 – 2024

The water levels within Bore A, Bore C and Bore D are (refer **Figure 7**) above their respective levels, with a generally stable trend observed across all the bores since the middle of 2023 when the Bores were able to be accessed following access restrictions.

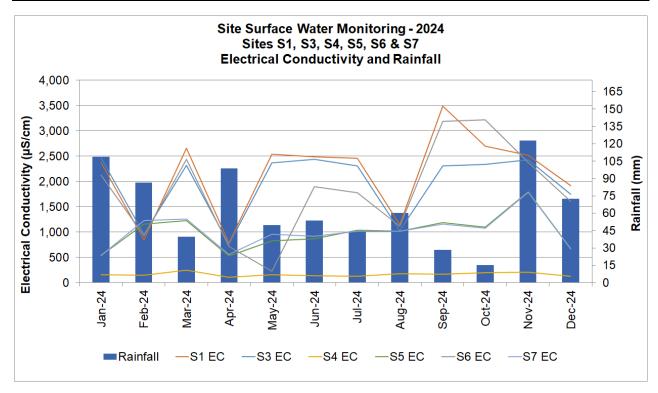
Figure 17 Site Surface Water Electrical Conductivity and Monthly Rainfall

The variation of electrical conductivity with rainfall is presented in **Figure 17**: electrical conductivity theoretically increases in response to decreased rainfall and the majority of the results in this monitoring period appear to reflect this. It is noted that other contributions to the salinity of the water, potentially including sediment which is eroded by rainfall from the catchment, has been considered to present an influence to electrical conductivity in previous monitoring periods.

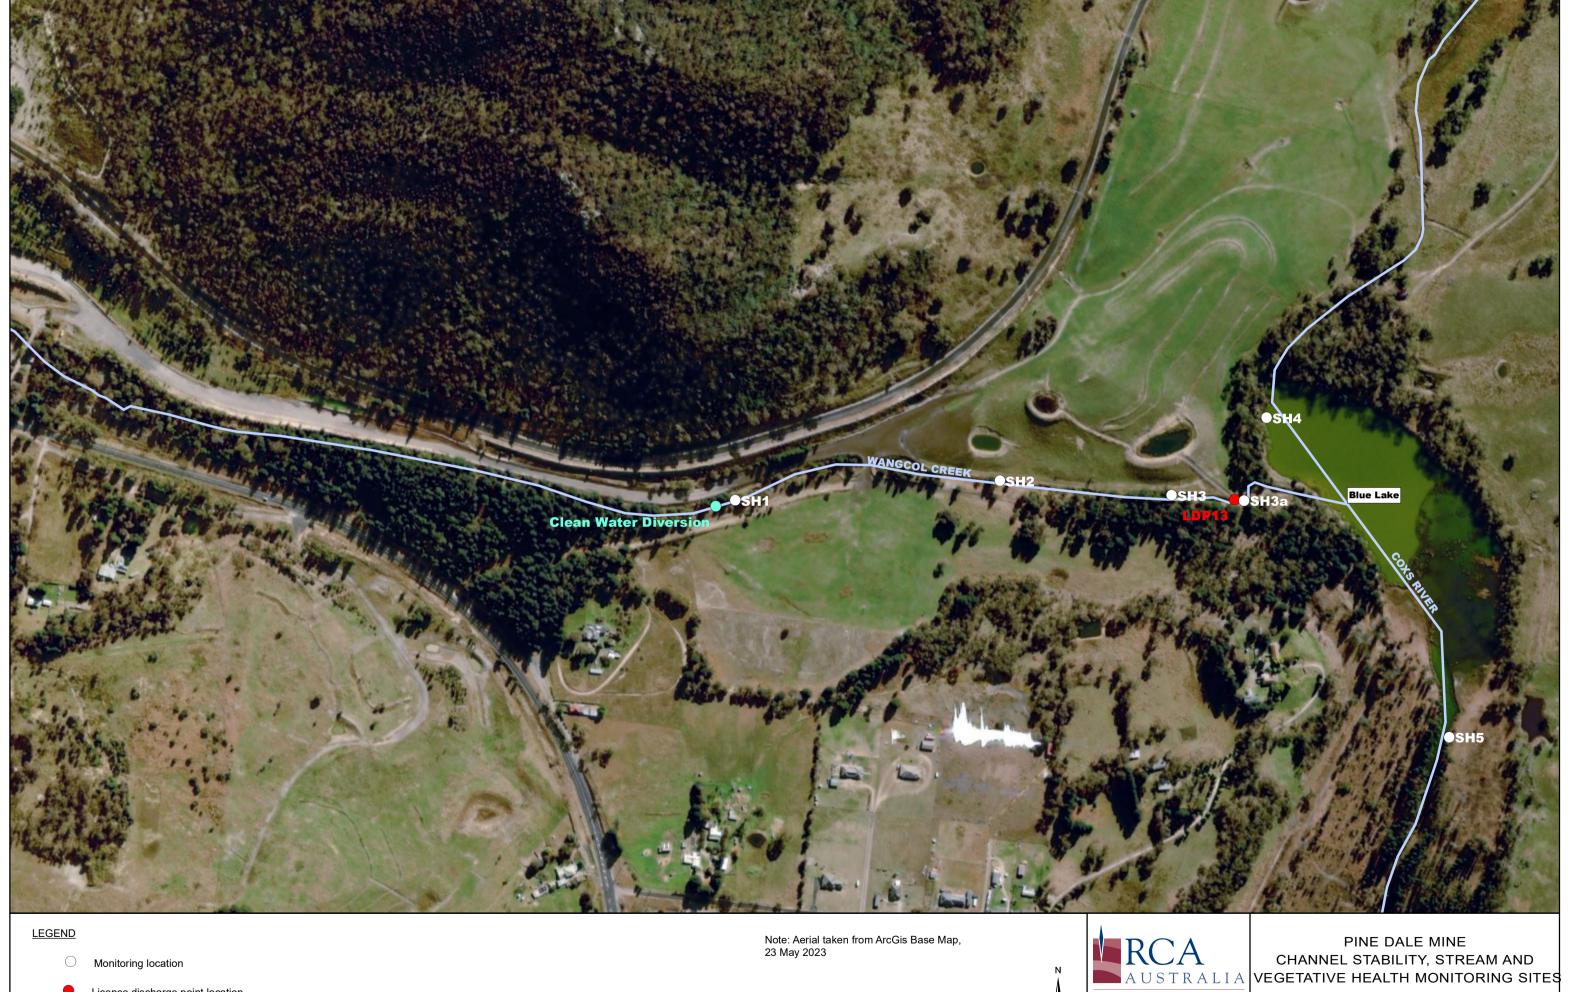
CLIENT Enhance Place Pty Ltd			RCA Ref	6880g-312	:/0 AppB	
DRAWN BY	MH	SCALE	1:5,000 (A3)	DRAWING	G 2	REV 0
APPROVED I	BY FB	DATE	18/02/2025	OFFICE	NEWCASTLE

Licence discharge point location

Clean water diversion location

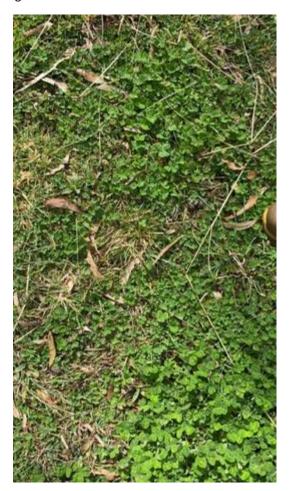
Figure 2 Pasture composition at analogue site

Species composition at pasture rehabilitation areas – Pasture rehabilitation areas were established with a mix of ~70% perennial grasses and ~20% annual legumes consistent with species composition at the analogue pasture site. Examples of analogue pasture and rehabilitated pasture at Area C are shown in Figure 2 and Figure 3.

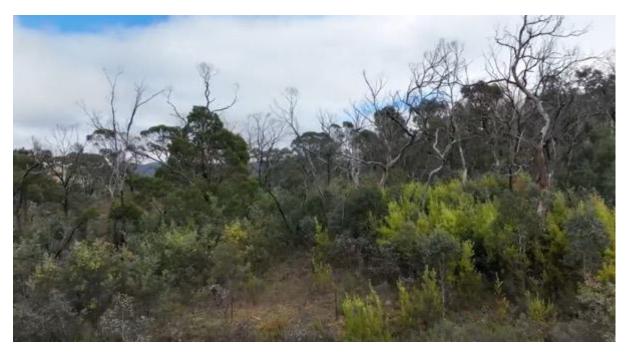
Figure 4 Natural regeneration of the treed analogue site

The treed analogue site was affected by fire in 2020 which resulted in the loss of groundcover, shrubby understorey and canopy. Natural regeneration is occurring and is characterised by an increase in shrubby vegetation and juvenile tree growth evident in Figure 4.

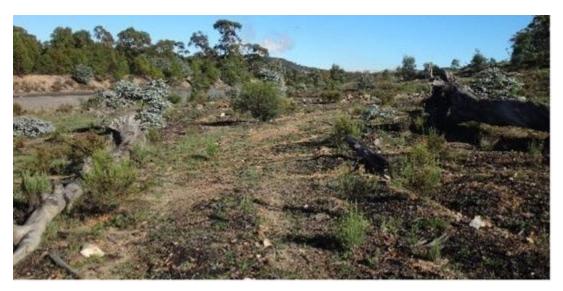
Transect 4 looking west 2024

Transect 4 Pasture rehabil	litation area 202	4						
Easting				Northing				
228318				6304224				
228249				6304227				
Landform and soils								
Slope	Transect loc	ated along a	contour. 1 -	<3% slope de	clining to the	e west.		
Erosion	Not observe	d.						
Cracking soils	Not observe	d.						
Surface drainage impediments	No significar	nt drainage ii	mpediments.					
Vegetation								
Vegetation structure	Groundcove	r of mixed n	ative and exc	otic grasses a	nd broadleaf	herbs.		
Species richness	>40 herbs a	nd grasses re	corded, dom	ninated by exc	otic species.			
Cover classification	% cover at e	ach observa	tion					
	September 2017	September 2018	September 2019	September 2020	November 2021	November 2022	September 2023	August 2024
Total living cover	90%	90%	90%	>90%	>90%	Not assessed due to	>95%	>90%
Annual living cover	30%	30%	40%	20%	20%	inaccessibility	20%	20%
Perennial living cover	60%	60%	50%	70%	70%		75%	70%

Litter cover	<10%	10%	-	-	-		-	<5%
Bare surface	<10%	10%	10%	10%	<10%		<5%	<5%
Target weed presence								
African Lovegrass (Eragrostis curvula)	<10%

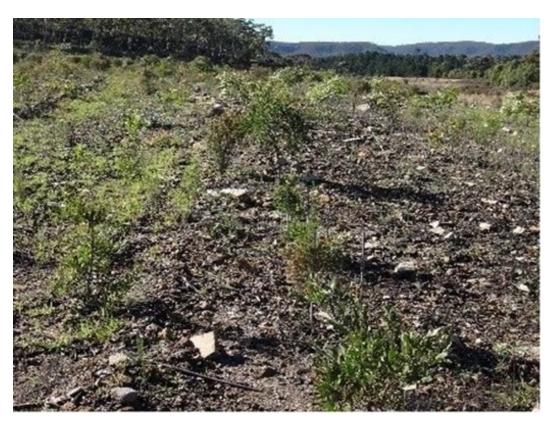
Transect 5 looking west 2024

Transect 5 Treed rehabilita	tion area 2024							
Easting			No	Northing				
227846		6304272						
227787		6304251						
Landform and soils								
Slope	Transect loc	ated along co	ntour of mid	slope inclining	10-20% to th	e north.		
Erosion	Minor wind	erosion obse	rved on expos	ed soils. Isolat	ted incidences	s of inactive g	ullying obser	ved.
Cracking soils	Not observe	d.						
Surface drainage impediments	No significa	nt drainage im	npediments.					
Vegetation								
Vegetation structure Sparse tree layer to 3 m height with juvenile trees and sparse mixed native shrub species. Sparse shrub layer consists of native species and juvenile trees to 2 m height. Groundcover dominated by native and exotic grasses with scattered mixed native and exotic herbs.								
						_	ve and exotion	c herbs.
Species richness	Groundcove	er dominated	by native and	exotic grasses		_	ve and exotion	c herbs.
Species richness Cover classification	Groundcove >45 species	er dominated	by native and	exotic grasses		_	ve and exotion	c herbs.

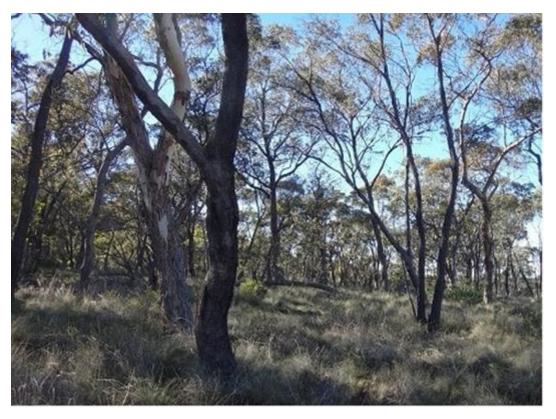
Transect 6 looking east 2024

Transect 6 Treed rehabilitation area 2024								
Easting			No	Northing				
226604				04724				
226647	6304706							
Landform and soils								
Slope	Transect loc	ated along co	ntour of mid	slope inclinin	g 10-20% to tl	ne northeast.		
Erosion	Minor wind	erosion obse	rved on expo	sed soils. Isola	ted incidence	s of inactive	gullying obse	erved.
Cracking soils	Not observe	d.						
Surface drainage impediments	No significa	nt drainage in	npediments.					
Vegetation								
Vegetation structure	Sparse shrul	b layer consis	ts of native sp	venile trees and juv ecies and juv exotic grasse	enile trees to	3 m height.		cic herbs.
Species richness	Groundcove >45 species	er dominated recorded.	by exotic gras	sses.				
Cover classification	% cover at e	ach observati	ion					
	September 2017	September 2018	September 2019	September 2020	November 2021	November 2022	September 2023	August 2024
Total living cover	80%	70%	70%	80%	>90%	80%	80%	80%

Annual living cover	10%	10%	10%	10%	20%	20%	20%	20%
Perennial living cover	70%	60%	60%	70%	70%	60%	60%	60%
Litter cover	10%	10%	15%	10%	-	10%	10%	>10%
Bare surface	10%	20%	15%	10%	<10%	10%	10%	<10%
Target weed presence								
None observed.

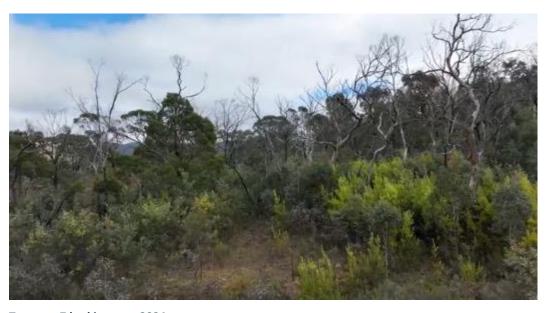
Transect 7 looking east 2024

Treed analogue site (transect 7) 2024	1	
Easting		Northing
226801		6305097
226838		6305039
Landform and soils		
Slope	Transect located along	contour of mid slope gently inclining to the north.
Erosion	Minor wind erosion ob	served on exposed soils.
Cracking soils	Not observed.	
Surface drainage impediments	No significant drainage	e impediments.
Vegetation		
Vegetation structure		neight. Dense shrub layer including juvenile tree species. ed by native grasses with sparse native herbs.
Species richness	>20 species observed.	
Cover classification		
Total living cover	>95%	
Annual living cover	<5%	
Perennial living cover	>90%	
Litter cover	10%	
Bare surface <5%		
Target weed presence		
None observed.
