PINE DALE MINE ANNUAL REVIEW 2025

Prepared by Enhance Place Pty Ltd

24 February 2026

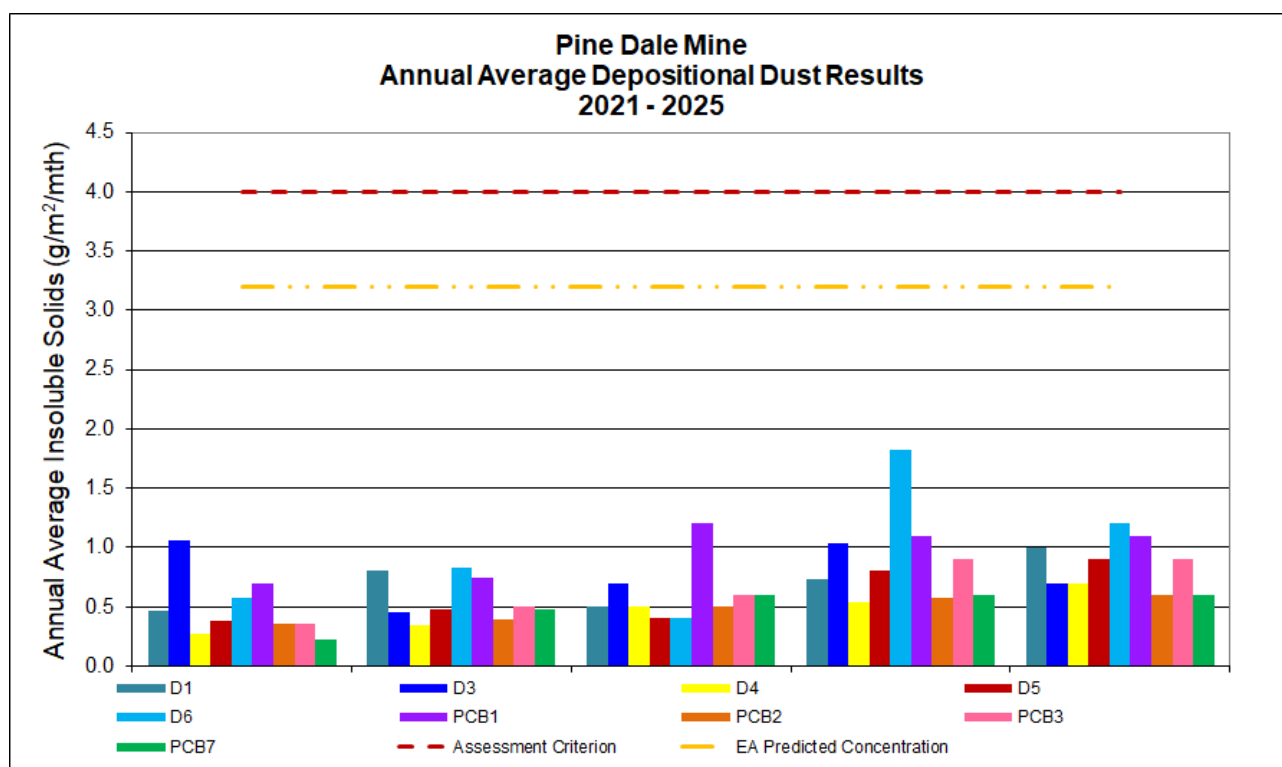
Figure 5-1 Depositional dust data: 2021 – 2025

The 2025 annual average deposited dust concentrations are shown to be significantly lower than the predicted 3.2 g/m²/month annual average (refer **Table 5-1**); this is as expected as the predicted value was for an operational mine.

An examination of the historical data (**Table 5-3**) that the 2025 annual averages are similar to those from 2024. All averages remain below the NSW EPA criterion. The substantial decrease in the 2021 & 2022 annual averages of deposited dust concentrations when compared to the 2020 historical data is not considered to be due to a change in site activities at PDM as the mine has been in Care and Maintenance since 2014, rather it is considered to be influenced by the increased rainfall following prolonged dry conditions and associated correlation with dust storms and bushfires (observed in early 2020).

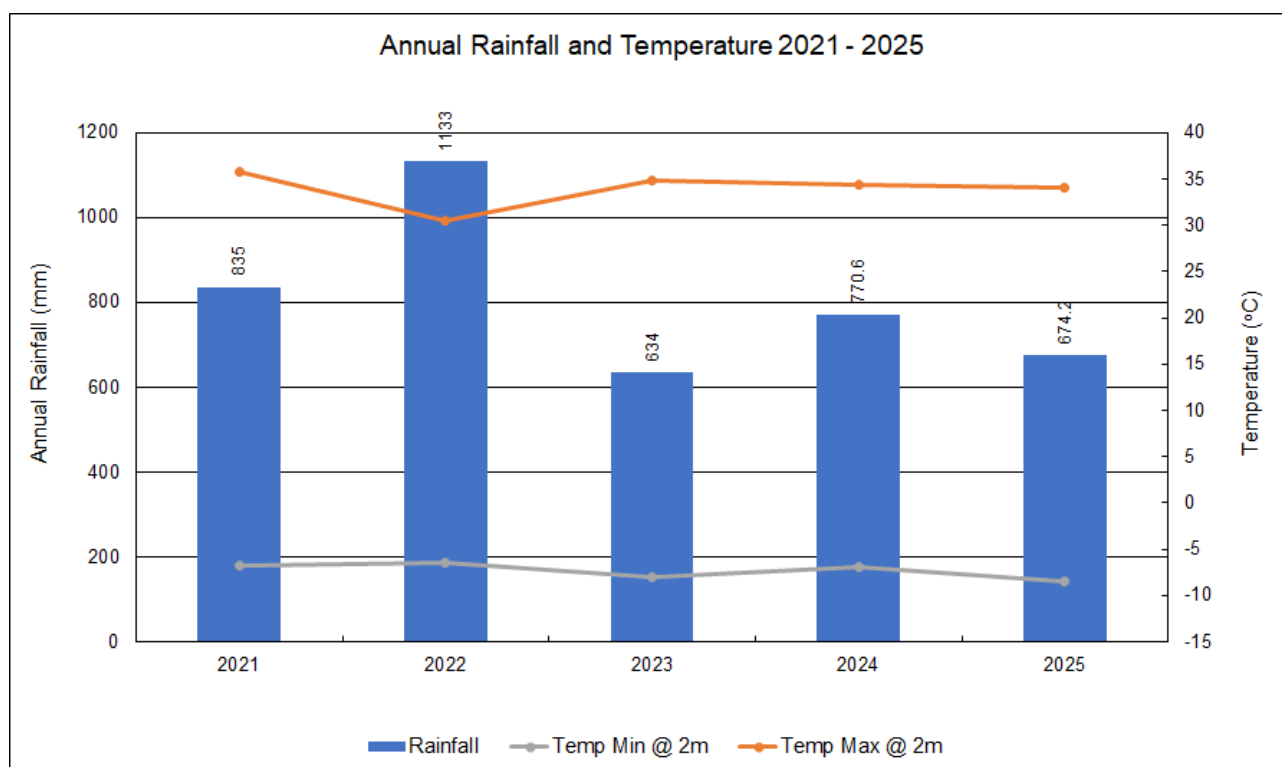
The total annual rainfall and the minimum and maximum temperature at 2 m from 2021 to 2025 are shown graphically in **Figure 5-2**.

Figure 5-2 Annual Temperature and Rainfall Summary: 2021 – 2025

PDM received 674.2 mm of rainfall across 190 rainfall days during the 2025 reporting period. Rainfall during this reporting period was observed to be greater than the annual rainfall recorded during 2023 and lower than that in 2021, 2022 and 2024 (**Figure 5-2**).

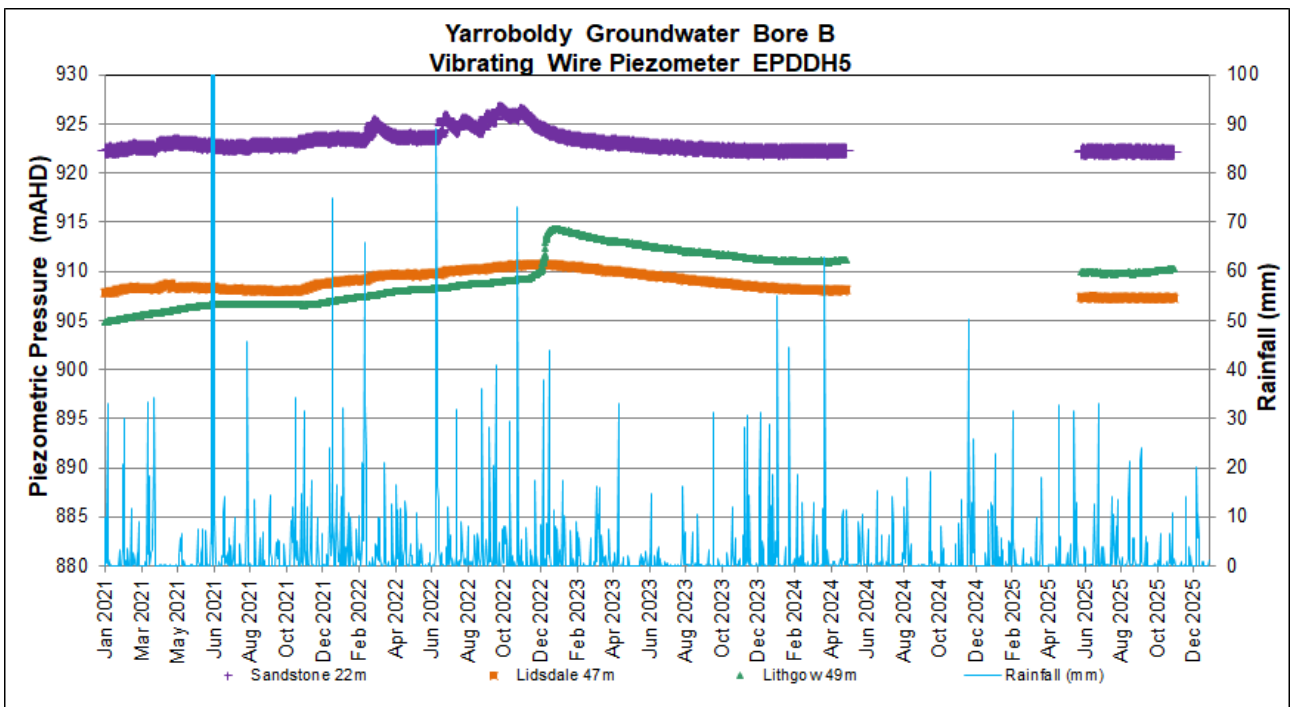
Data logger measurements for Bores B and C are presented in **Figure 6-7** and **Figure 6-8** below. The gaps in the graphs are associated with malfunctions of the loggers.

Figure 6-7 Yarraboldy Bore B Hydrograph and Rainfall 2021 – 2025

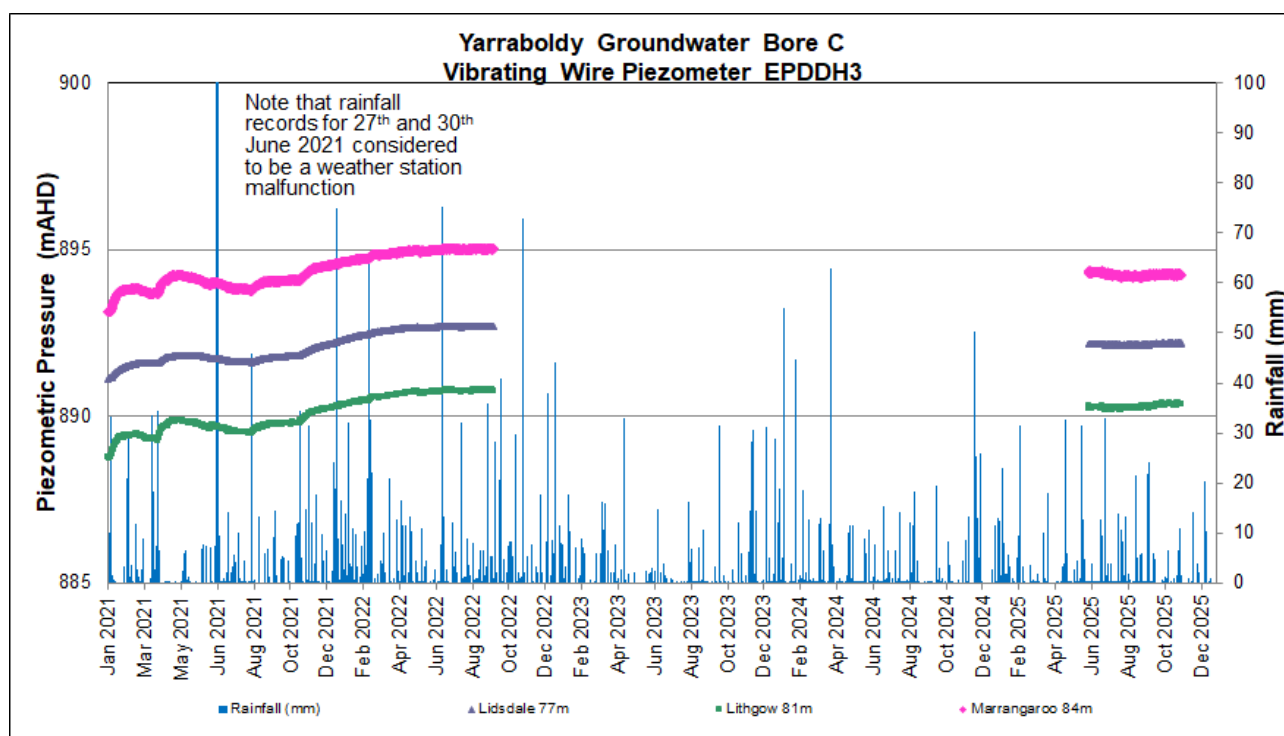
Figure 6-8 Yarraboldy Bore C Hydrograph and Rainfall 2021 – 2025

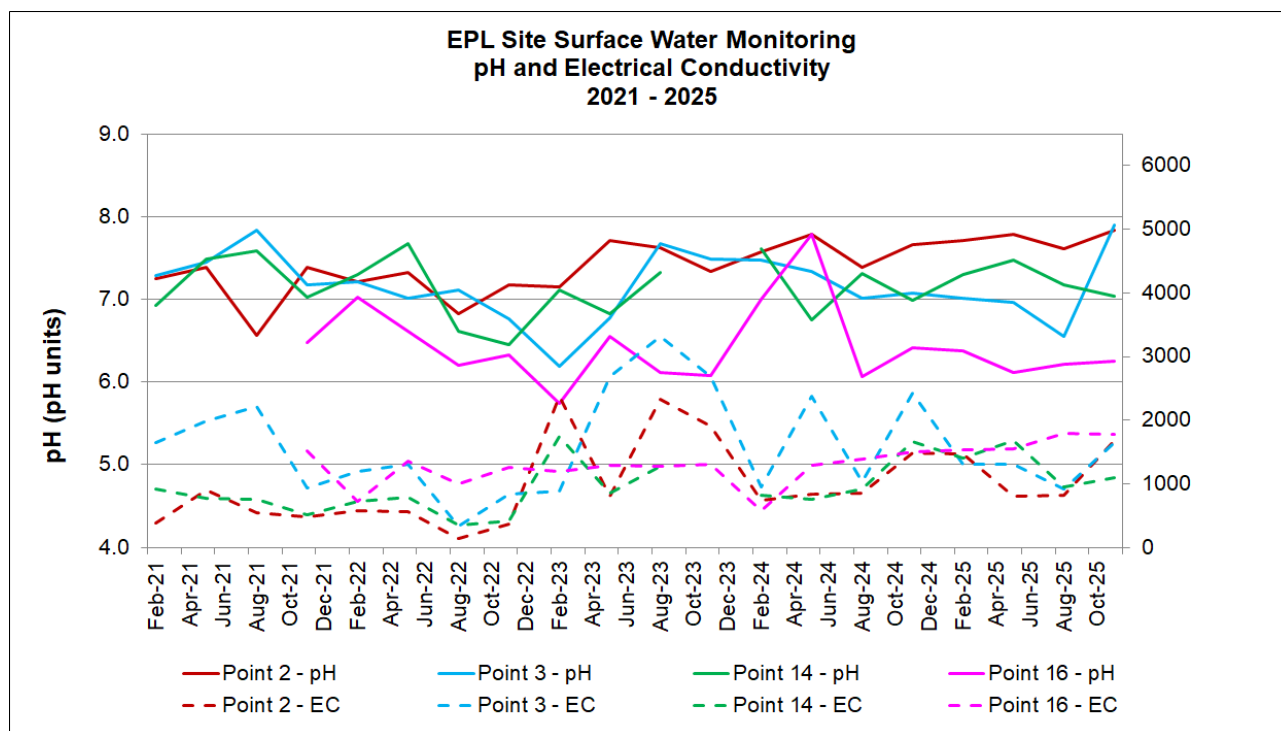
The electrical conductivity and pH for the period 2021 – 2025 for the EPL 4911 specified monitoring points are shown in **Figure 6-9**; electrical conductivity and rainfall for the same period is shown in **Figure 6-10**.

Figure 6-9 Surface water at EPL monitoring points: pH and Electrical Conductivity (2021 – 2025)

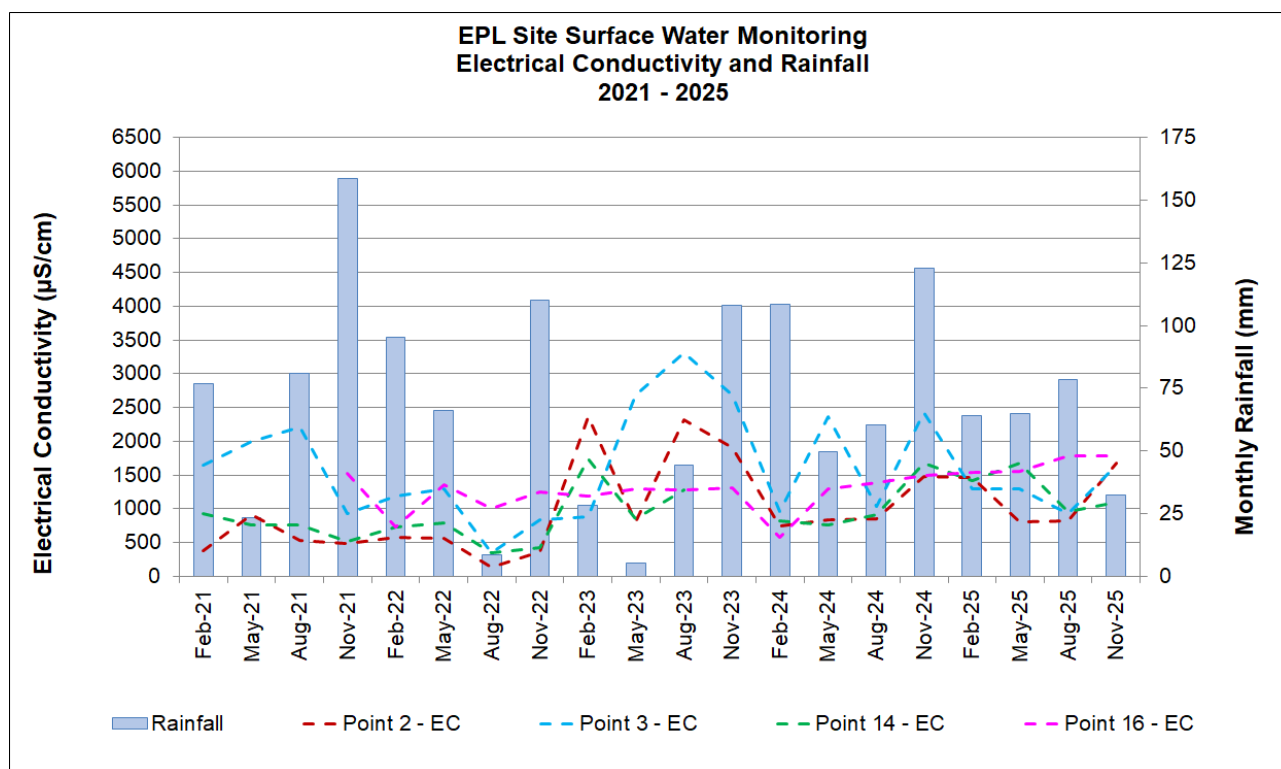
Figure 6-10 Surface water at EPL monitoring points: Rainfall and Electrical Conductivity (2021 – 2025)

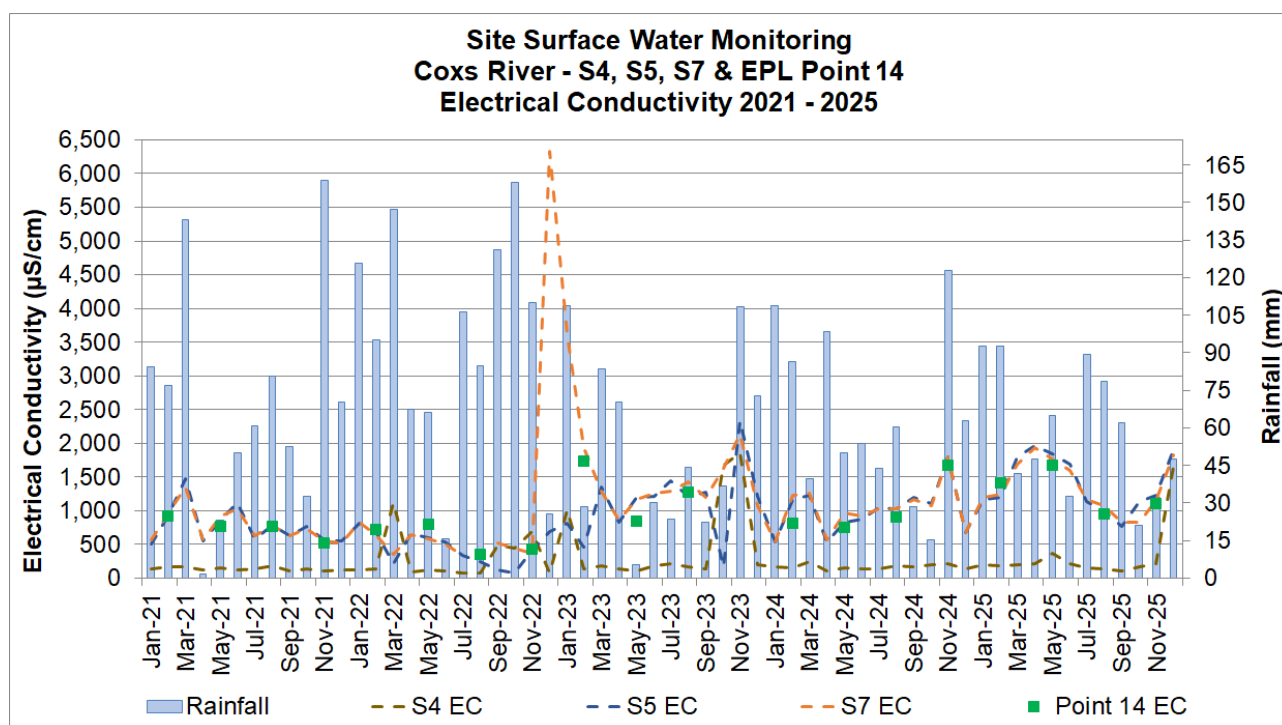
Figure 6-14 S4, S5, S7 and EPL Point 14 Electrical Conductivity Results & Rainfall 2021 – 2025 (noting that EPL Point 14 was dry in November 2023 such that no sample was collected)

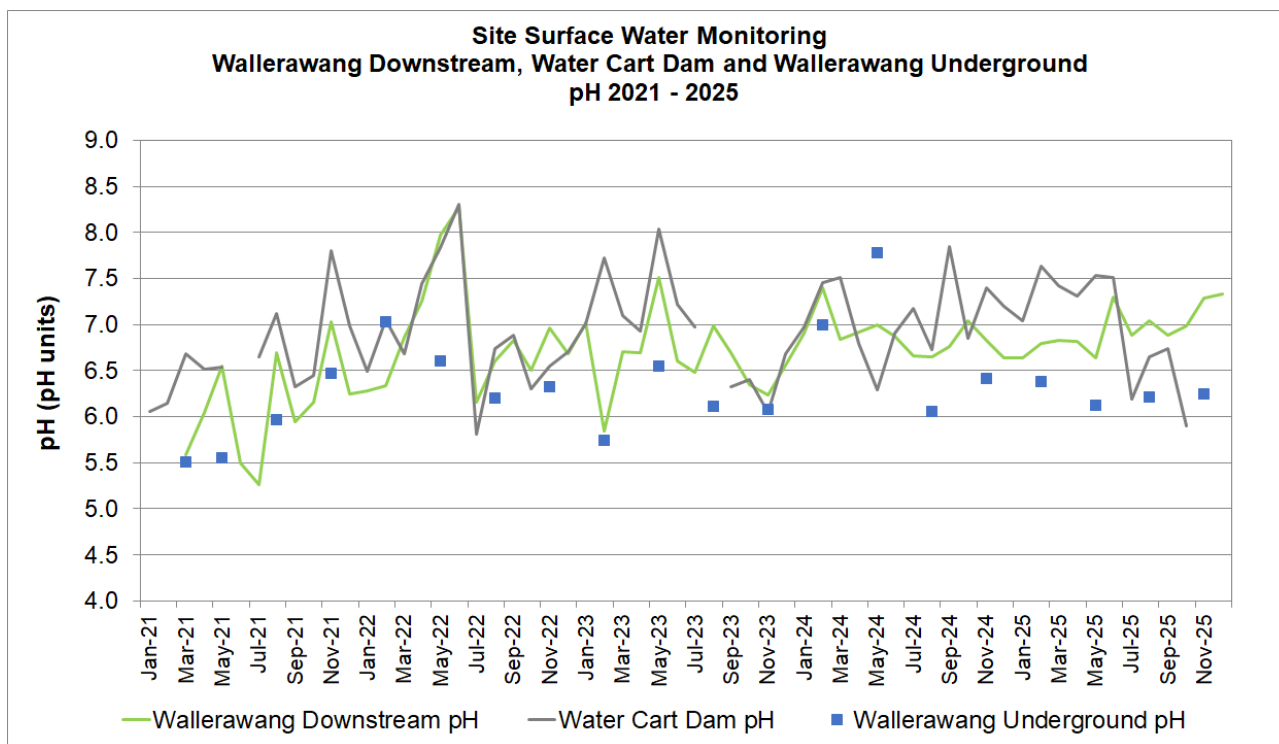
Figure 6-15 Wallerawang Downstream, Water Cart Dam and Wallerawang Underground pH Results 2021 – 2025 (noting that data gaps are when Water Cart Dam was dry and dates prior to the commencement of sampling at Wallerawang Downstream and Underground)

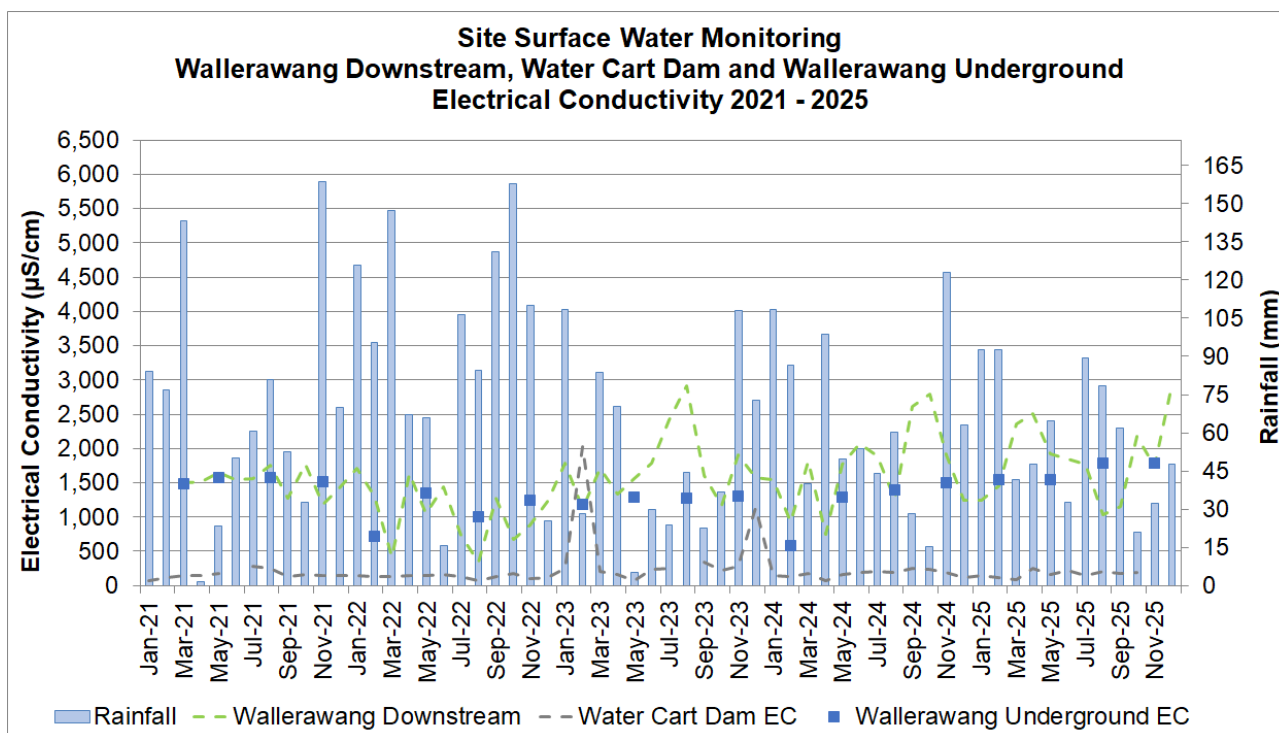
Figure 6-16 Wallerawang Downstream, Water Cart Dam and Wallerawang Underground Electrical Conductivity Results 2021 – 2025 (noting that data gaps are when Water Cart Dam was dry and dates prior to the commencement of sampling at Wallerawang Downstream and Underground)

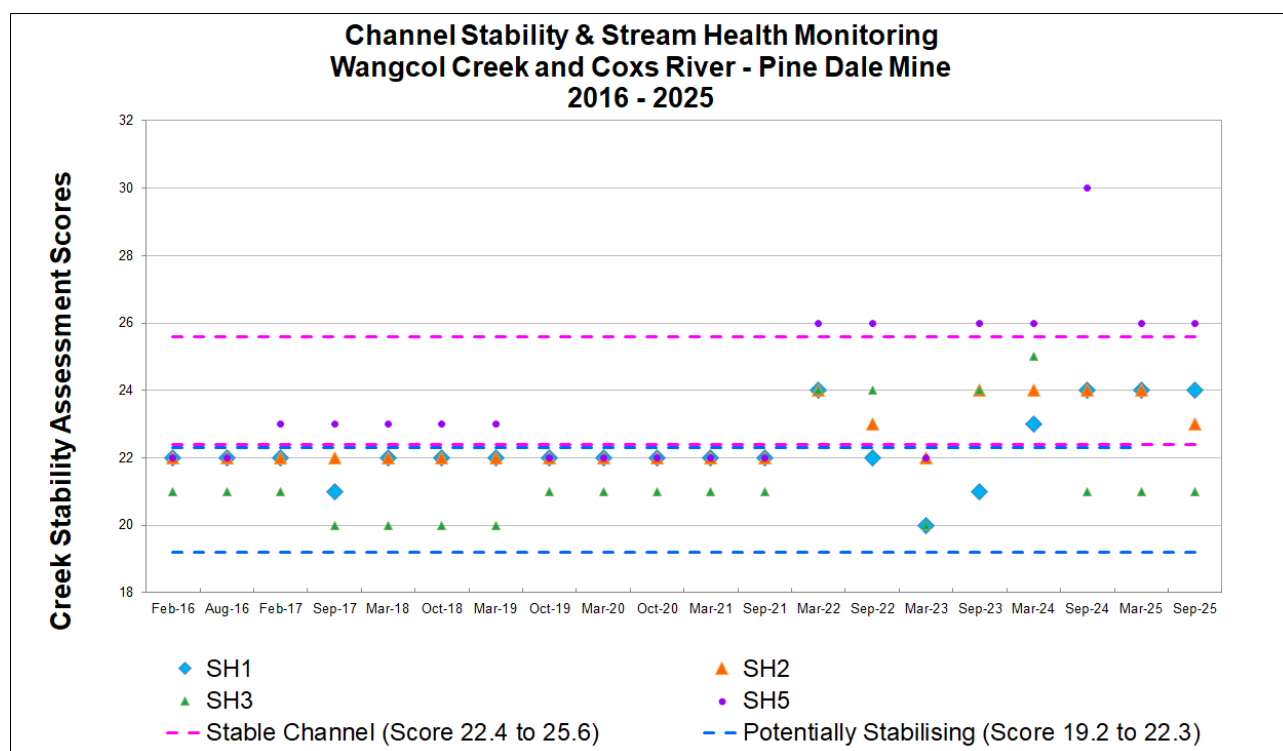
Follow-up (six-monthly) assessments have been conducted at the same monitoring locations; results are presented **Figure 6-17**. Generally, the stability of all the locations has remained consistent or increased with the exception of decrease in classification based on a loss of vegetation in October 2019 presumed to be due to below average rainfall (drought conditions). Locations SH1 and SH2 were considered 'stable', SH3 was considered 'potentially stabilising' and SH5 was considered 'very stable' during the 2025 assessment, noting that the stability at SH3A is based on the presence of spray-concrete lining.

Figure 6-17 Channel Stability and Stream Health Scores during 2016 – 2025

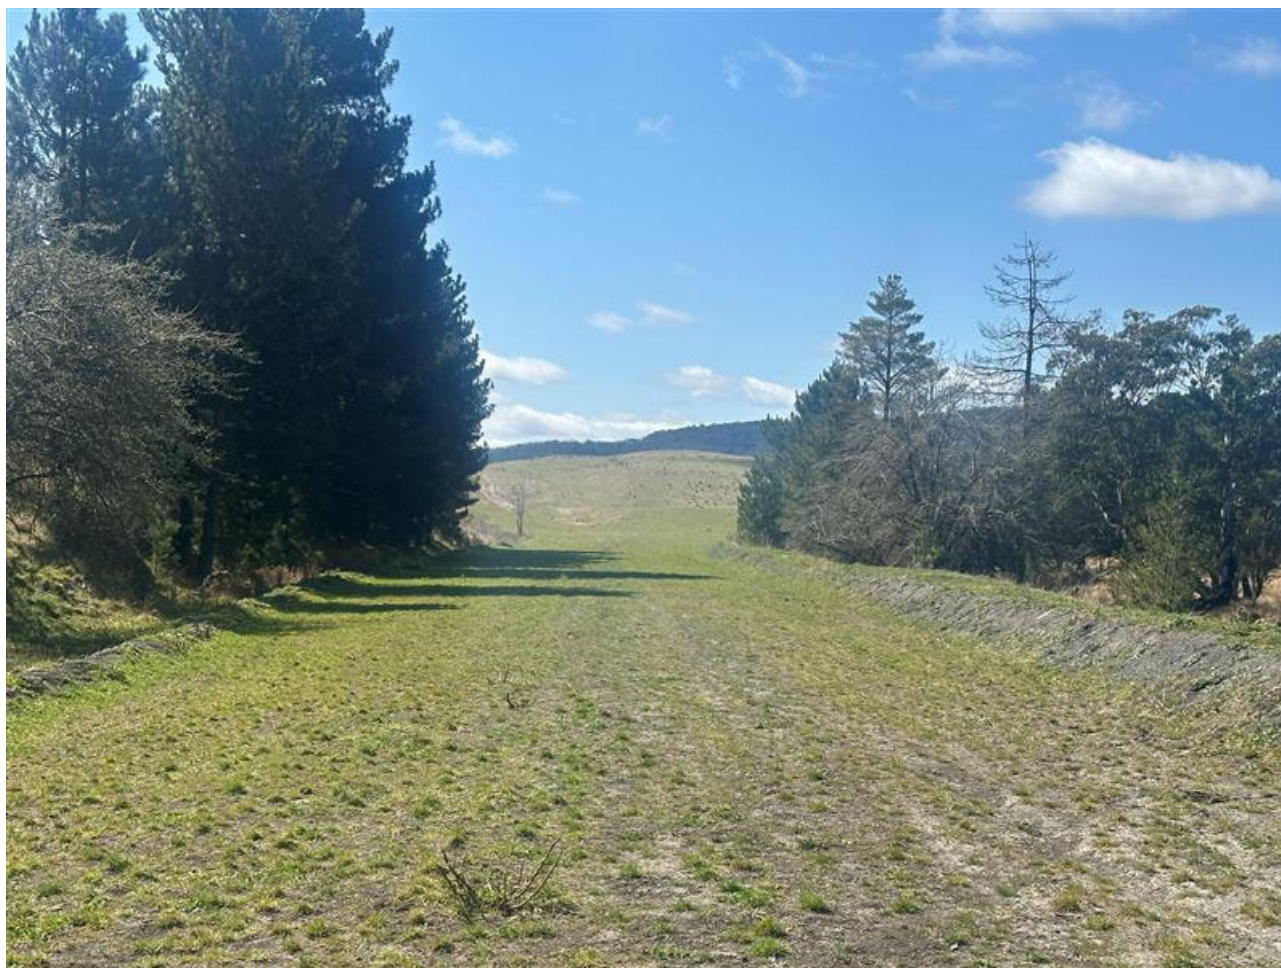
Maintenance rehabilitation works undertaken within the reporting period comprised topsoiling and mulching of the eastern portion of ML1578 in February / March 2023. A photograph of the area as per September 2024 is presented in **Photograph 7-1**.

Photograph 7-1 *Rehabilitated area within ML1578 looking east in September 2024.*

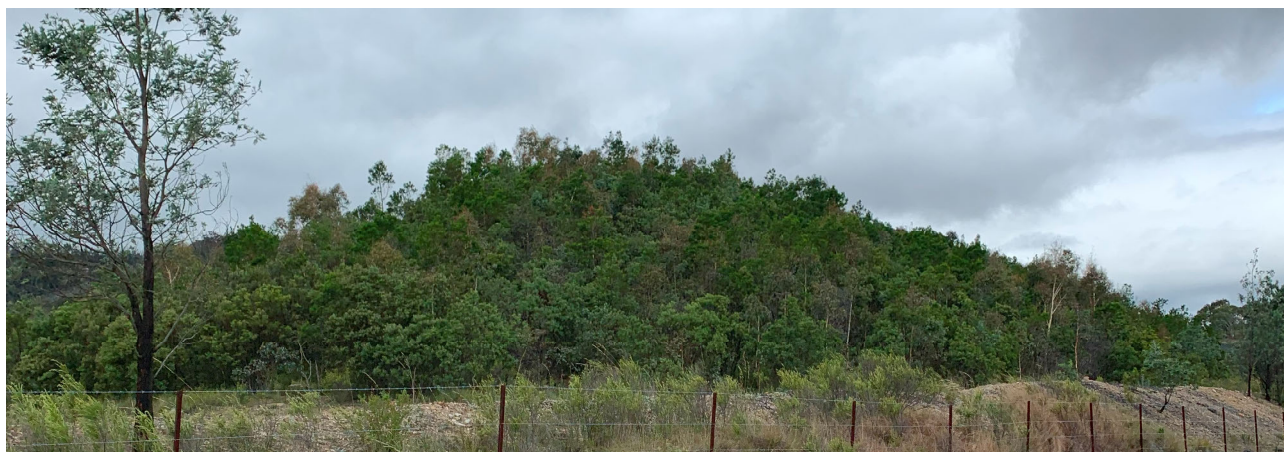
Photograph 7-2 *Amenity Bund looking northeast, January 2025*

During the reporting period, maintenance works was not required to be undertaken in the Yarraboldy Extension. No rehabilitation maintenance activities were undertaken. The vegetative cover at the start of the monitoring period on the bund is shown in **Photograph 7-2**.

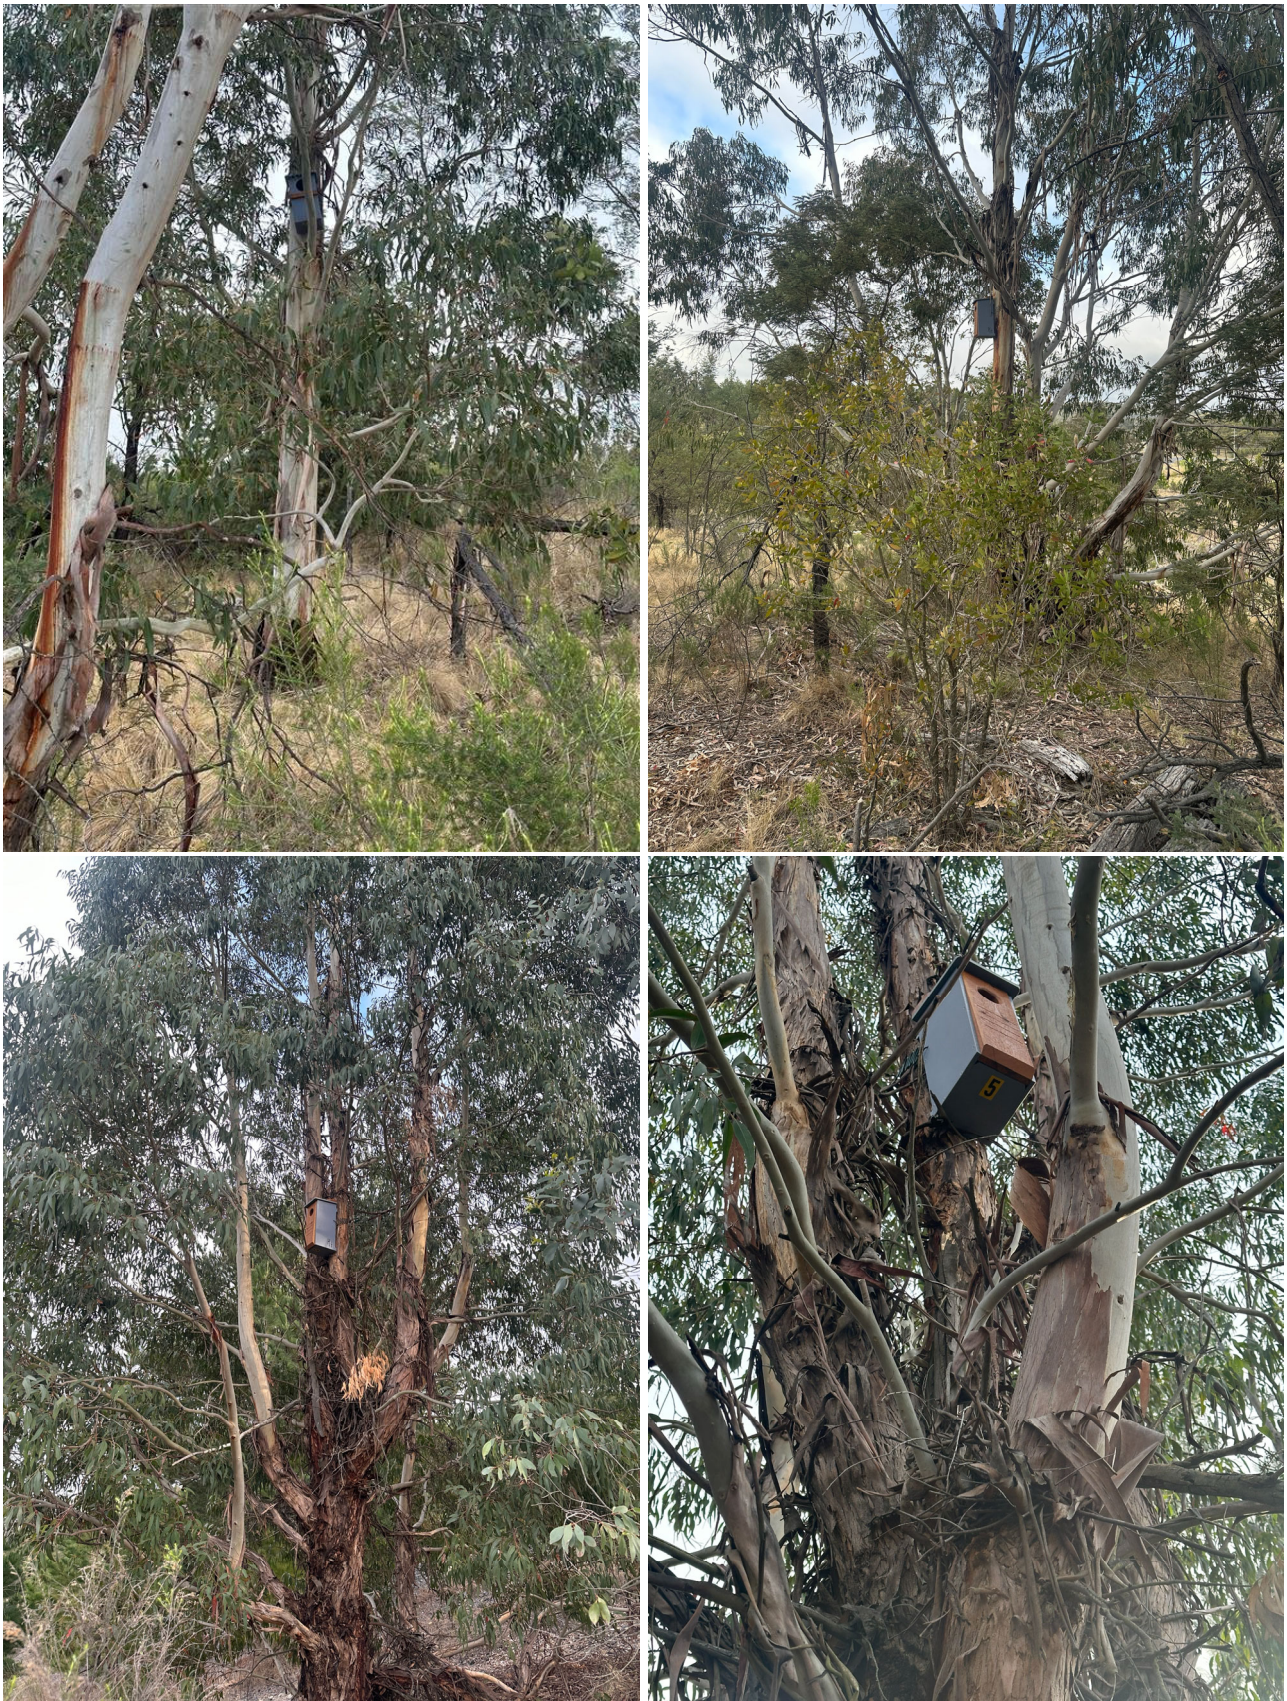
The locations of the nesting boxes installed in Area A are presented in **Figure 7-1** below; indicative photographs of the boxes are presented in **Photograph 7-3**.

Photograph 7-3 *Location and Indicative Photographs of Nesting Boxes within Area A*

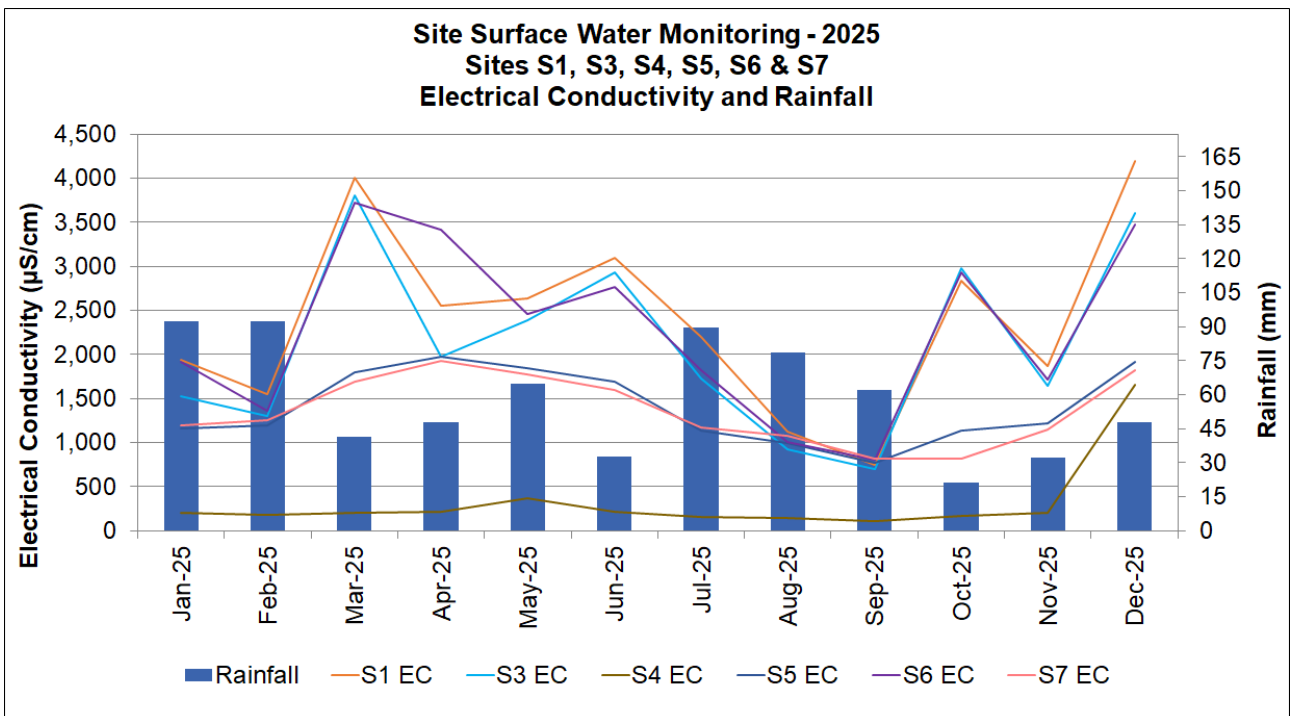
The variation of electrical conductivity with rainfall is presented in **Figure 16**: electrical conductivity theoretically increases in response to decreased rainfall however there are other contributions to the salinity of the water such as sediment which is eroded by rainfall from the catchment.

Figure 16 Site Surface Water Electrical Conductivity and Monthly Rainfall

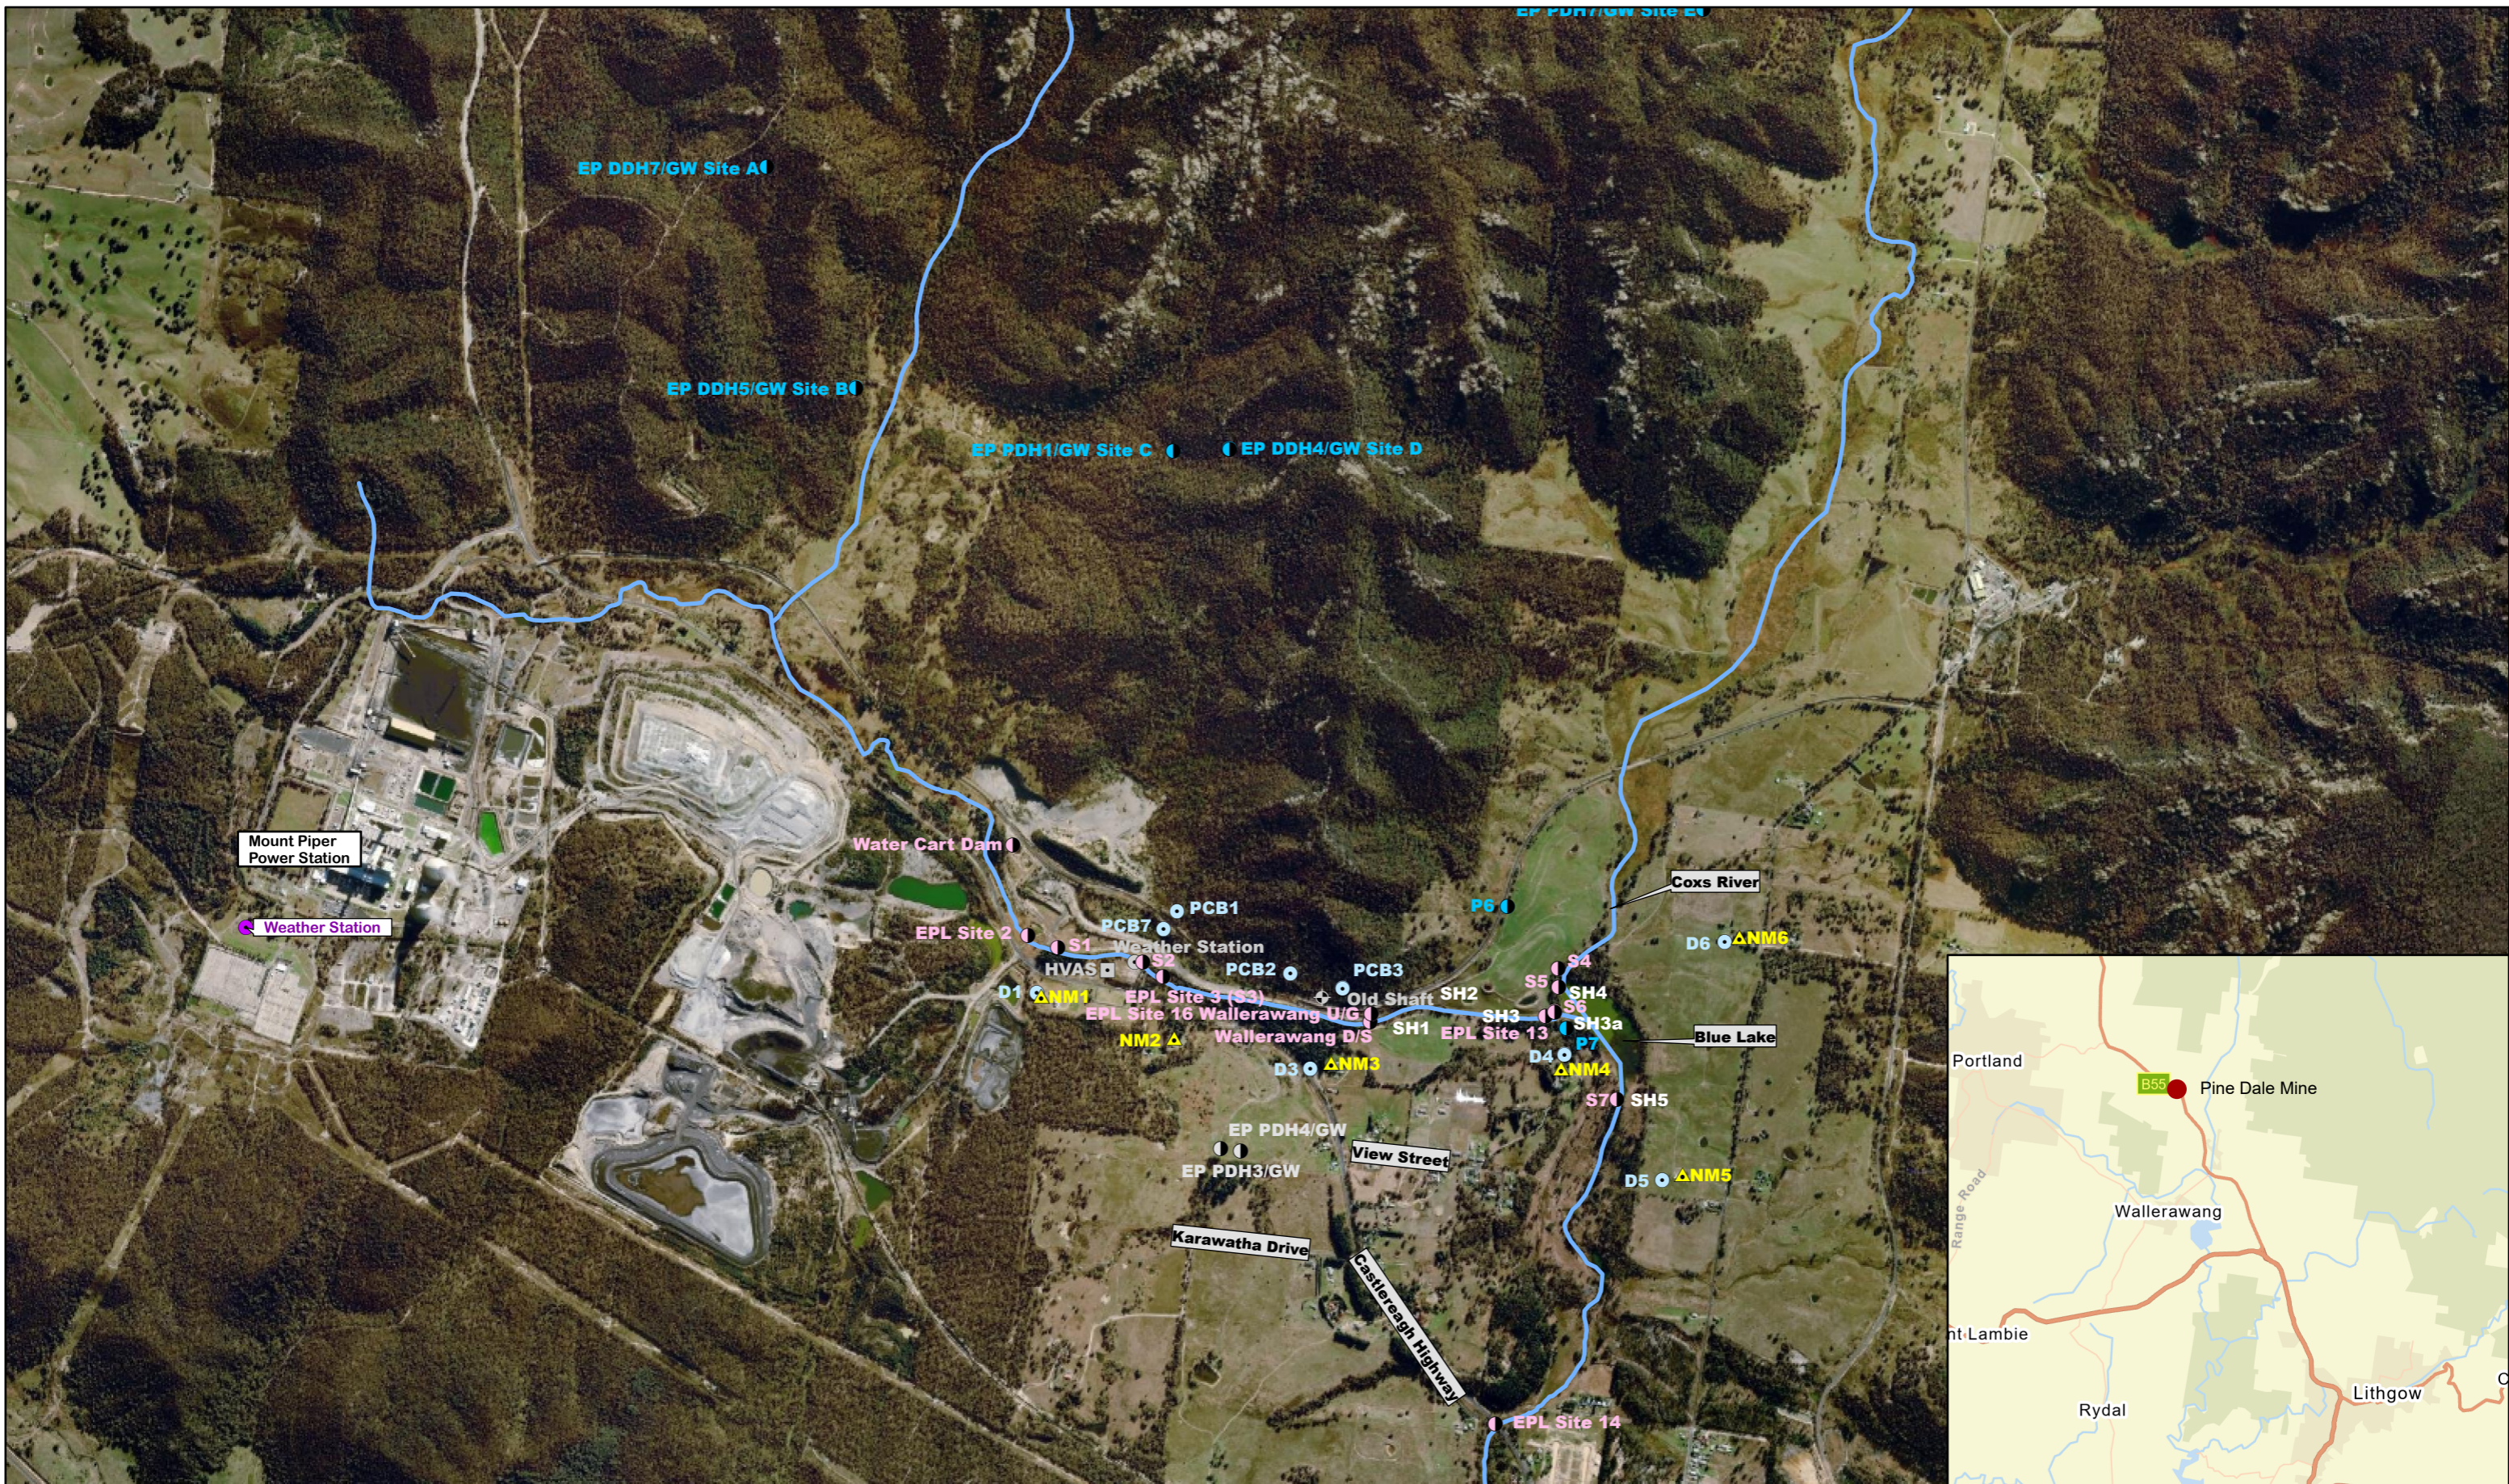
Drawing 1 – Environmental Monitoring Locations

- ▲ Noise Monitoring Location
- Depositional Dust Monitoring Location
- Groundwater Monitoring Location
- Surface Water Monitoring Location
- Meteorological monitoring location (from 10 November 2021)
