PINE DALE MINE ANNUAL REVIEW 2025

Prepared by Enhance Place Pty Ltd

24 February 2026

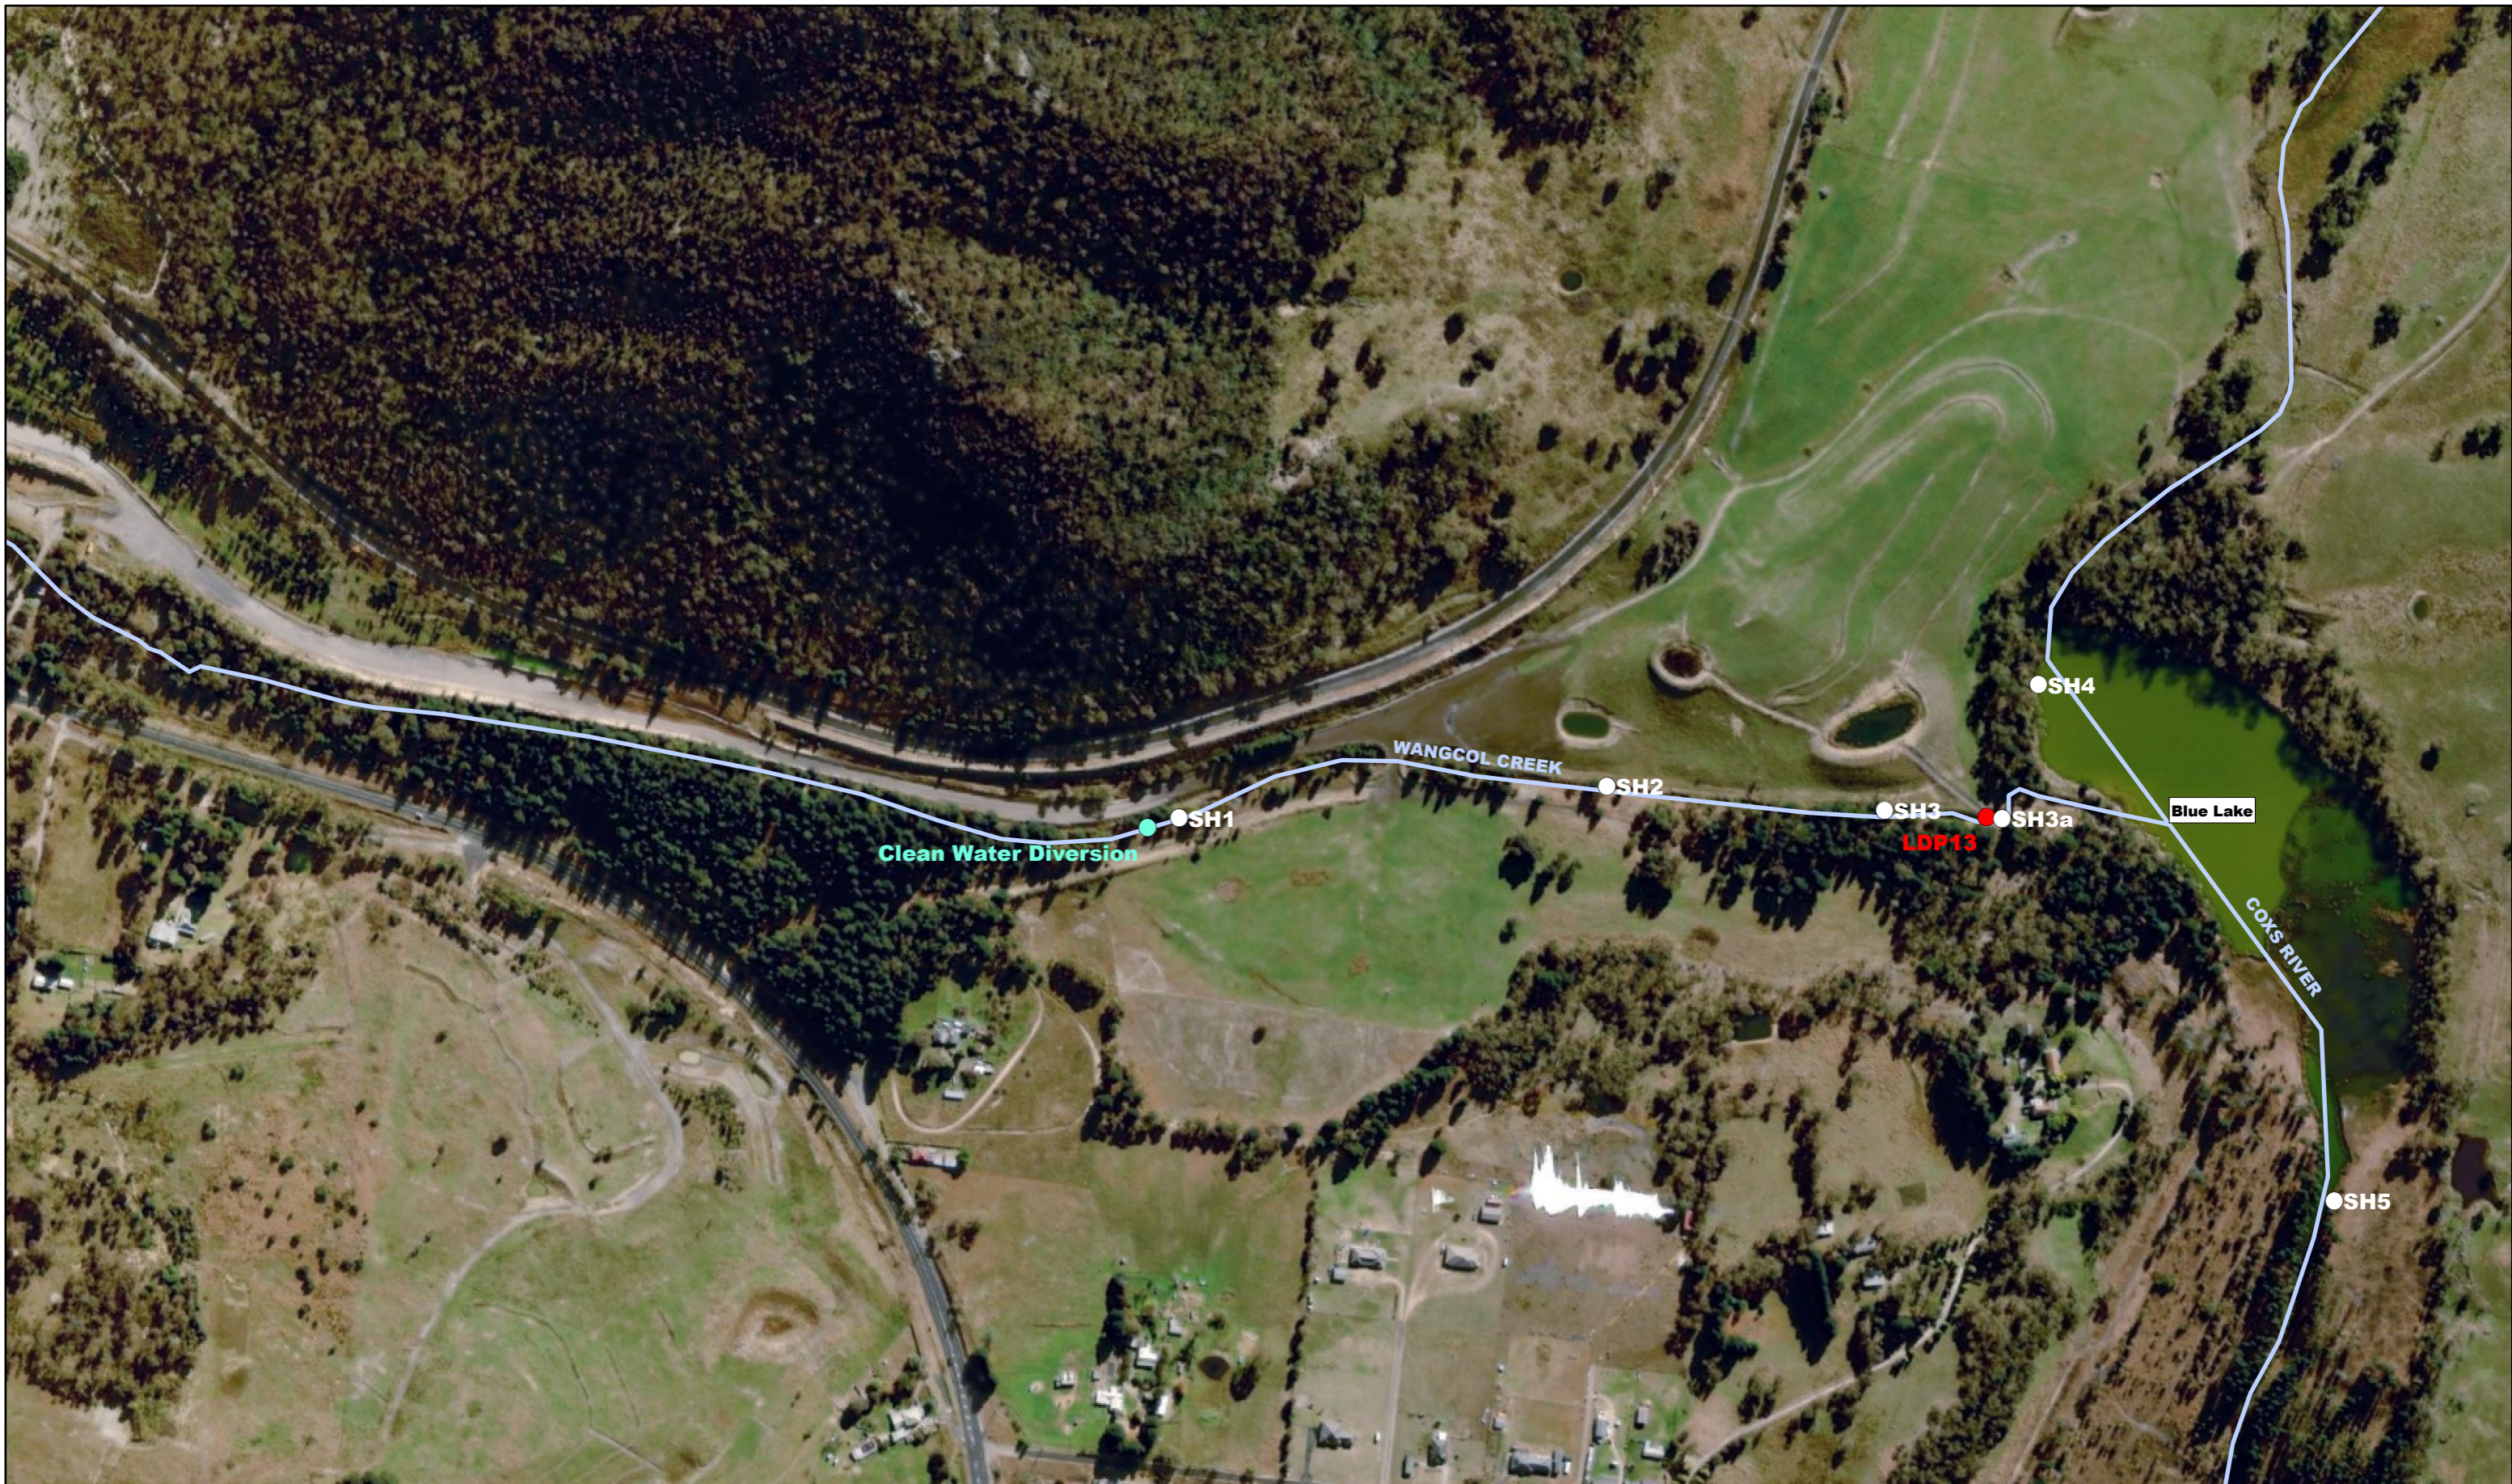
Drawing 2 – Stream Health & Channel Stability
Monitoring Locations

- Monitoring location
- Licence discharge point location
- Clean water diversion location

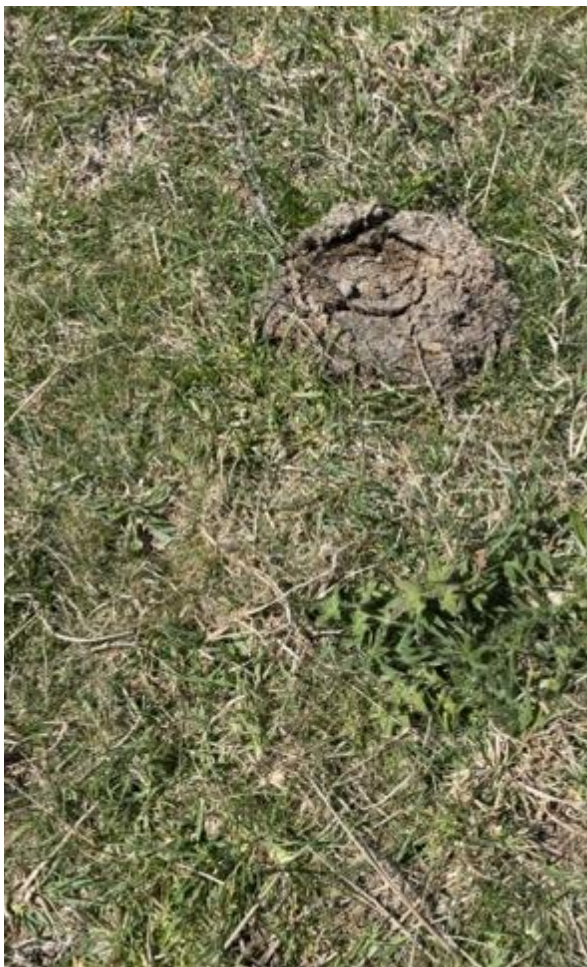
Figure 2 Pasture composition at analogue site

Species composition at pasture rehabilitation areas – Pasture rehabilitation areas were originally established with a sown mix comprising approximately 70% perennial grasses and 20% annual legumes, consistent with the analogue pasture site. Surveys undertaken in 2025 indicate that this composition has generally been maintained, with rehabilitation areas continuing to be dominated by introduced perennial pasture species such as *Phalaris aquatica* and *Lolium perenne*, and naturalised legumes including *Trifolium subterraneum*.

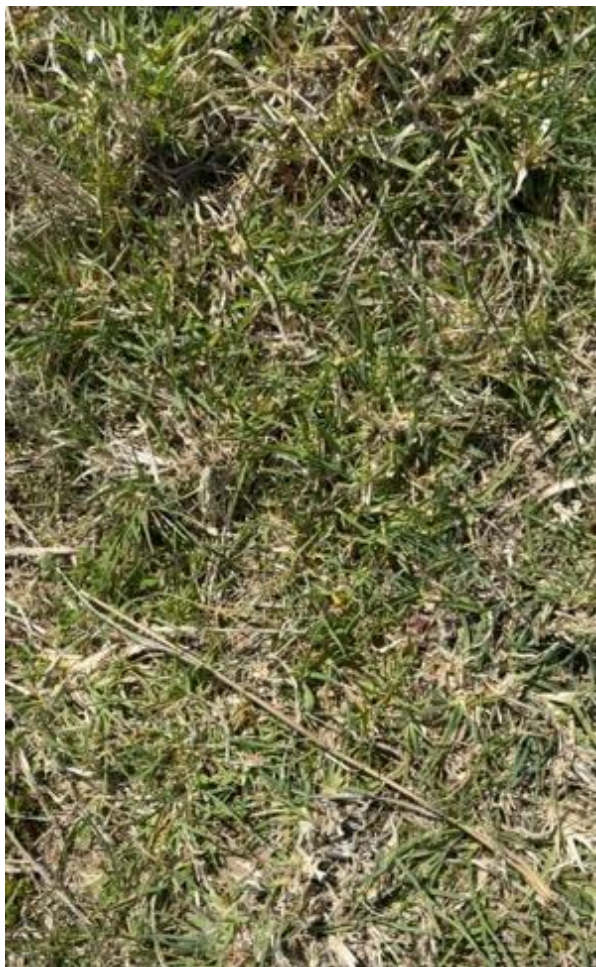
Figure 3 Pasture composition Area C

At Transect 4, the composition of the pasture sward has been locally influenced by increased cover of African Lovegrass (*Eragrostis curvula*), which exceeded 10% and may be suppressing sown and native species in some areas.

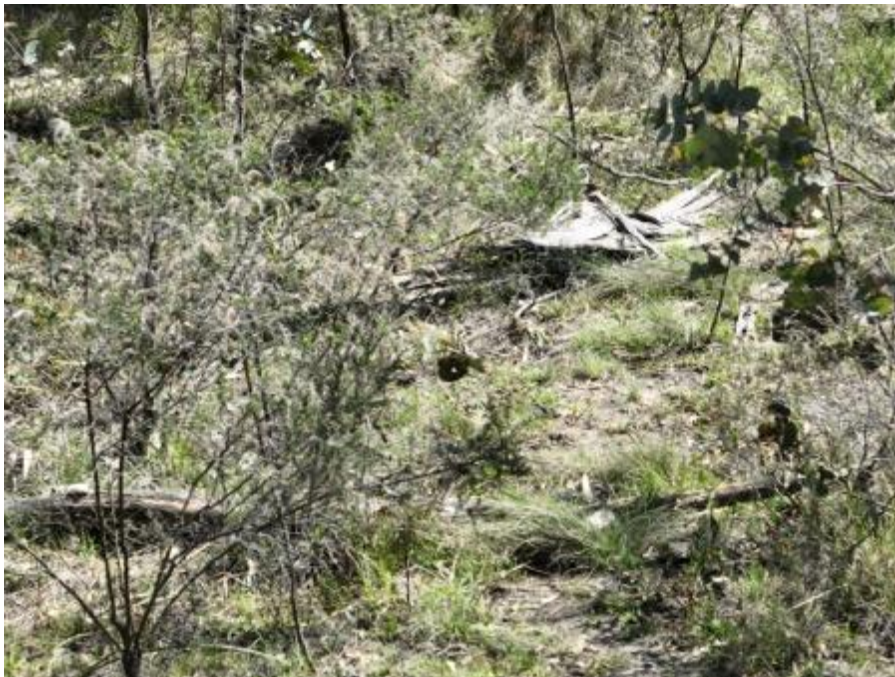
Rehabilitation at the treed analogue site - The treed analogue site, first assessed in 2019, was affected by fire in 2020, resulting in the loss of canopy and understorey vegetation. Post-fire recovery continues, with observations in 2025 indicating an increase in shrubby vegetation and juvenile eucalypt regrowth. The canopy has partially recovered, with canopy height reaching 14 m and approximately 20% cover, consistent with pre-fire conditions. Groundcover at the analogue site was >95%, consisting of a mix of native grasses and forbs.

Figure 4 Natural regeneration of the treed analogue site

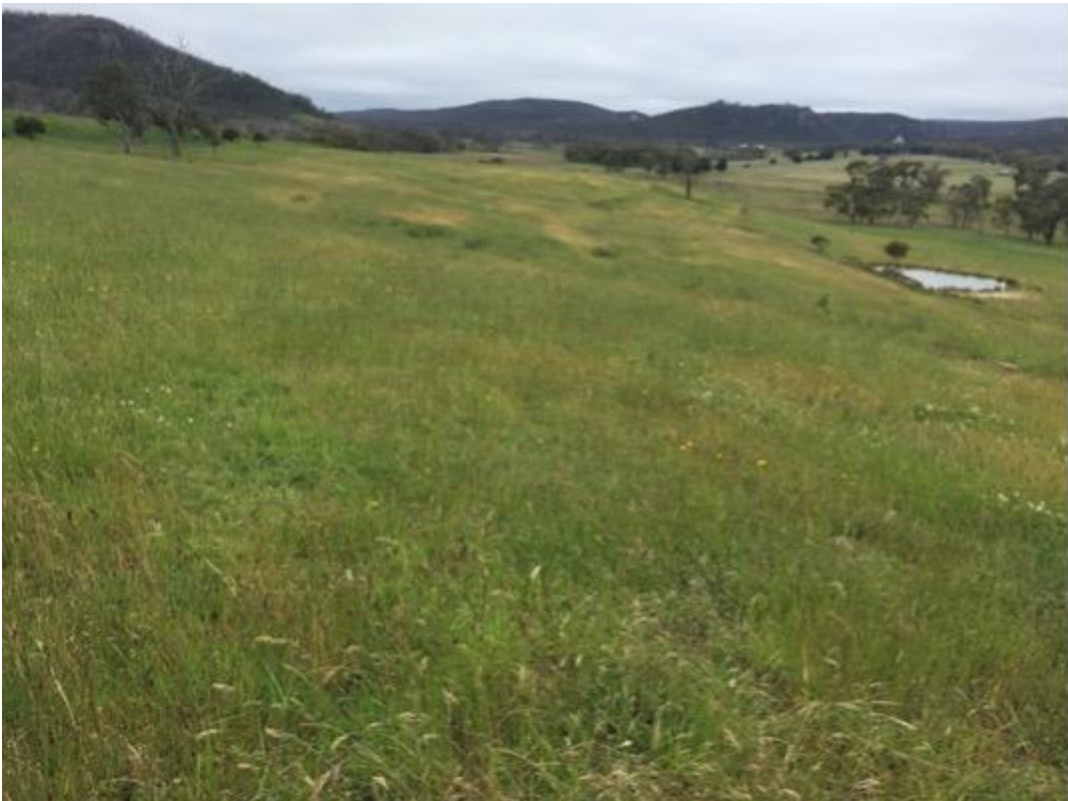
Transect 1 looking east 2021 note that the transect 1 photo-monitoring point was inaccessible to the presence of livestock
