Mt Piper Ash Placement Project Lamberts North
Annual Environment Management Report
September 2019 – August 2020

Lamberts North Annual Environment Management Report

Name of Operation	Mt Piper Ash Placement Lamberts North
Name of Operator	EnergyAustralia NSW
Development Consent / Project Approval #	09_0186
Environment Protection Licence (EPL) #	13007
Water Access Licence (WAL) #	10AL116411
Water Supply and Water Use Approval #	10CA117220
AEMR start date	1 st September 2019
AEMR end date	31 st August 2020

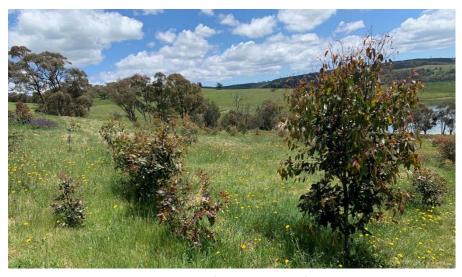
Plate 1. Eucalypt species have successfully established from revegetation undertaken in 2017.

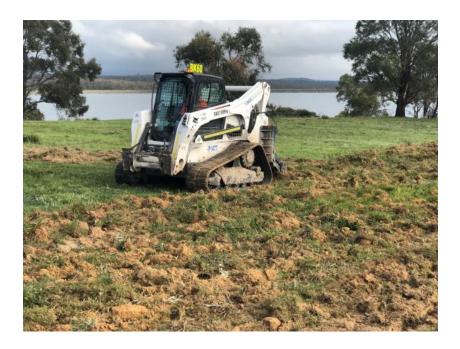
Plate 2. Bobcat Positrack fitted with rear ripper tines creating a seed bed at the BOA.

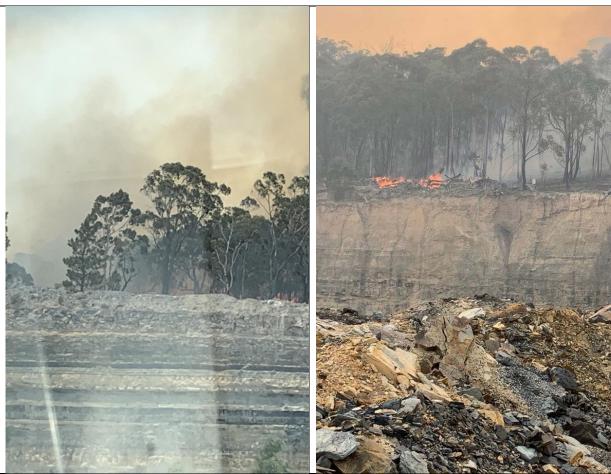
Plate 3: Gospers Mountain Bushfire adjoining Wangcol Creek at the Pinedale Mine.

Plate 4: Gospers Mountain Bushfire adjoining Wangcol Creek at the Pinedale Mine.

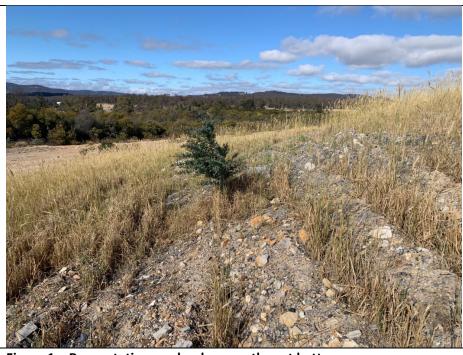
Figure 1 – Revegetation works along north east batter

No.	Monitoring measures	Status	Comment
1.	A monitoring program will be developed in conjunction with the revegetation procedure (Table 6-33 #6) commence once the first revegetation area has been planted.		The first revegetation area was sown in the 2019/2020 reporting year. The monitoring program to be developed.

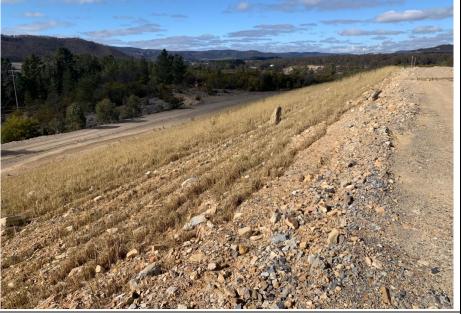
Figure 2 – Revegetation works along north east batter
