**ENHANCE PLACE MINE**

**2020**

**ANNUAL ENVIRONMENTAL  
MANAGEMENT REPORT**

**(Small Mine Version)**

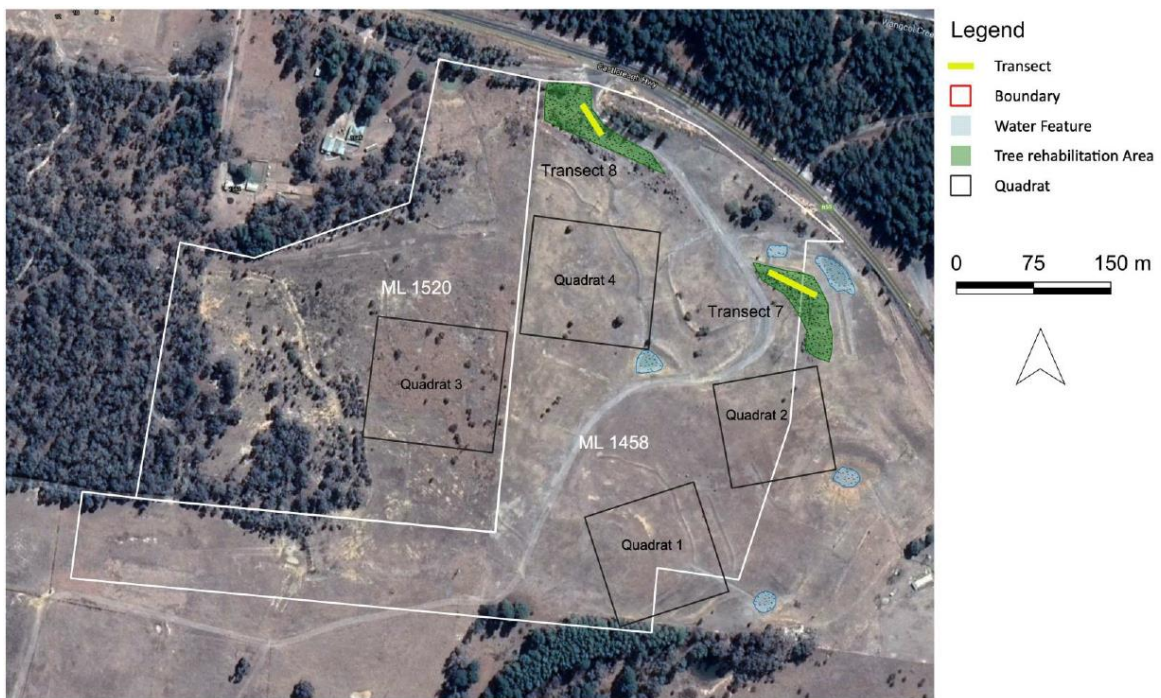
**Figure 1** Enhance Place Rehabilitation Survey Quadrat Locations (Ref [2])

Monitoring of pasture conditions was undertaken in September 2020 and detailed in the Rehabilitation Monitoring Report (Ref [2]). Monitoring of pasture conditions is undertaken at quadrats 1, 2, 3 and 4, as shown in **Figure 1**. Groundcover in quadrats 1, 2 and 4 have increased from 85% total living ground cover in 2019 to 90% in 2020. Groundcover during the September 2020 field survey is shown in **Photographs 1 – 4**.
